**COMISIÓN DE  
INVESTIGACIÓN  
DE ACCIDENTES  
E INCIDENTES DE  
AVIACIÓN CIVIL**

## **Report IN-015/2018**

Incident involving a DIAMOND  
DA20-C1 aircraft, registration  
EC-MQT, at the La Axarquía  
aerodrome in Vélez-Málaga  
(Málaga) on 9 May 2018

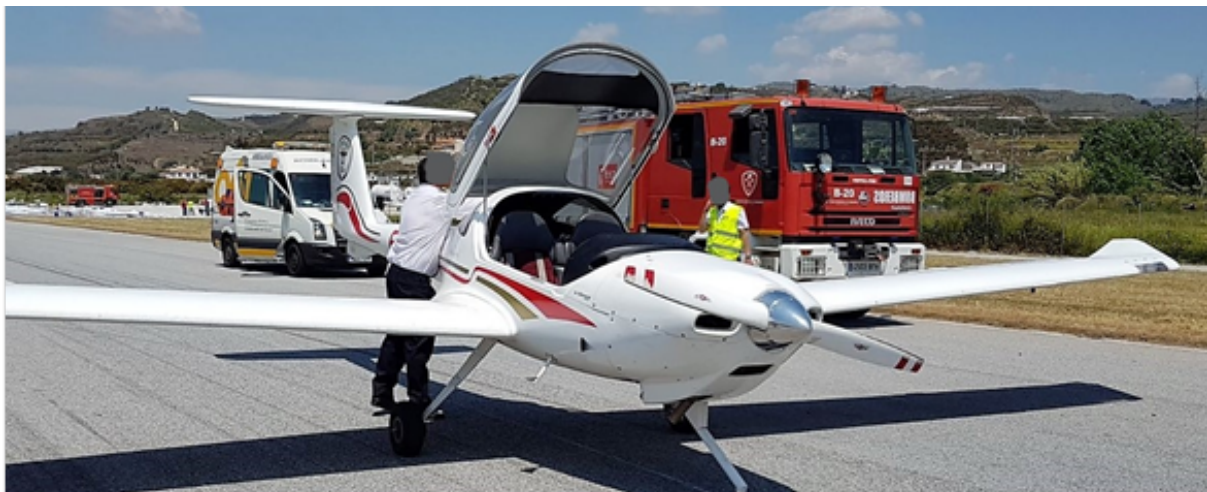
Photograph 1. Incident aircraft after the emergency landing

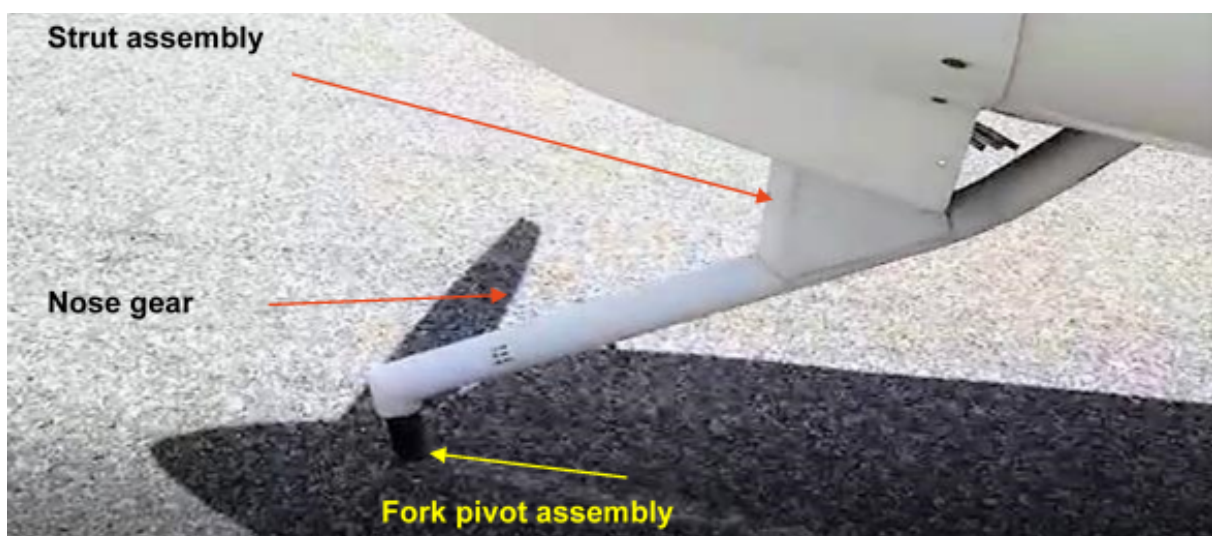
Photograph 4 shows the main components of the nose gear on the aircraft after the incident.

Photograph 4: Nose landing gear on the aircraft after the incident

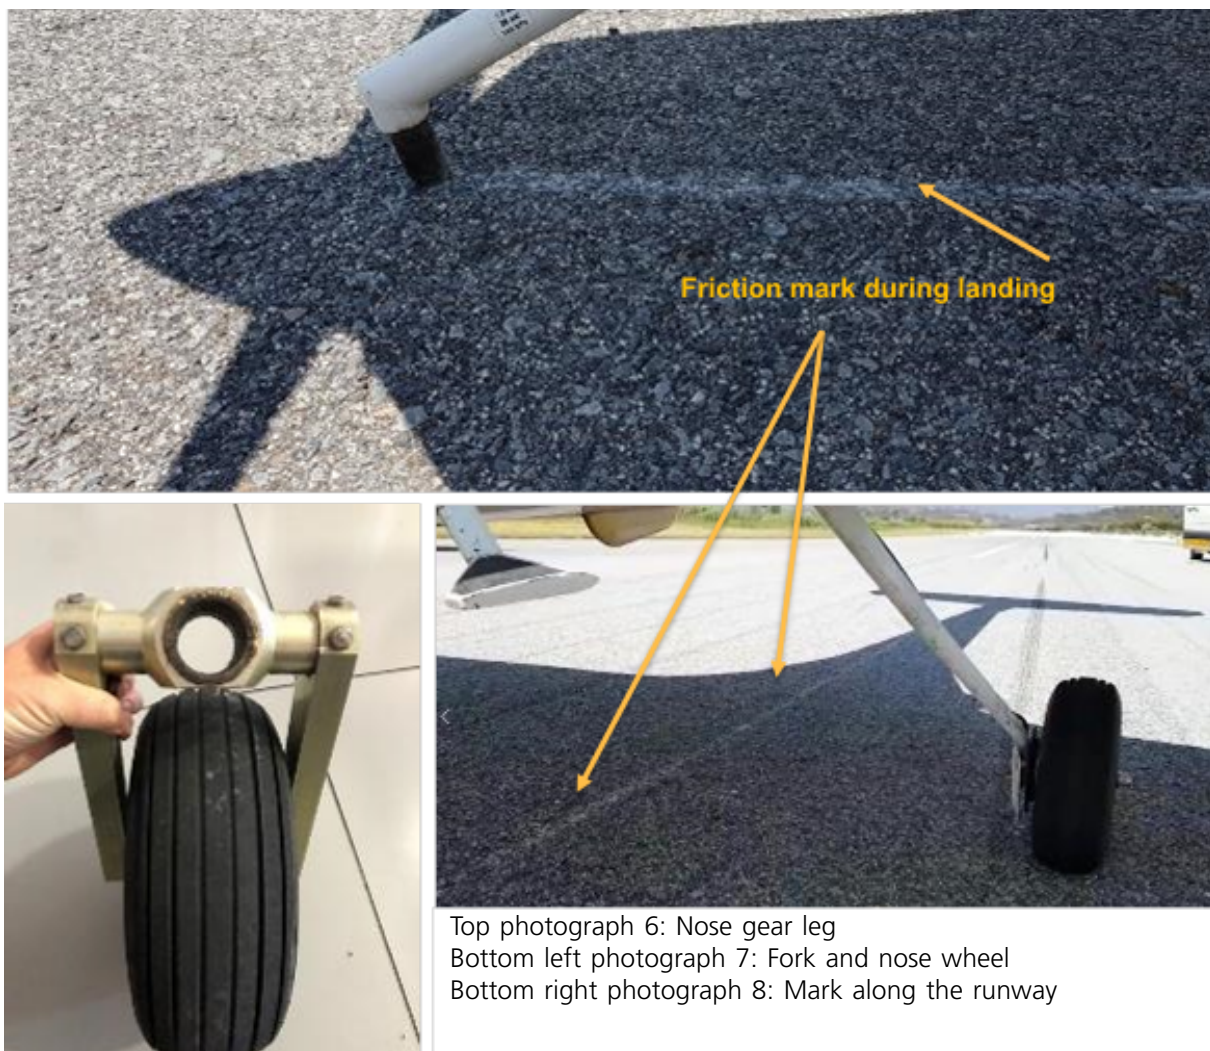
This mark consists of a friction mark on the asphalt with hardly any wear or depth on it.

The damage to the aircraft was minor, and affected only the nose landing gear. The bottom coupling with the detached nose wheel was recovered from the runway where the airplane landed.

Top photograph 6: Nose gear leg  
Bottom left photograph 7: Fork and nose wheel  
Bottom right photograph 8: Mark along the runway

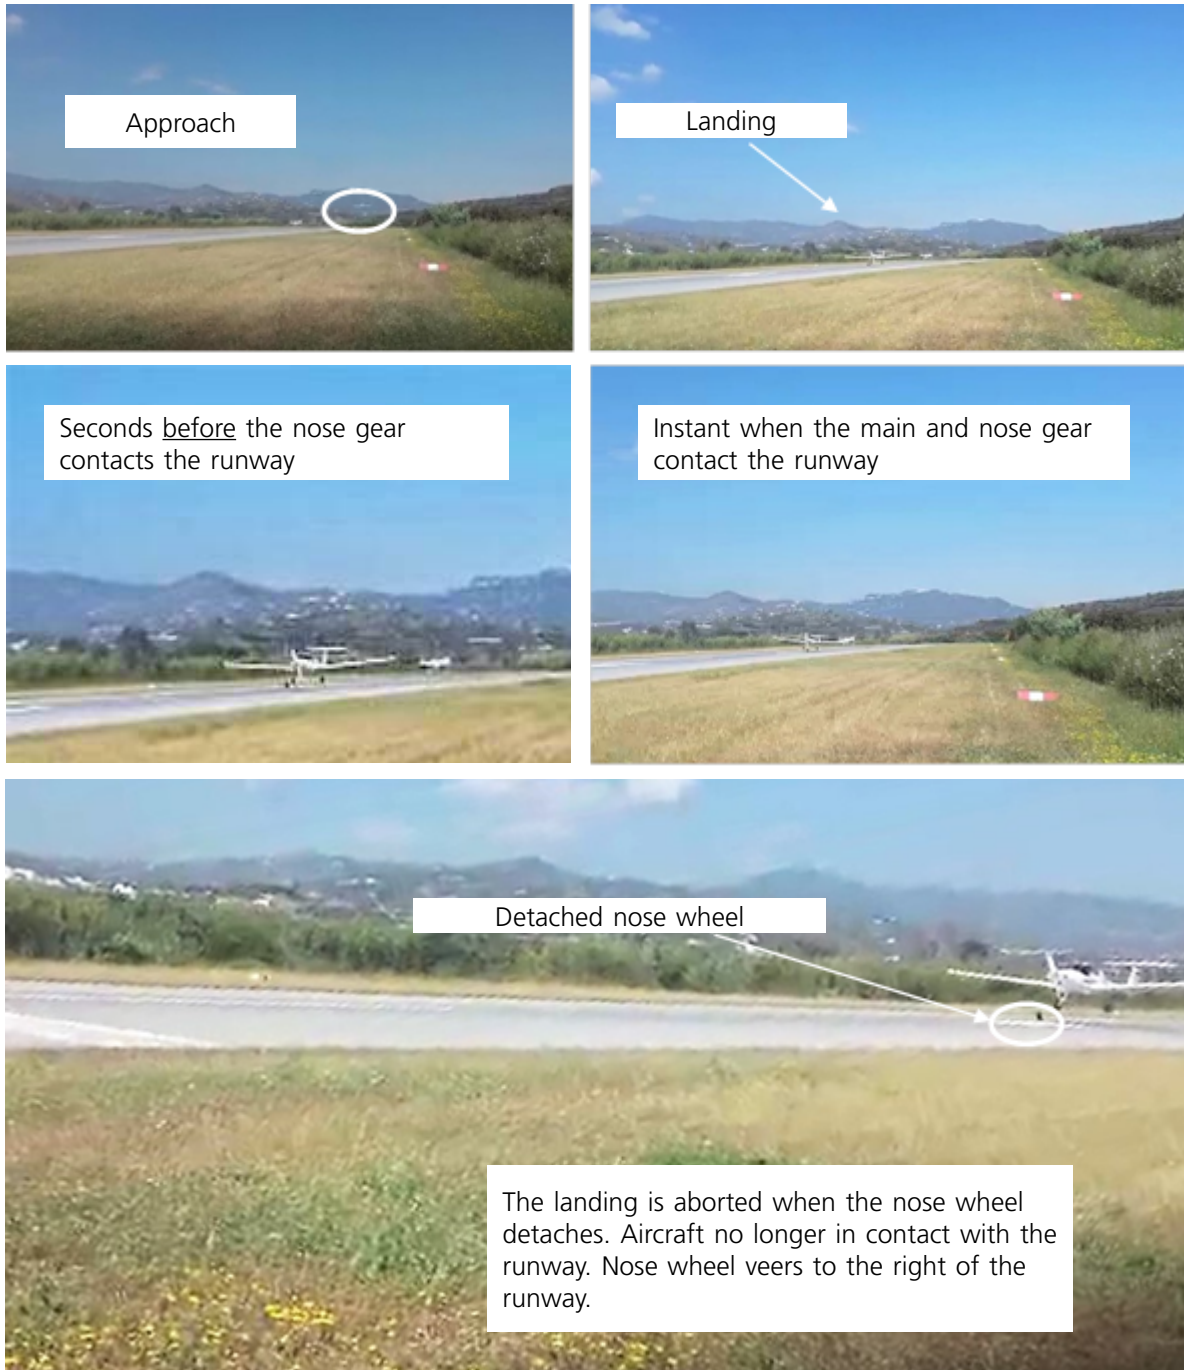
First is the series of photographs from when the student, after completing his first solo flight, attempts to land. This landing was aborted when the student heard a strange noise and felt an unusual vibration in the aircraft, at which time he decided to go around. At the same time, the instructor, who was on the ground, radioed him to tell him that part of the nose gear had detached.

Series of photographs 9: Aborted landing sequence

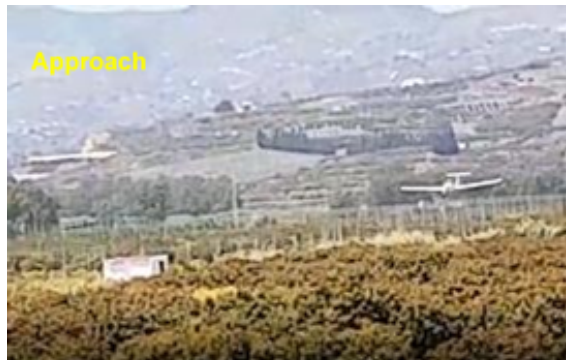
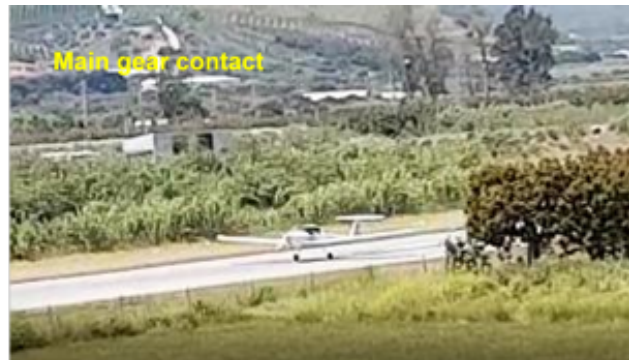
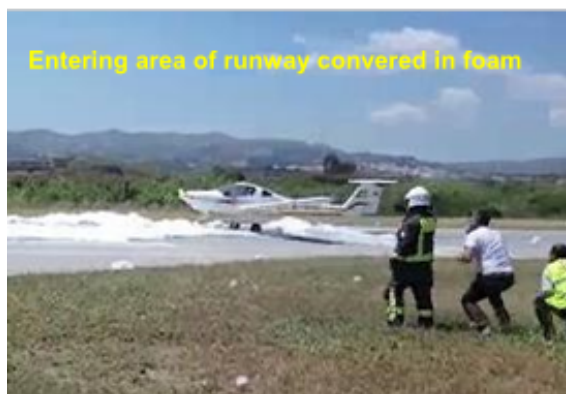
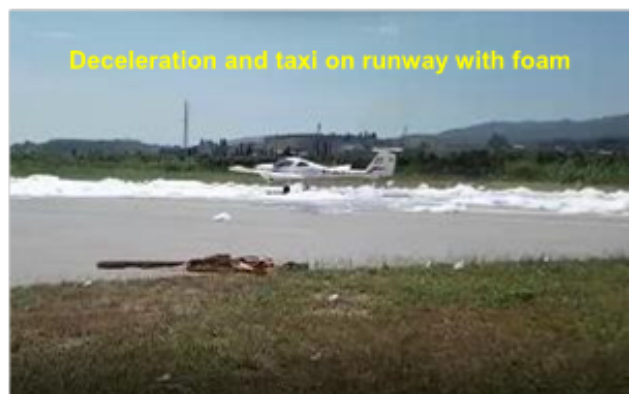
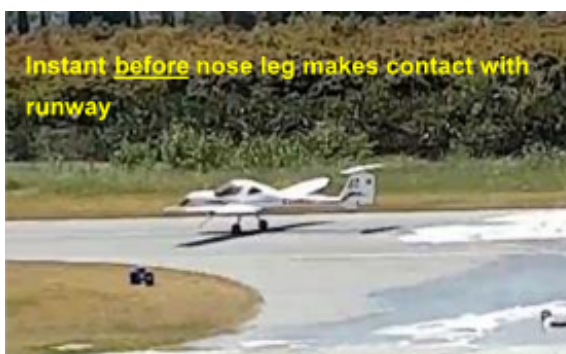
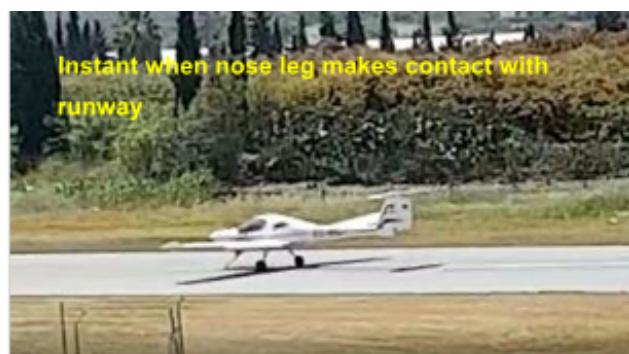
Series of photographs 10: Emergency landing sequence

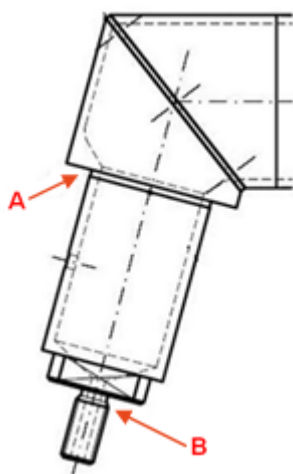
The most recent maintenance manual published by the aircraft manufacturer is Rev. 22, issued on 30 May 2014, which is affected by temporary revision DA201-C1 TR 32-01, from 11 September 2018, after the date of this event. This temporary revision is mentioned because the aircraft manufacturer evaluated the need to conduct an additional inspection of the nose gear, and specifically of the pivot that connects the gear to the nose wheel fork, since there have been cases where cracks have appeared in these components that can affect operational safety. Of particular concern is the area labeled A in Figure 4, pivot radius. This component has P/N 20-3220-02-00, and is an assembly that is welded to the threaded end of the nose gear leg. Said component was also replaced by P/N 20-3220-02-00\_1, which improves its structural design. In the incident investigated in this report, area B, pivot stud, in Figure 4, is the area that was severed after the emergency landing.

Figure 4: Pivot at end of nose landing gear

This temporary revision includes a new task to be performed in the 2000 flight hour inspection consisting of checking the pivot on the nose landing gear using liquid penetrants (LPI<sup>3</sup>), as per the testing procedure that is contained in the revision itself.

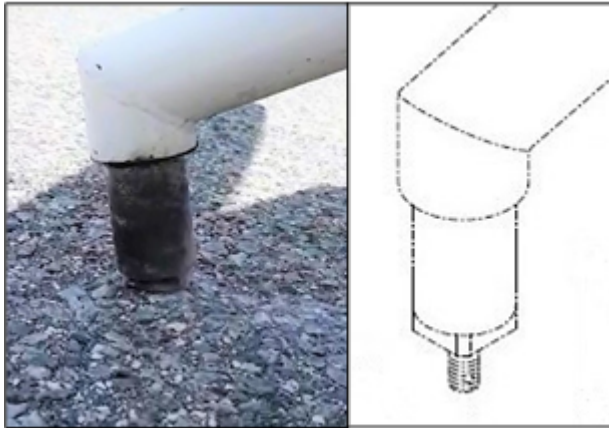
Left photograph 11: Close-up of pivot where the Wheel fork attaches to the nose landing gear.  
Right figure 6: Close up of pivot in the IPC.

Photograph 11 shows the pivot that attaches the nose gear to the wheel fork. As the video footage shows, the stud supported part of the aircraft's weight at the end of the landing run after the fork assembly broke off, causing the stud to come into direct contact with the runway surface. The aircraft was also supported by this end of the nose gear after coming to a stop.

As Figure 6 shows, the threaded end of the pivot in the incident aircraft, which attaches the nose wheel fork, was missing. The rest of the surface on the pivot exhibited signs of corrosion.

- 1– the threaded end of the nose landing gear had been severed, and there was wear and corrosion on the stud.
- 2– the coupling bushings where the pivot is inserted into the leg also showed a lack of lubrication, as well as corrosion and wear on the contact surfaces.

The subsequent wear on the severed pivot caused by traveling on the runway during the emergency landing made it impossible to identify how the threaded end fractured. There were signs of corrosion throughout its surface, however.

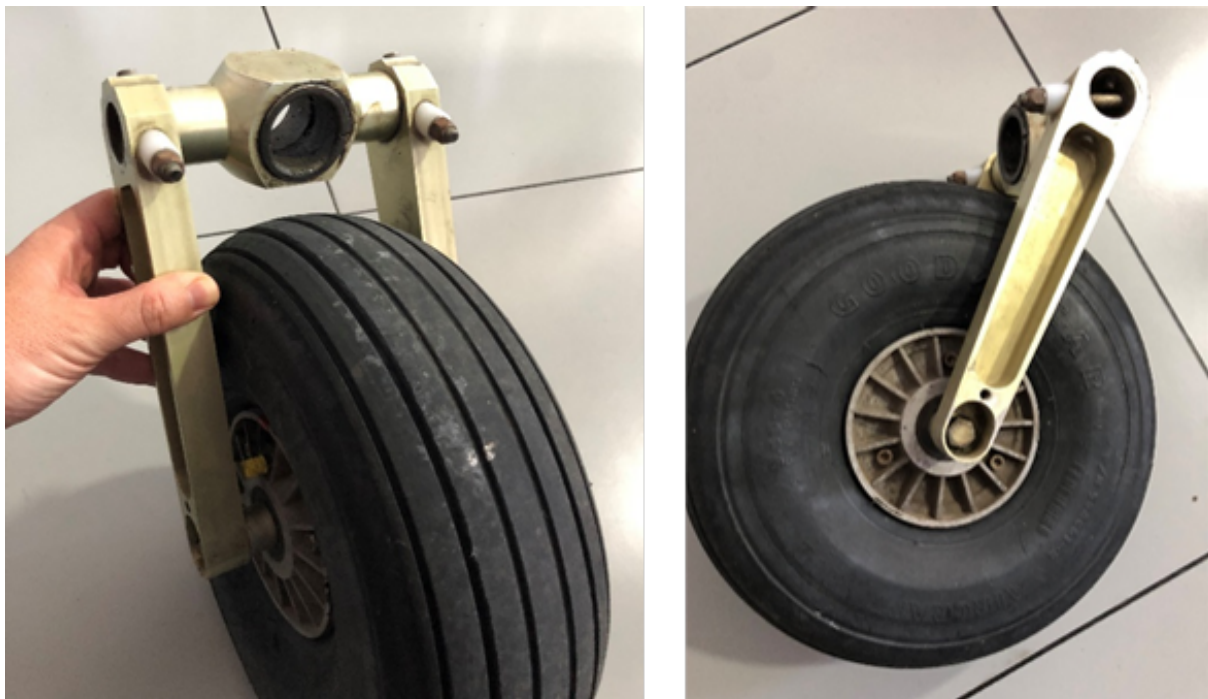
Series of photographs 12: Nose landing gear fork from the incident aircraft

The nose wheel fork assembly that detached during the aborted landing was recovered, but the nuts, washers and other components used to secure it to the nose gear were not.

The fork was in acceptable condition, as were the wheel and tire, as series of photographs 12 shows.

The nose wheel fork and the wheel itself were in good condition, so it is unlikely that they could have influenced the incident. Not even the wear or lack of lubrication on the flanged bushings are deemed to have had any effect on the detachment of the fork.

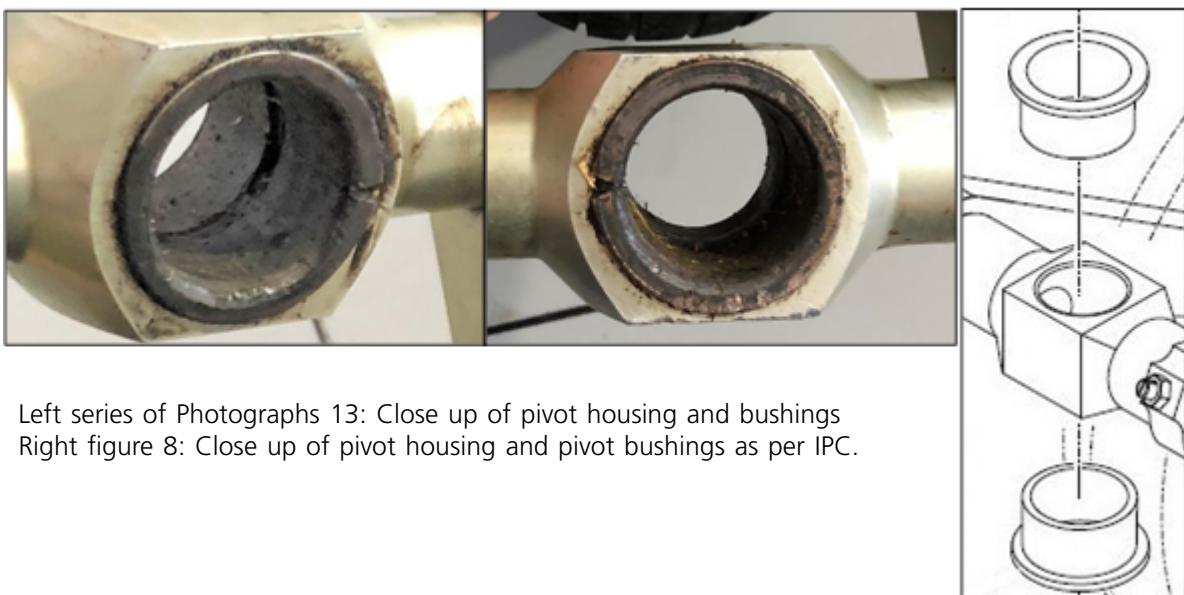
These bushings exhibited wear and corrosion.

The play between the pivot and flanged bushings could not be measured due to the poor condition of the parts.

Left series of Photographs 13: Close up of pivot housing and bushings  
Right figure 8: Close up of pivot housing and pivot bushings as per IPC.
