**COMISIÓN DE
INVESTIGACIÓN
DE ACCIDENTES
E INCIDENTES DE
AVIACIÓN CIVIL**

Report IN-015/2019

Incident involving a BOEING
B-737-524, registration LY-KLJ,
at the Getafe Air Base (Madrid)
on 5 April 2019

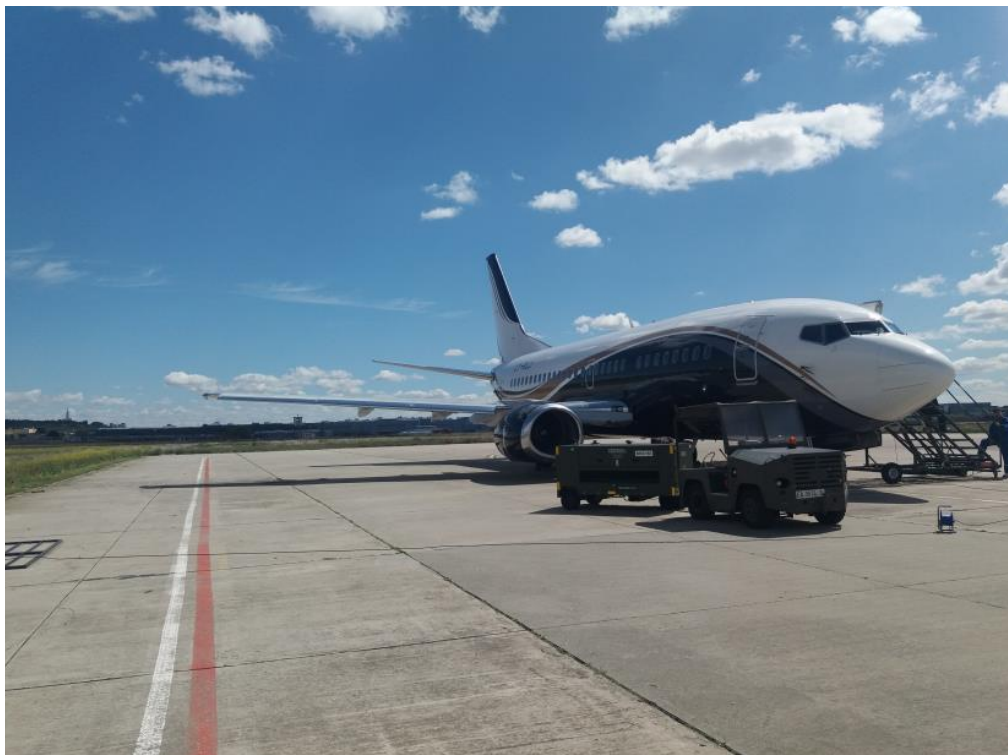
Figure 1. Photo of the aircraft at the air base

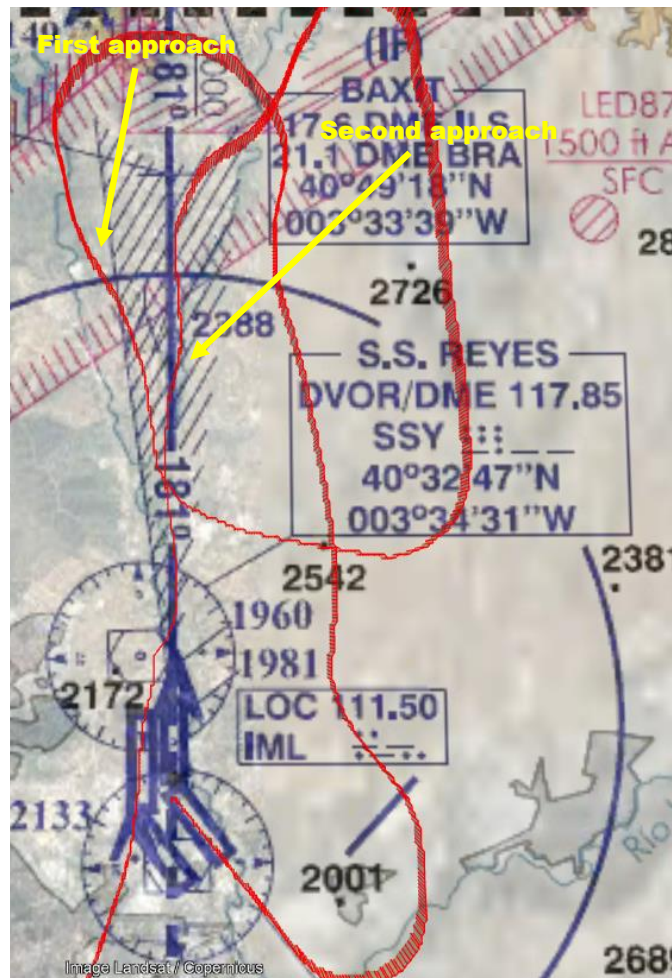
After going around, the airplane began to climb as it turned right. It then proceeded to the Getafe Air Base (LEGT) after being diverted by ATS. The flaps were extended at 14:23:42 h, during the first landing attempt at LEMD, and they were kept extended in various positions until 14:37:48 h, by which time it was already climbing while proceeding to LEGT after the second go-around.

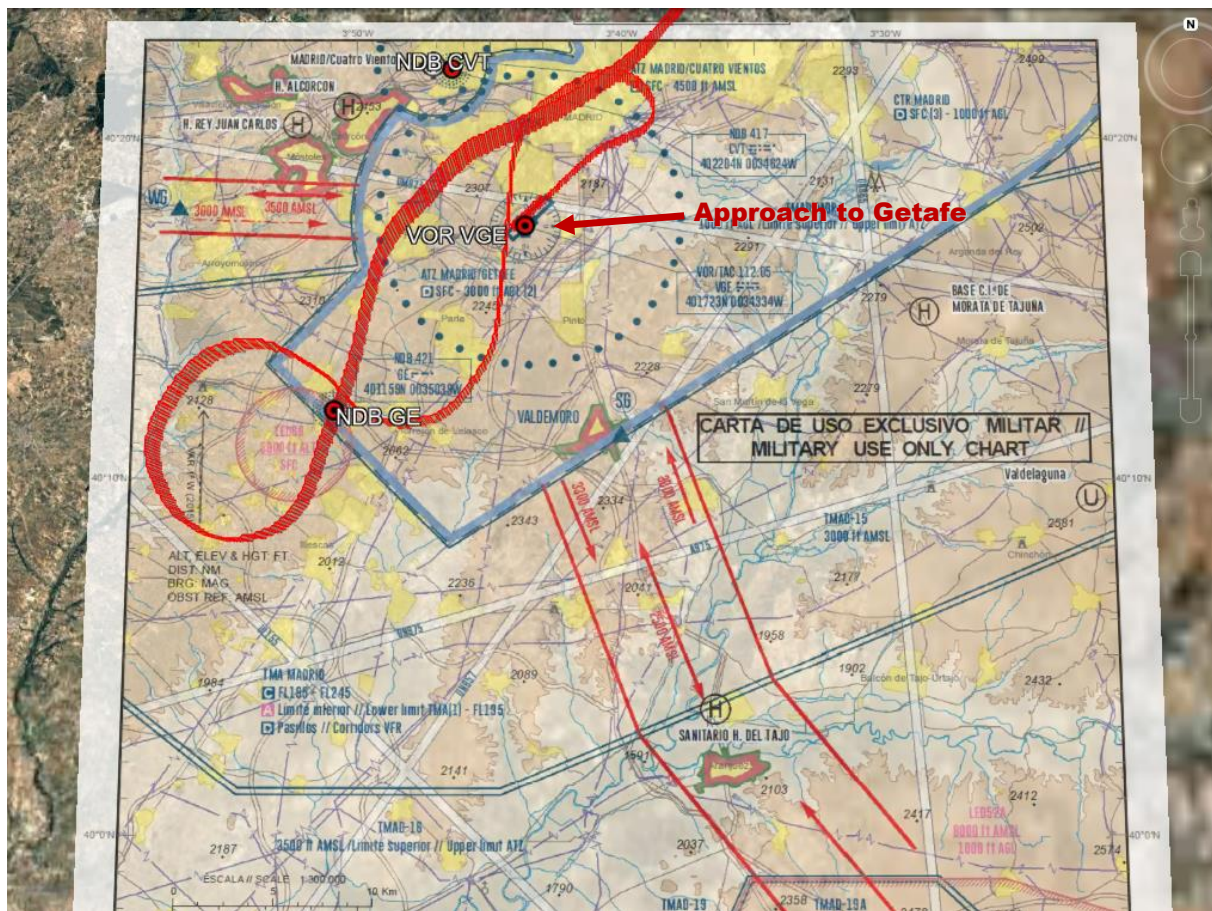
At 14:50:43 h, it was on the runway heading (229°) with a GS of 170 kt at an altitude of 3520 ft. It eventually landed at 14:52:28 with a GS of 160 kt (CAS of 145 kt).

Figure 14. Approach to runway 23 at Getafe

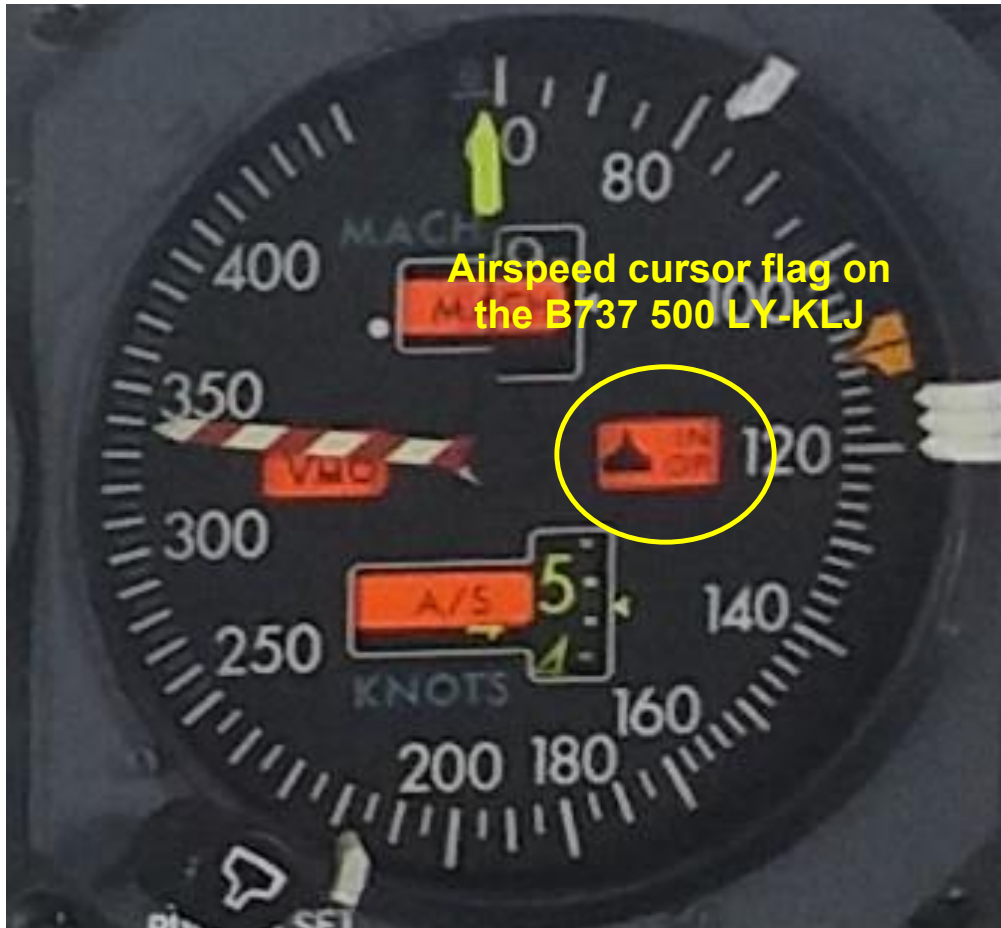
Figure 4. Photograph of the airspeed indicator
