**COMISIÓN DE
INVESTIGACIÓN
DE ACCIDENTES
E INCIDENTES DE
AVIACIÓN CIVIL**

Report IN-019/2019

Incident involving a Boeing 737-86N, registration G-GDFS, and a Diamond DA20-C1, registration EC-KMH, near point E in the Reus Airport CTR on 12 May 2019

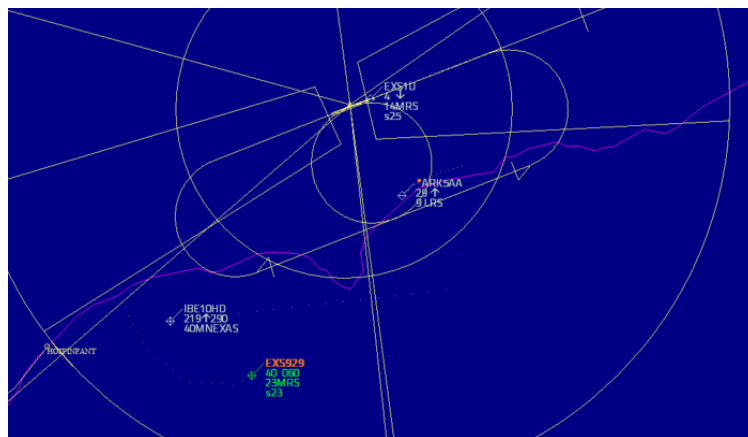
Illustration 1: Position of G-GDFS at 10:32:26

At 10:32:26, G-GDFS, whose callsign was EXS929, after missing its approach due to not being stabilized, was on the outbound leg to try a new ILS Y approach based on the RUS NDB. The instrument approach chart published in the AIP specifies that the outbound leg is to be flown descending from an altitude of 5000 ft to 3800 ft by DME mile 13 on the ILS; however, the aircraft was flying at an altitude of 4000 ft, as it had been cleared to do so by the air traffic controller.

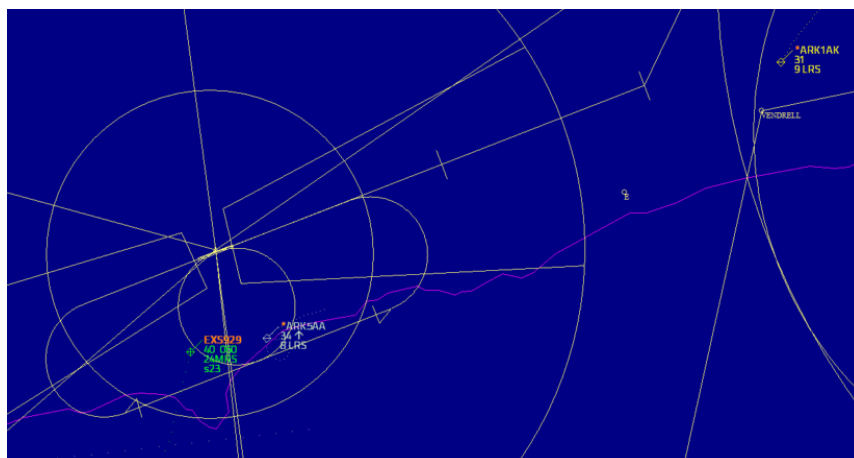
Illustration 2: Position of the aircraft at 10:34:40

At 10:34:40, EC-KMH, whose callsign was ARK1AK, was preparing to enter the Reus Airport CTR via reporting point E. At that time, it was at an altitude of 3100 ft. This aircraft had been instructed by the controller to maintain 3500 ft or higher due to an aerobatic show that was taking place over Tarragona.

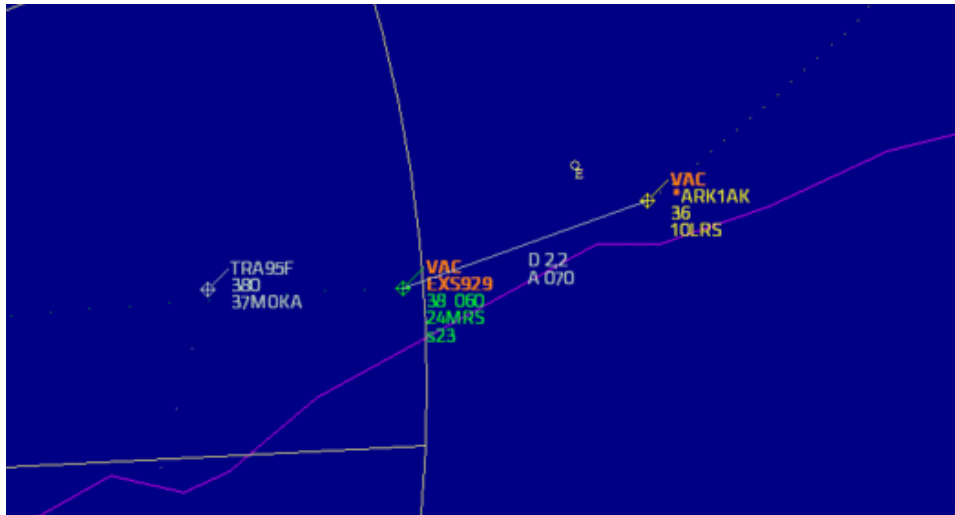
Illustration 3: Position of the aircraft at 10:37:41

At 10:37:41, G-GDFS was on the outbound leg, approaching mile 13 on the ILS DME at an altitude of 3800 ft, and EC-KMH was near reporting point E in the CTR at an altitude of 3600 ft. (On the outbound leg, mile 13 on the ILS DME practically coincides with reporting point E). At this time, the two aircraft were separated by 2.2 nautical miles horizontally and 200 ft vertically.

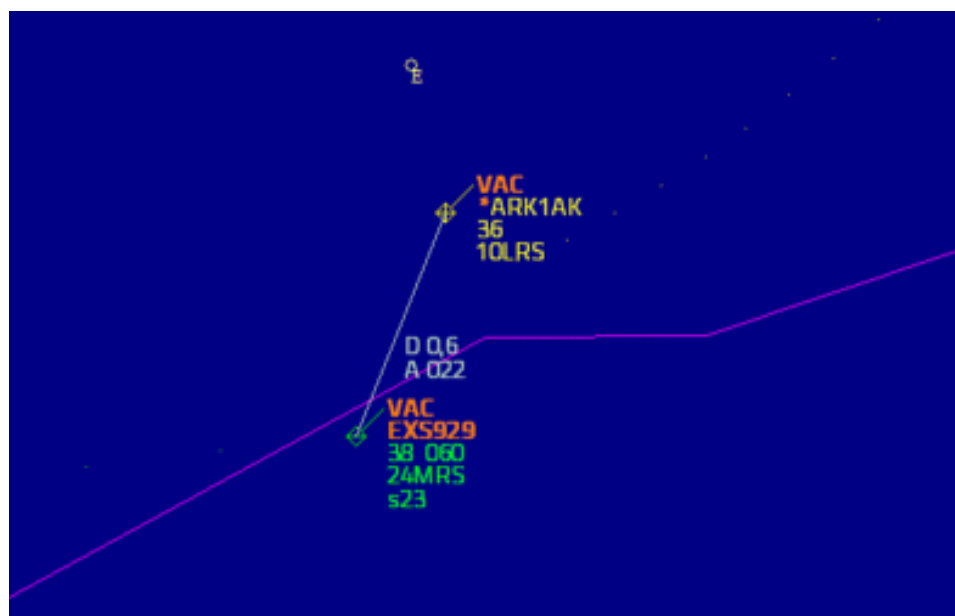
Illustration 4: Position of the aircraft at 10:38:05

The minimum separation between the aircraft occurred at 10:38:05, after which G-GDFS began to climb and separate from EC-KMH after receiving a TCAS resolution advisory.

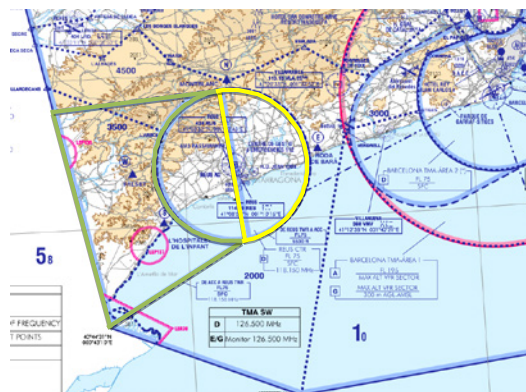
Illustration 5: Airspace where approach control services are provided

The approach control service provided by the control tower at the Reus Airport in the Reus CTR airspace is conventional, meaning it is procedural. The service is provided in the Reus CTR airspace and in an airspace delegated by the Barcelona TMA (highlighted in green in the chart below) up to FL75. Reus also delegates to the Barcelona TMA a semicircular segment (highlighted in yellow) between FL75 and 5500 ft AMSL.

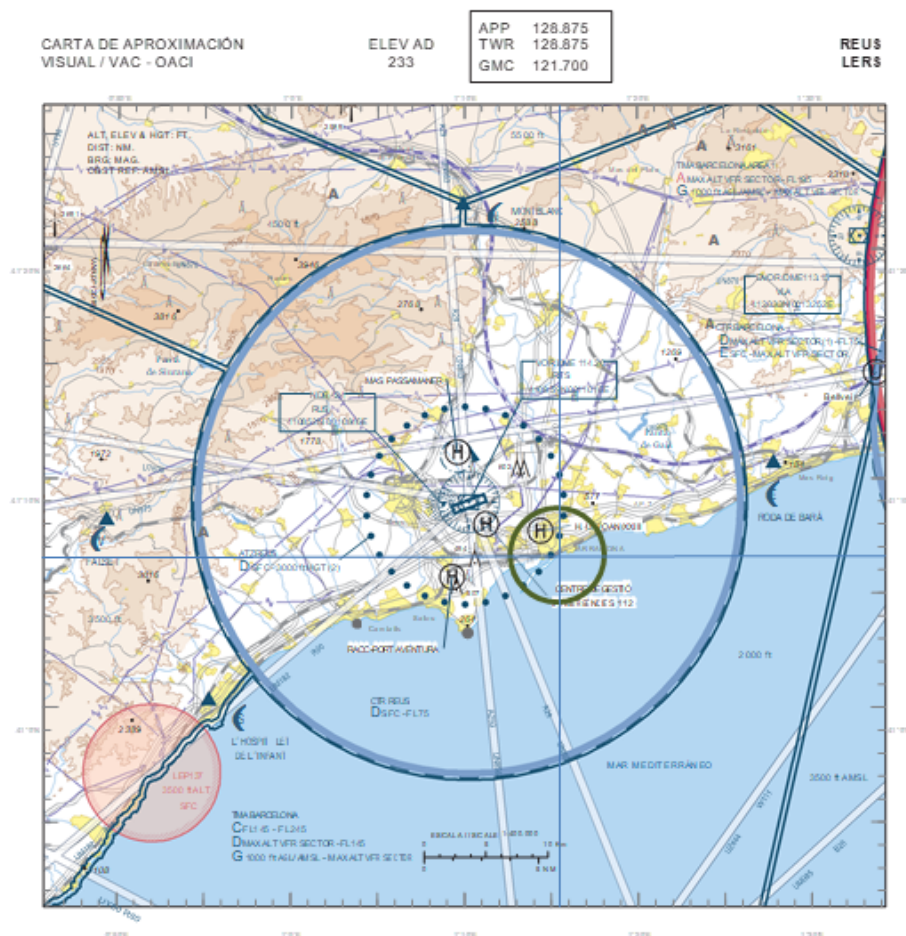
Illustration 6: Close-up of the airspace where the air show was taking place (in green)

Shown in green on the visual approach chart for the Reus Airport is the outline of the airspace that was used for this aerobatic air show.

As the chart shows, a small part of this airspace was within the Reus ATZ, and was thus monitored on radar by the air traffic controllers; however, the majority of this area was inside the Reus CTR, and the controllers were not aware of the aircraft in this area:

REC 02/20. It is recommended that ENAIRE establish more safety measures when aerobatic flights are near an aerodrome.
