# Technical report

## IN-019/2022

Incident on 31 March 2022 involving a Boeing 737-8AS aircraft operated by Ryanair, registration EI-DLC, at Adolfo Suárez Madrid-Barajas Airport

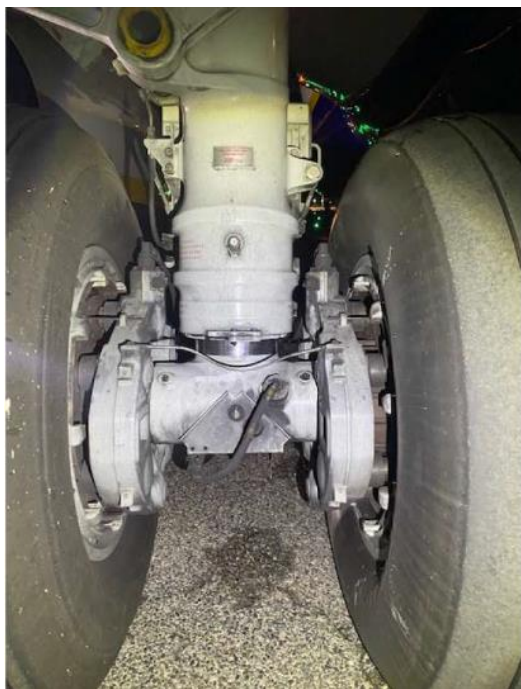
Figure 4 - Left main landing gear.

Figure 4 shows that the left wheel was misaligned in relation to the right wheel.

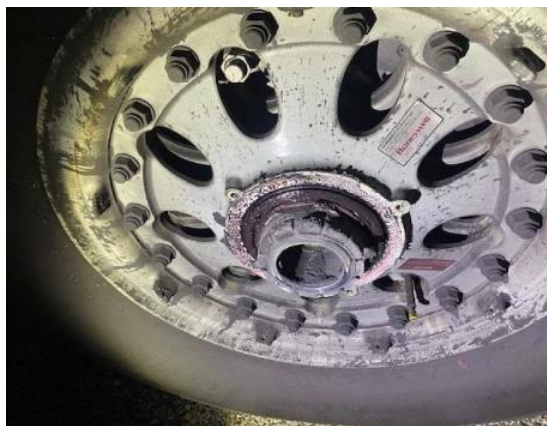
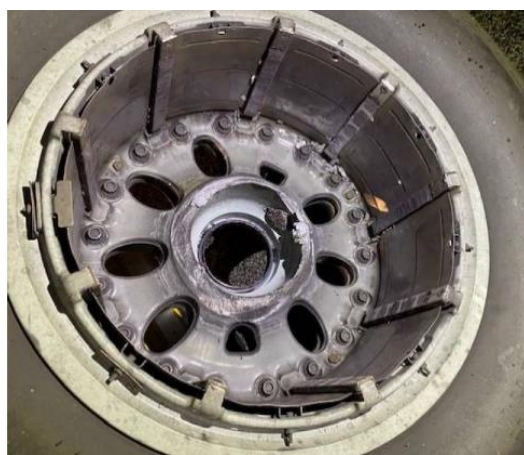
Figure 5 - Exterior and interior of the affected wheel.

Figure 5 shows the condition of the inner wheel half and the outer wheel half. The part of the hub that remained attached to the wheel half can be observed.

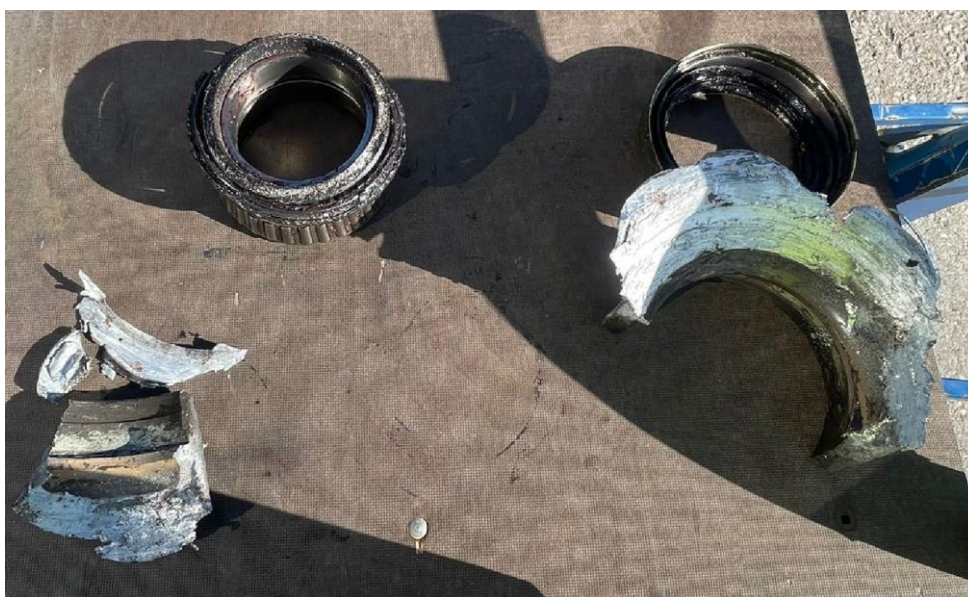
Figure 6 - Associated fractures to the affected wheel.

Figure 6 shows the part of the hub of the inner wheel half that detached from the wheel (broken into several fragments), as well as the inner wheel bearing and its cup.

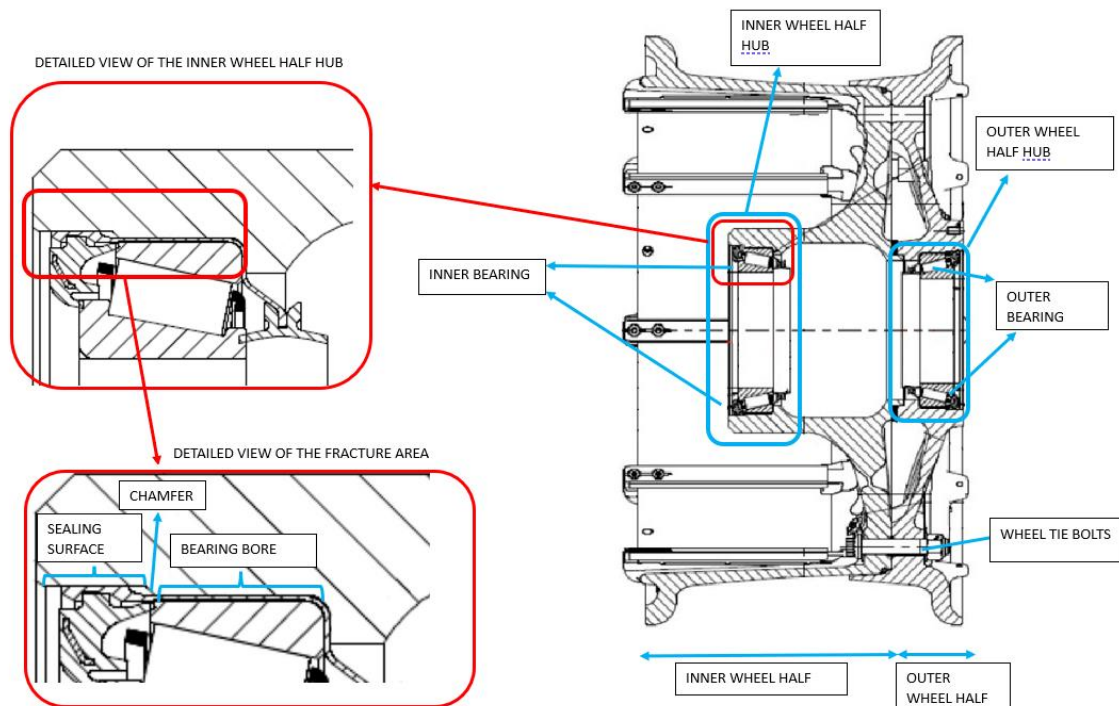
- The study identified several radial and circumferential fractures in the hub fragments from the inner wheel half.
- The primary fracture was caused by a fatigue crack originating from one corner of the chamfer between the bearing bore and the sealing surface on the hub of the inner wheel half. The analysis of the area in which the crack originated revealed the existence of corrosion. Said crack was identified on the surface of one of the radial fractures.

Figure 7 – Sketch of the wheel showing the area in which the fracture originated.

The wheel manufacturer's report found that the primary fracture was caused by a fatigue crack originating in one of the corners of the chamfer between the bearing bore and the sealing surface on the hub of the inner wheel half, and that there was corrosion in that area. This crack was hidden by the bearing cup.

As indicated by the AAIB in its report (see section 1.18), the wheel manufacturer developed, as a mitigation measure, an ultrasonic inspection technique to locate cracks in the area of the wheel where the fracture occurred (the chamfer between the bearing bore and the sealing surface on the hub of the inner wheel half), which is also the area of the wheel affected by the fracture in the incident that is the subject of this investigation. The AAIB report also indicated that the operator had incorporated the ultrasonic inspection technique into its maintenance programme for the fleet of BOEING 737-8AS aircraft.

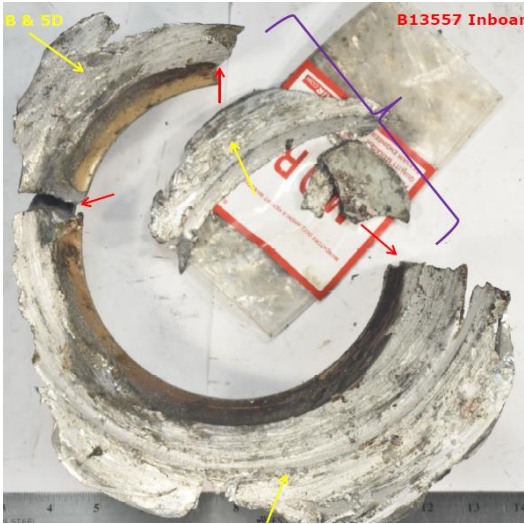
Figure 8 – Hub fragments from the inner wheel half studied by the laboratory.

Figure 8 shows the hub fragments from the inner wheel half that were studied by the laboratory. Figure 9 shows a close-up of the largest fragment studied.

In both figures, the red arrows indicate the radial fractures, while the yellow arrows indicate the circumferential fractures. The green arrow indicates wear marks on the exterior of the hub.

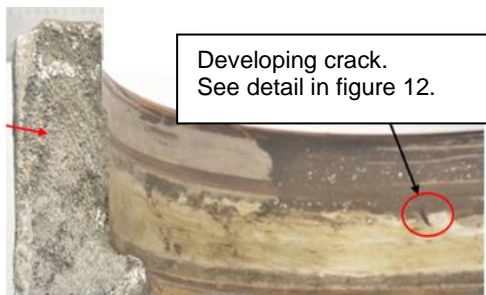
Figure 10 – Close-up of the inner wheel half hub fracture surface (1).

The following figures (figures 10 and 11) show close-up views of the two radial fracture surfaces on the largest hub fragment. Figure 10 also shows the other developing crack mentioned at the beginning of this section (detailed view in figure 12). In addition, figure 11 highlights, with a red bracket, the chamfer between the bearing bore and the sealing surface of the inner wheel half hub, which is where the fatigue crack that led to the fracture was found (detailed view in figure 13).

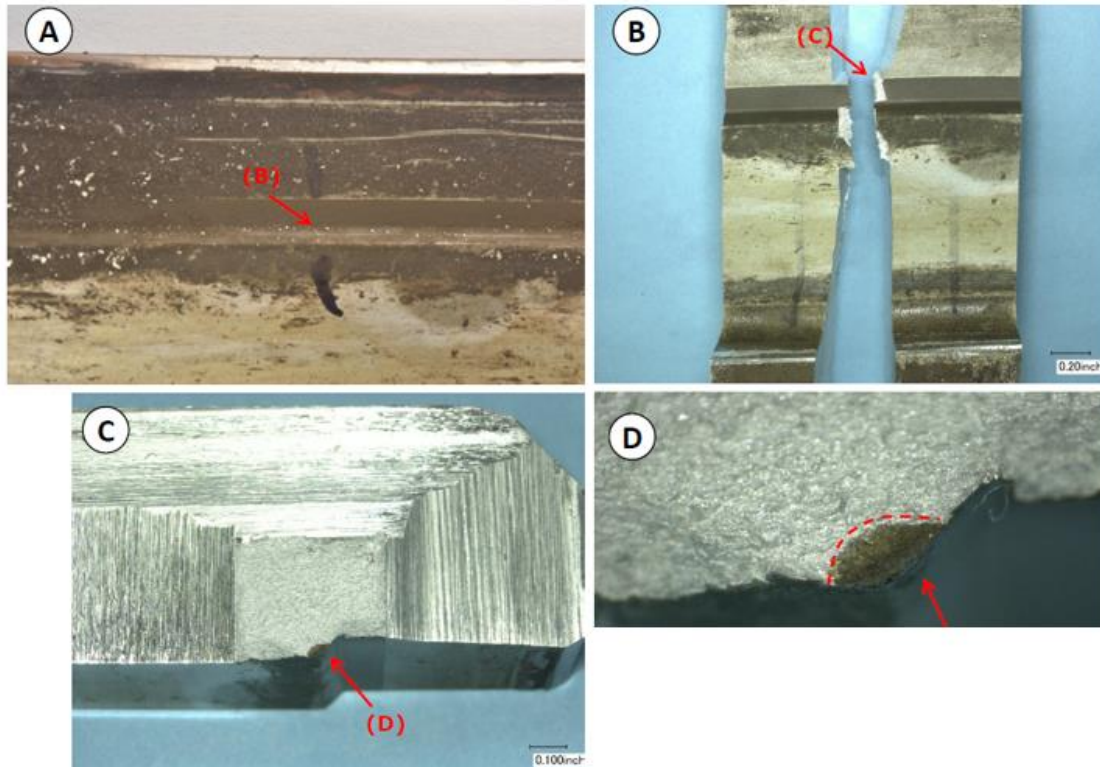
- A second developing crack was detected in another section of the hub of the inner wheel half. Laboratory work determined that this developing crack had the same origin and propagated in the same way as the crack that caused the primary fracture.

In the next figure (figure 12), image A shows the other crack identified (developing crack) by eddy current testing in another part of the hub of the inner wheel half. Laboratory work determined that this developing crack had the same origin and propagated in the same way as the crack that caused the primary fracture. Images C and D show the area where the corrosion was found and its approximate extent.

*Figure 12 – Close-up of the other crack, with the same origin and characteristics as the crack that caused the primary fracture, in another section of the hub.*

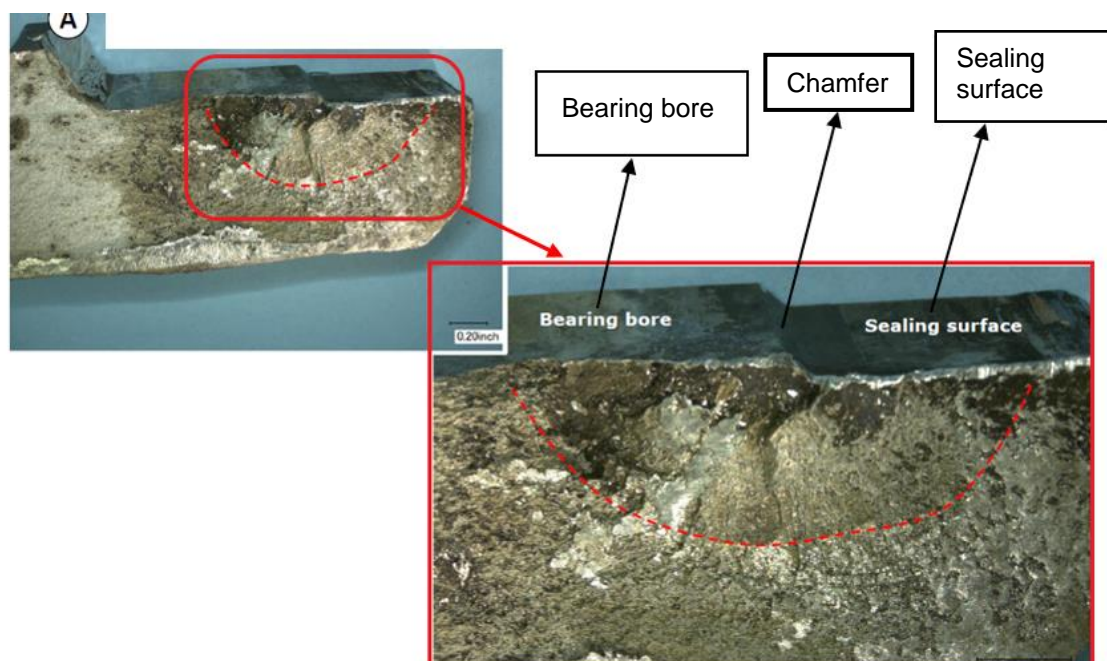
Figure 13 – Close-up of the fracture surface.

The figure below (figure 13) shows a close-up image of the fracture surface where the fatigue crack that led to the fracture was found. Typical fatigue fracture features were identified, originating around the chamfer between the inner bearing bore and the sealing surface. The dashed red line delineates the approximate extent of the area exposed to fatigue.

Thus, in this case, it is considered that the primary fracture had as a remote cause (the mechanism that initiated the failure procedure) the presence of corrosion pits on the internal surface of the hub and, as a direct cause, the creation and subsequent propagation of a fatigue crack that eventually caused sufficient damage to the material to result in the sudden fracture of the hub (overload fracture).

Therefore, it is considered that the failure process began with the creation of a fatigue crack in a corrosion pit (a weak point on the surface of the part where stresses are concentrated), which grew over time due to the varying nature of the loads to which the wheels are subjected. The crack continued to grow over time until it reached a critical size, at which point the hub ruptured suddenly due to overload when the wheel could no longer withstand the stresses to which it was subjected.
