**COMISIÓN DE  
INVESTIGACIÓN  
DE ACCIDENTES  
E INCIDENTES DE  
AVIACIÓN CIVIL**

## **Report IN-020-2017**

Incident involving an ATR  
72-212A aircraft, registration  
EC-KKQ, operated by Swiftair,  
at flight level 170 in the vicinity  
of reporting point NARGO  
(Albacete-Spain)  
on 9 September 2017

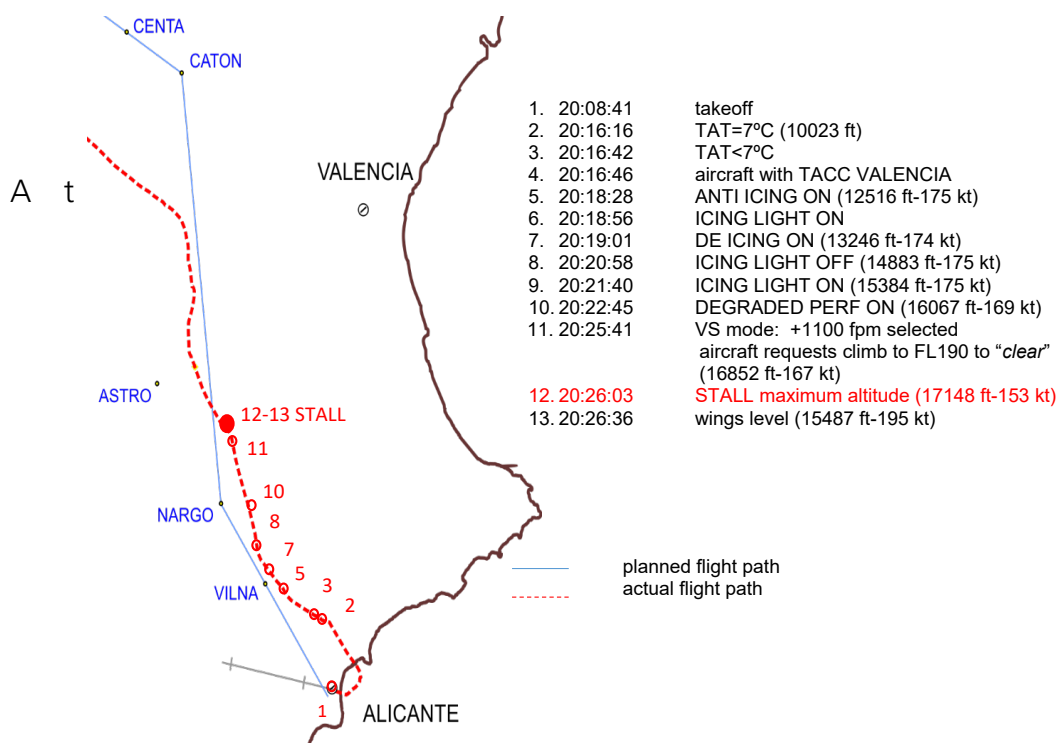
Figure 2. Flight path up to the event (18 min of flight time)

By 20:26:03, as a consequence of the previous actions, the aircraft had lost speed and was stalling at 153 kt. For 33 s, the aircraft descended, from 17148 ft to 15487 ft. During this descent, a minimum speed of 151 kt, an angle of attack of up to 19.6°, a pitch angle of up to -11°, and left and right bank angles of 58° and 39°, respectively, were recorded.

Stall was recovered at 20:26:36, 15487 ft and 195 kt.

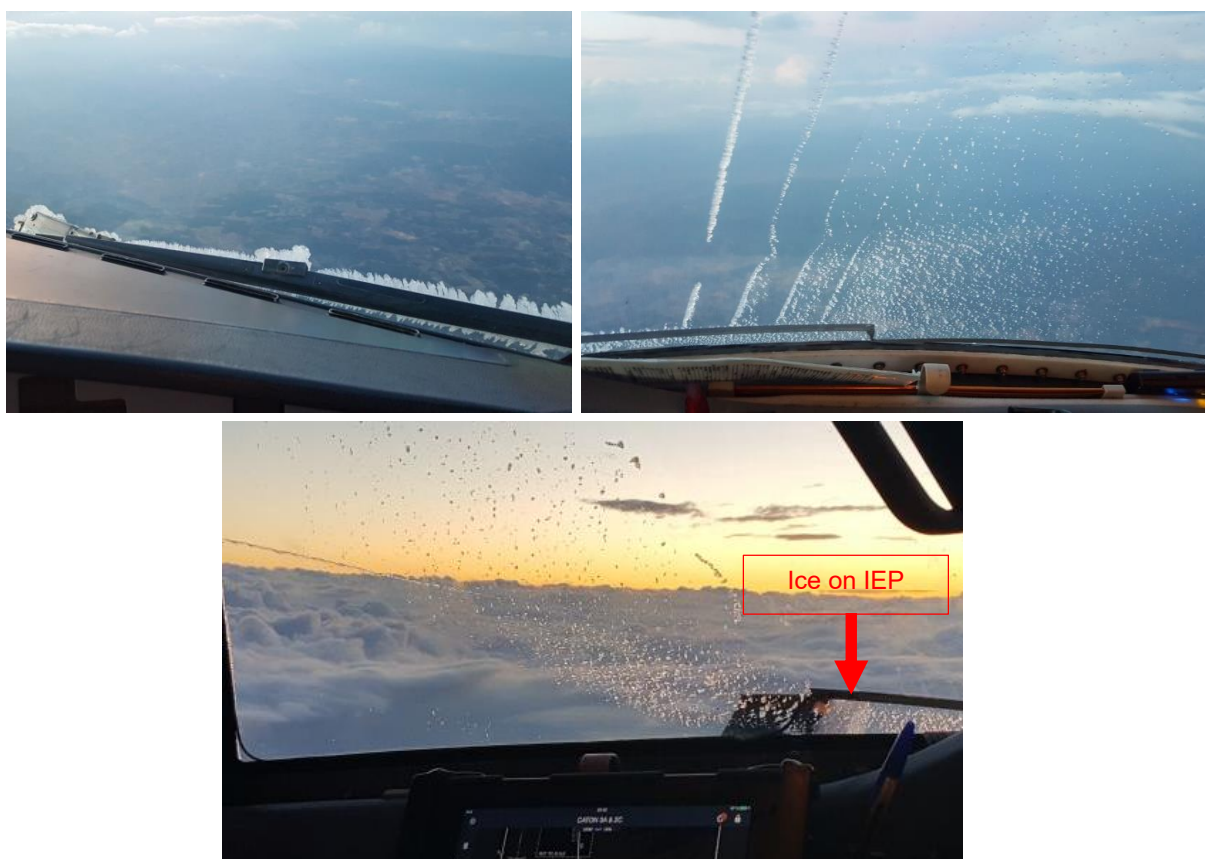
Figure 5. Photos taken by the first officer

The crew took photographs from the cockpit 8 min (and 27 NM) after the event (point marked on Figure 4). These photos<sup>21</sup> show:

- Ice build-up on the windshield wipers, on the side windows of the cockpit, at the interface between the boots and the leading edge of the right wing and on the flap actuator fairings.
- A 5-cm block of ice on the IEP.

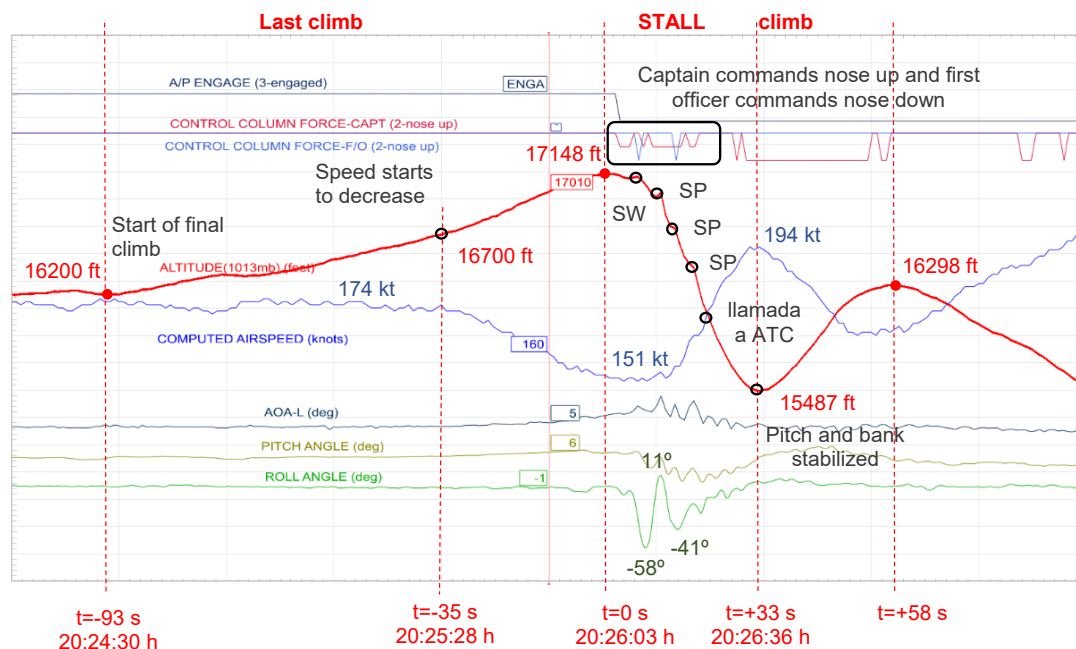
Figure 7. Detail of the stall

The aircraft managed to reach its highest altitude of 17148 ft at 20:26:03, at a speed of 153 kt and pitch angle of 6°. Six seconds before reaching its highest point, the vertical speed was changed, first to 800 fpm and then to -200 fpm.

<sup>31</sup> The activation threshold for the stall warning, based on information from the aircraft manufacturer, for the conditions at the time (no flaps, icing and cruise) is  $11.2^\circ$ .

<sup>32</sup> The activation threshold for the stick pusher, based on information from the aircraft manufacturer, for the flight conditions (no flaps, icing and cruise) is  $15.3^\circ$ . This value can drop by  $3^\circ$  if the change in the angle of attack reaches  $4.87^\circ/\text{s}$ .
