Report IN-022/2019

Accident involving a CESSNA
560XL-XLS+, registration
D-CGAA, at Alicante-Elche
Airport (Spain), on 30 May 2019

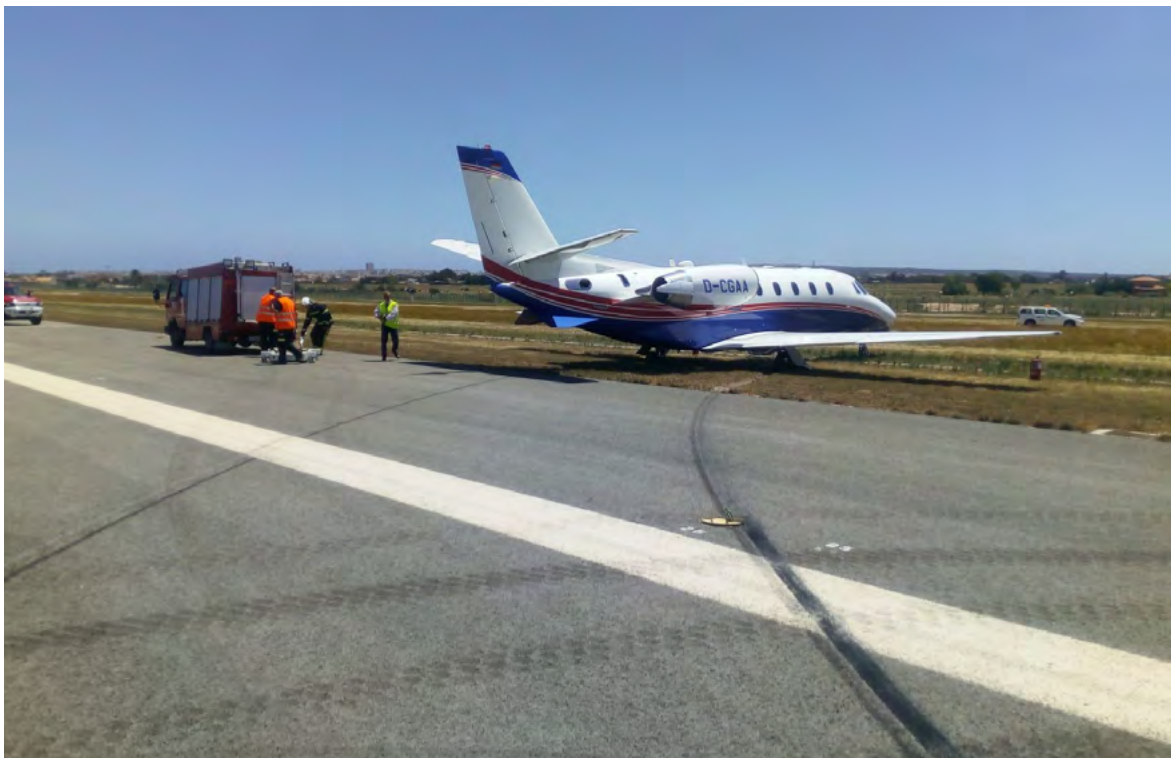
Photograph 1: Aircraft at the accident site

The aircraft veered to the right leaving the runway in section R2, at gate B, stopping on the unpaved area on the right strip of the runway.

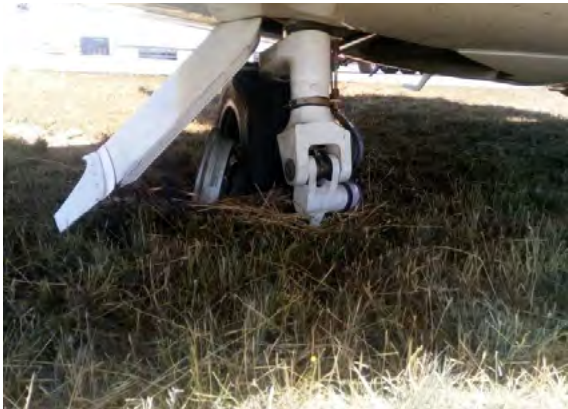
The main landing gear had lost its left tyre, and the right was partially detached. The rims of both wheels, which were damaged and deformed, had sunk into the ground and parts were missing.

Photograph 4: MLG RH

- Right main landing gear (MLG RH): the tyre was blown and partially dislodged from its rim, the brake discs and brake hose were badly damaged. The emergency brake hose was also badly damaged. The references for the damaged parts are: RH Wheel assy p/n: 6641650-15, RH Brake assy p/n: 2-1601-1T3 y RH emergency brake hose p/n: 6627100-80.
- Left main landing gear (MLG LH): no tyre, wheel and brake damaged. References for the damaged parts: LH Wheel assy p/n: 6641650-15, LH Brake assy p/n: 2-1601-1T3.

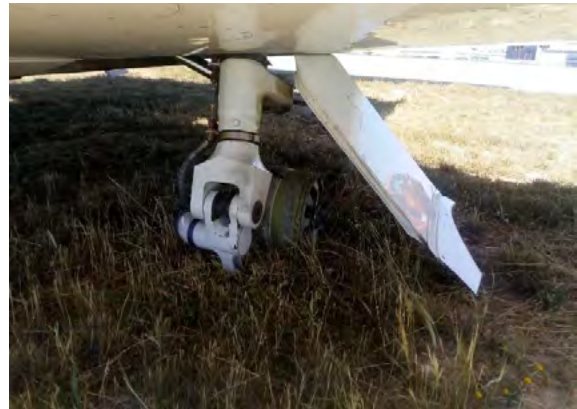
Photograph 5: MLG LH

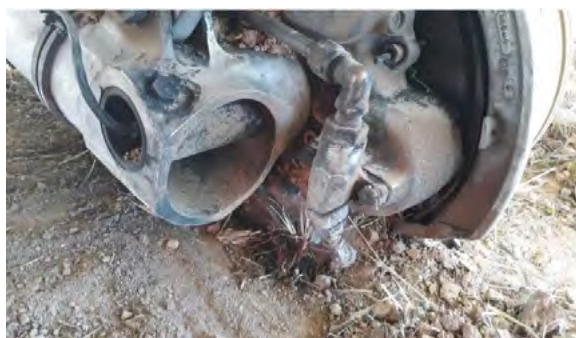
Photograph 6: MLG RH, wheel assembly

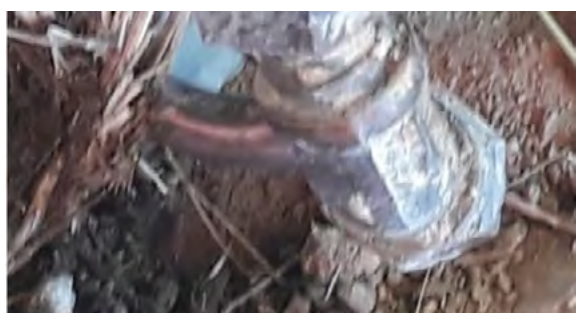
Photograph 7: Emergency brake hose

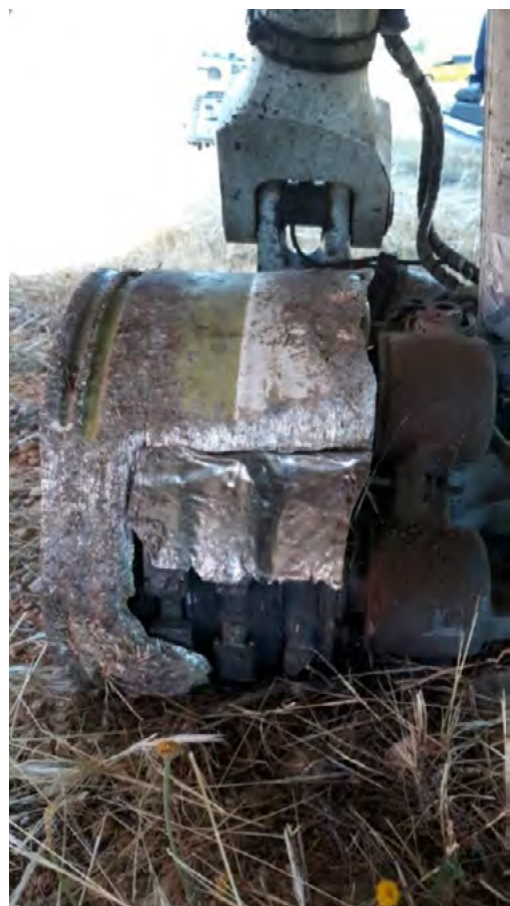
Photograph 8 right: MLG LH,
wheel assembly

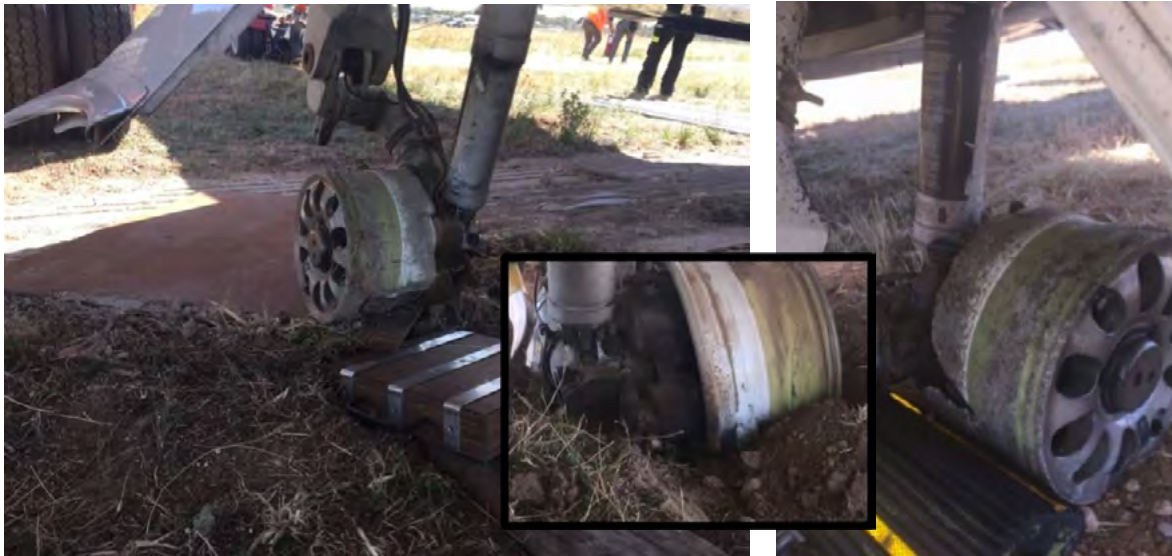
Photograph 9: MLG LH, rim, detail of the brake housing surfaces

- The rims and brake disc housings were severely deformed, and the brake cylinder was damaged. The possible presence of corrosion on the painted surfaces was also noted.
- No hydraulic fluid spills were observed on the surfaces around the fluid lines, and the joint fittings appeared to be in good condition.

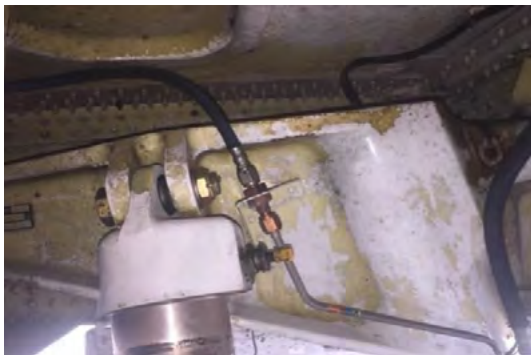
Photograph 10: hydraulic fluid lines

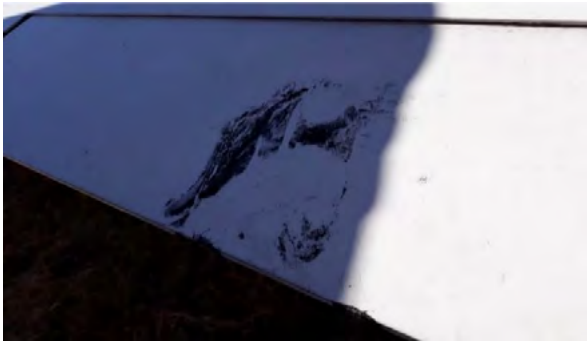
Photograph 11: LH Damage to inboard flap, top side

- The left inboard flap had damage to the upper surface, apparently caused by the detachment of the different layers of the tyre. There was no damage to the right wing. Three 2 to 3" diameter holes and surface cracks were observed on the underside of the left-wing inboard flap. Wave-shaped roughness was also observed on the underside of the left wing, between the FWD and AFT main spar, in this case with no evidence of apparent cracks. The reference for the damaged part was: flap inboard assy p/n: 6525130-37.

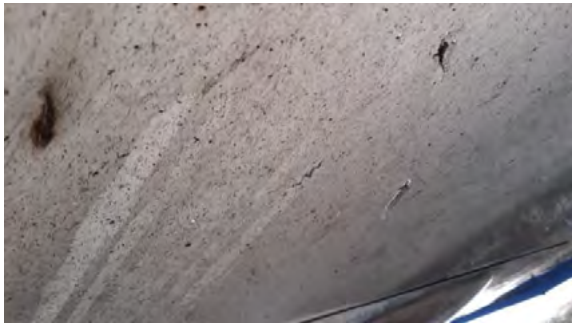
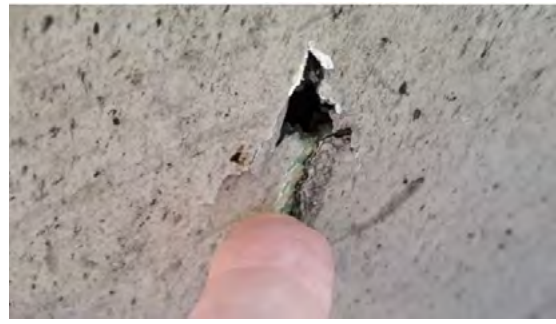
Photograph 12 and 13: LH Damage to inboard flap, underside and detail of puncture hole

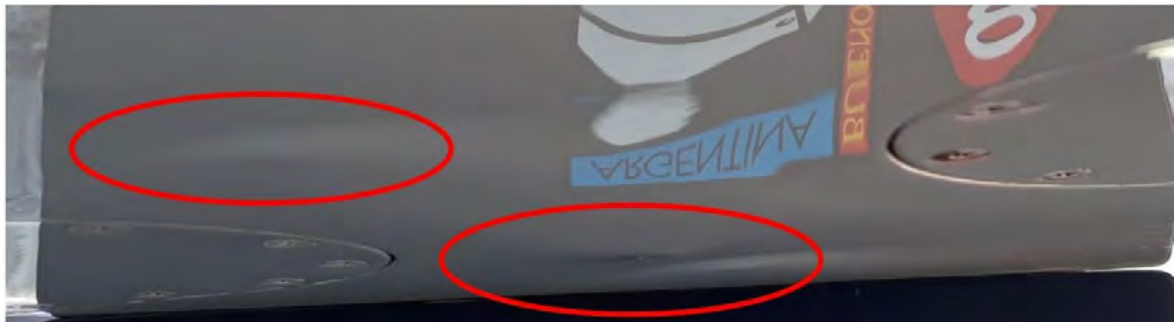
Photograph 14: LH Deformation on underside of wing

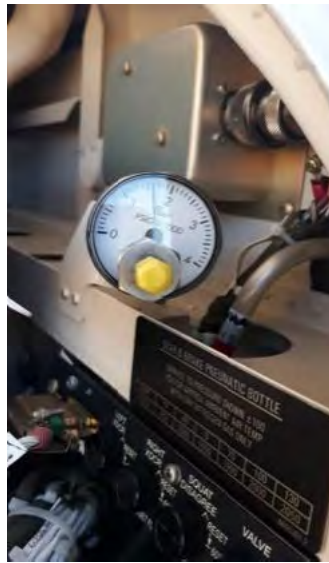
Right Photograph 16: Pneumatic brake accumulator pressure gauge (emergency brake)

- The remaining control surfaces were in good condition. It should be noted that the rudder was deflected to the left.
- Normal brake system: The hydraulic brake system reservoir was empty, the pressure indicated on the system gauge was 600 psi.
- Emergency Brake System: the pneumatic system brake accumulator pressure was 1600 psi (normal pressure is between 1800 and 2050 psi).

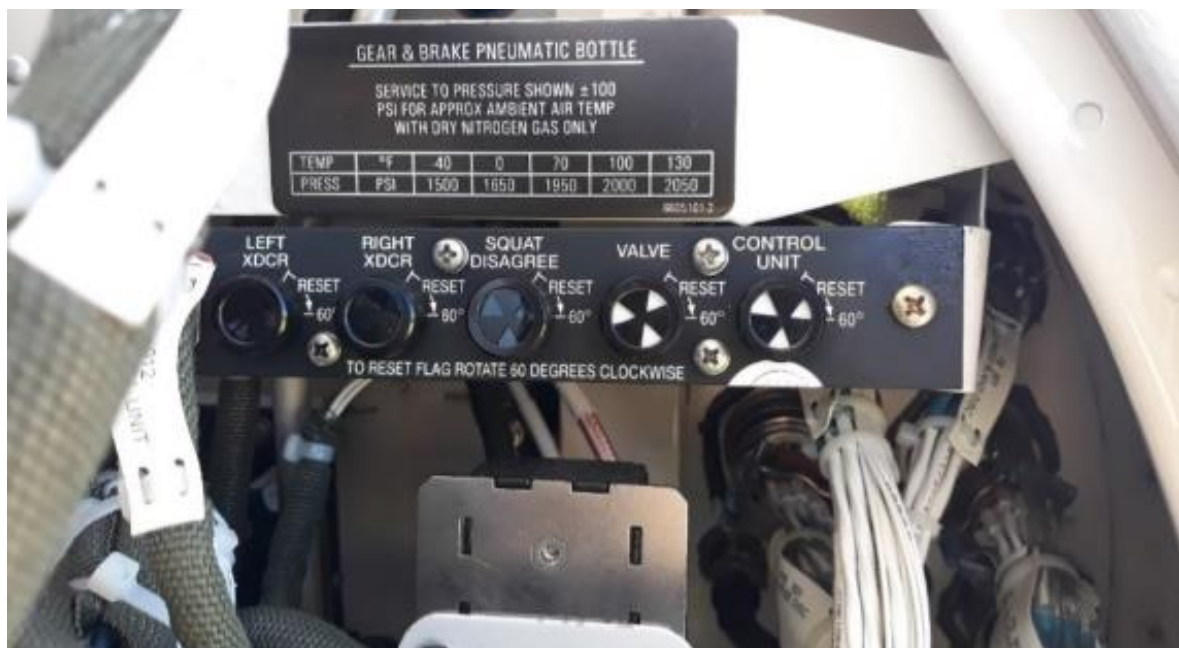
Photograph 17: B.I.T.E. indicator.

- B.I.T.E. Indicator for the anti-skid brake system: The white flags visible in the equipment circles show failures of the anti-skid system's control valve and control unit.

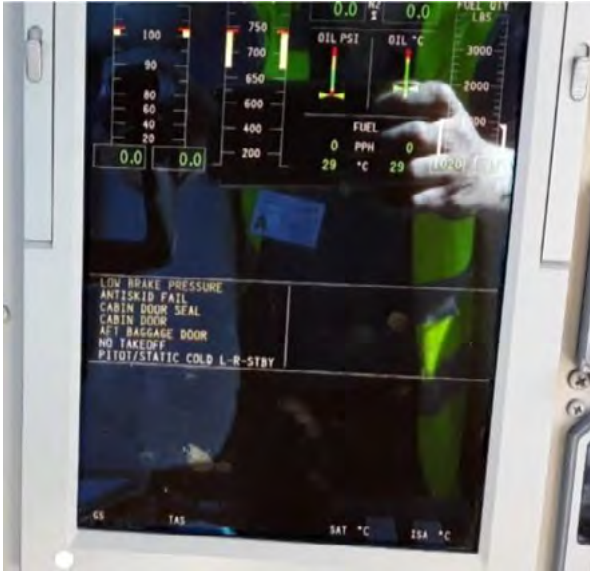
- Inside the cockpit on the control and indication panel:
 - The messages LOW BRAKE PRESSURE and ANTISKID FAIL were displayed on the CAS screen after the incident.

Photograph 18: CAS messages

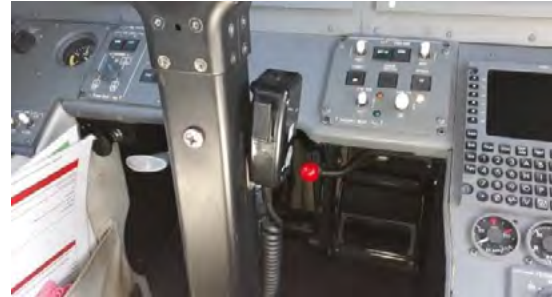
Photograph 19: Emergency brake lever

- Emergency brake lever activated.
- Position of left panel circuit breakers (CB): the only one popped is the FLT HR Meter (flight hour meter).
- Position of right panel circuit breakers (CB): two popped breakers found, RADAR and MASTER APU.

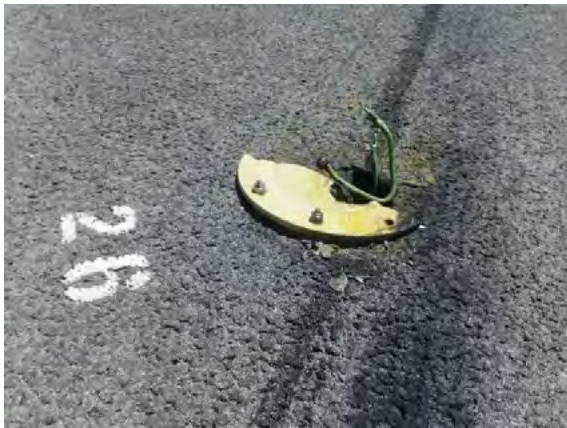
Photograph 22: Runway edge light remains

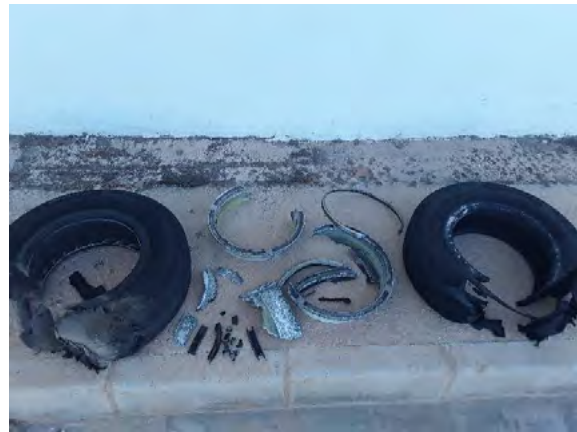
Photograph 23: Main landing gear tyres (to the right, LH wheel, to the left, RH wheel)

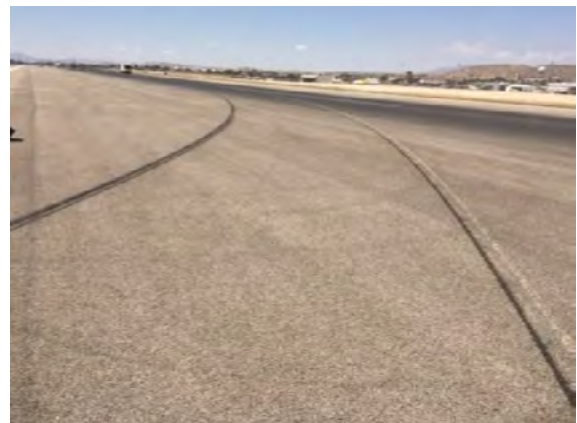
Photograph 25: Skid marks on the runway

- Tyre and wheel wreckage found on the runway: remains of the two wheels, the brake discs, lines, rims and tyres. The marks on the runway contained tyre debris stuck to the asphalt in parallel tracks corresponding to the distance between the main landing gear wheels. The mark left by the right wheel transferred a large amount of rubber from the tyre to the asphalt. The mark made by the left wheel was predominantly caused by surface erosion/abrasion.

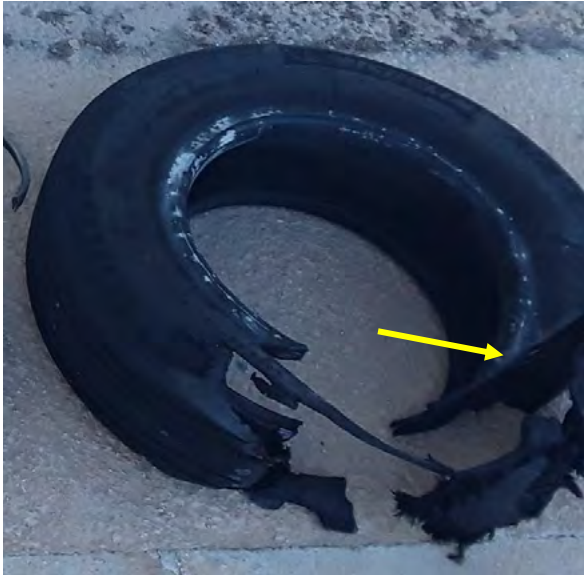
Photograph 26 corresponds to the main landing gear left wheel tyre. The rupture visible in the section of material is perpendicular to the tyre, which indicates an explosion due to overpressure. This type of direct breakage occurs when the rupture originates in a place where there is enough energy to be able to break all the layers at the same time. This area could correspond to the one marked in the photograph with a yellow arrow, similar to a linear cut in the tyre.

This tyre was ejected during the landing roll-out, which probably coincided with the moment when the pilot-in-command noted the sensation of the left tyre having burst.

Photograph 26: Left wheel tyre

The braking attempt made with the pedals pressed to the maximum after the take-off was what caused the brakes to lock and generated overpressure in the tires causing the left tire to burst and detach, allowing the loss of brake pressure while the tire was eroding on the pavement during the movement of the aircraft.

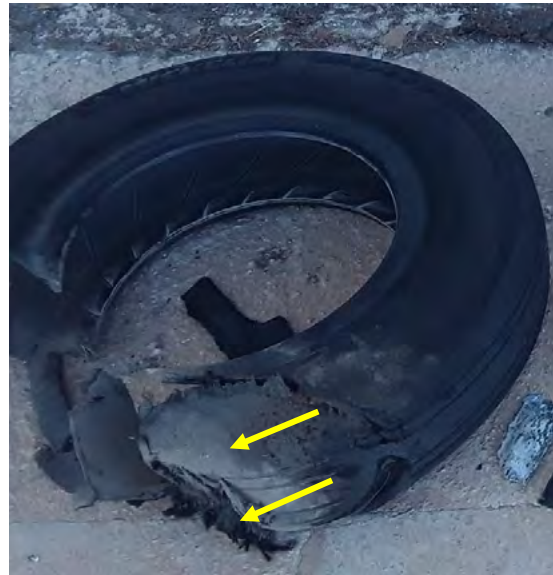
Photo 27 shows the tyre on the right wheel of the main landing gear, which remained attached to its rim until the aircraft stopped. In the photograph, the top yellow arrow indicates a whitish area which is typical of wear caused by friction between an immobilised tyre, fixed to its rim, and the asphalt on the runway. The bottom arrow

points to what's known as conical breakage, whereby, starting at the initial point of rupture, the tyre's interior gas travels to the outside, gradually decreasing the tyre's pressure, so that the gas that remains inside is no longer capable of breaking the layers of material simultaneously but produces a breakage in a gradual and staggered way.

Photograph 27: Right wheel tyre

The type of breakage produced in the MLG RH tyre and the fact that it was partially detached, confirms that it burst from a progressive loss of pressure, wearing down as a result of friction with the runway and transferring the tyre rubber to the asphalt until the aircraft came to a standstill.
