**COMISIÓN DE
INVESTIGACIÓN
DE ACCIDENTES
E INCIDENTES DE
AVIACIÓN CIVIL**

Report **IN-027/2017**

Incident involving a Diamond
DA-20 aircraft, registration
EC-LTE, operated by One Air
Aviación, at the aerodrome of
La Axarquía, in Vélez-Málaga
(Málaga-Spain), on 28 October
2017

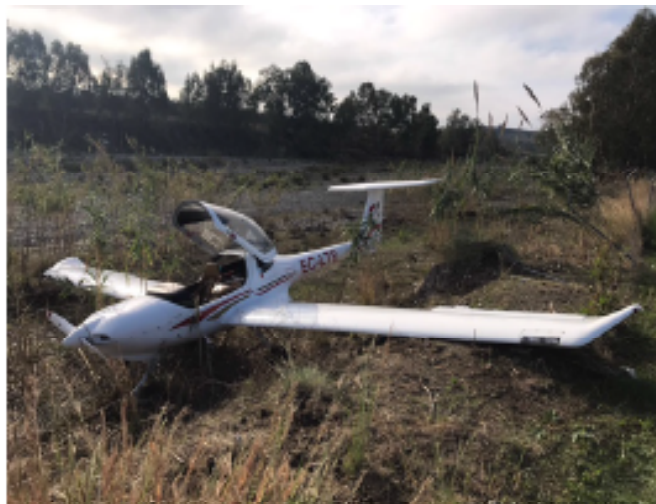
Figure 1 Photograph of the aircraft at the location where it stopped after the incident.

As a result of impacting the aerodrome's perimeter fence, the aircraft sustained damage to its propeller, the leading edges of both wingtips, the base of the right wing and the nose landing gear.

There was no debris field. As a result of impacting the aerodrome's perimeter fence, the aircraft sustained damage to its propeller, the leading edges of both wingtips, the base of the right wing and the nose landing gear. A 15-meter long section of fence was also damaged.

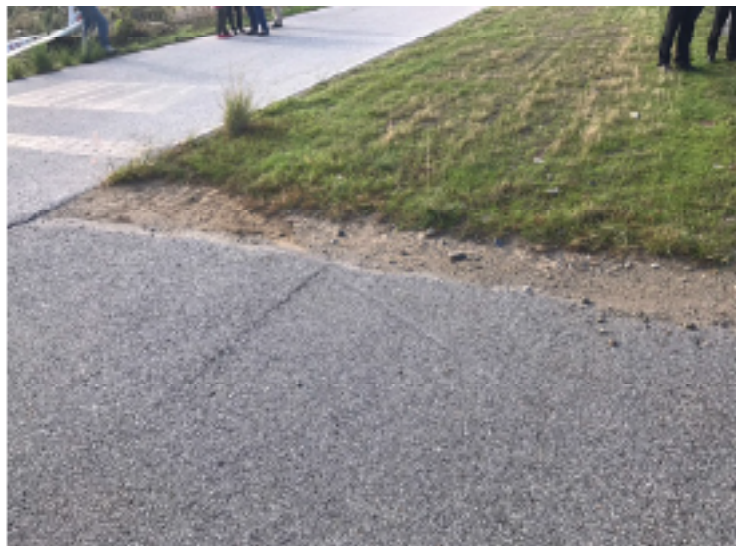
Figure 2 - Mark left on the ground by the airplane's right tie-down ring.

Moreover, in the area where the runway connects to the perimeter road, past the final exit on the runway, there was a mark on the ground caused by one of the tie-down rings used to secure the airplane to the ground. This ring is located on the lower surface of the right wing, near the wingtip.

In light of the marks left on the ground by the lock-down ring on the underside of the right wingtip in the area where the end of the runway connects to the perimeter road, past the final exit taxiway, the instructor's assessment is deemed to be correct. Moreover, the damage found on the left wingtip and the aircraft's final position are consistent with the student's description.
