Report IN-030/2018

Incident involving an Airbus
A320-214 aircraft, registration
EC-JFN, at Adolfo Suárez
Madrid-Barajas Airport
on 3 July 2018

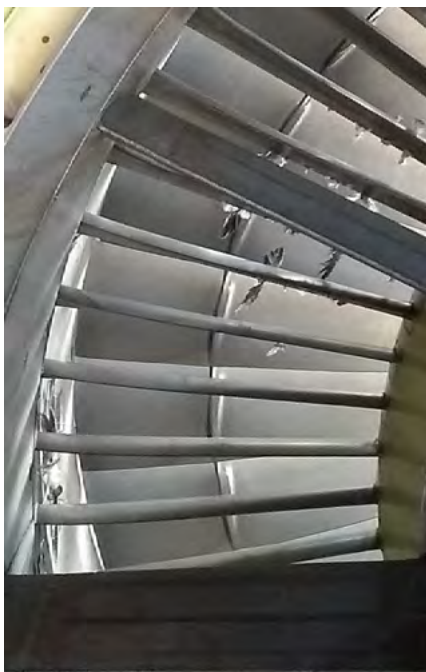
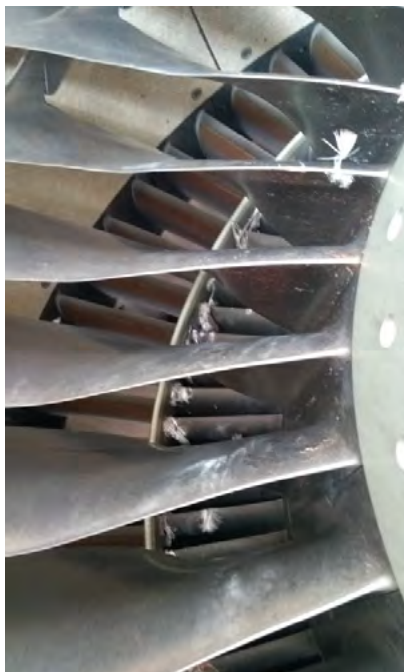
The visual inspection confirmed bird ingestion in both engines. Engineers carried out the required AMM 05-51-14-200-803-A inspection for engines that have undergone a bird strike as per the aircraft maintenance manual. They found evidence of bird ingestion in both engines. The AMM 36-11-00200-804 task to inspect the cold bleed airflow route is required following confirmed bird ingestion and should also have been carried out. However, there is no evidence that the technicians cleaned the ducting, or confirmed bird remains inside it.

Photographs 1 and 2. Remains of birds in engines

Finally, the engines were commissioned without cleaning engine 1 after the bird ingestion.

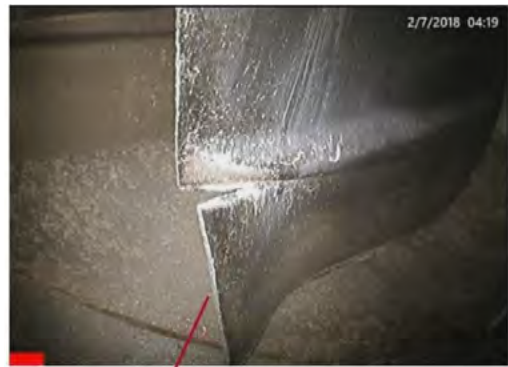
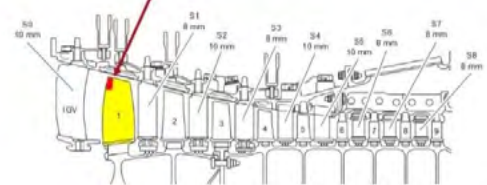
In engine 2, a crack was found on the leading edge of a blade tip in the first stage of the compressor. The part had exceeded its permitted limit and an engine replacement was, therefore, required.

Photograph 3. Damage to impeller blade engine 2

The following day, 02/07/2018, the engine with s/n: 577627 was received from the Engine Workshop where it had been repaired. The damaged engine 2 was, therefore, dismantled and replaced with the one from the workshop according to AMM 71-00-00 PB 40.
