**COMISIÓN DE  
INVESTIGACIÓN  
DE ACCIDENTES  
E INCIDENTES DE  
AVIACIÓN CIVIL**

## **Report IN-031/2018**

Incident involving several aircraft  
in the airspace of the Madrid CTR  
(control zone) on 27 May 2018

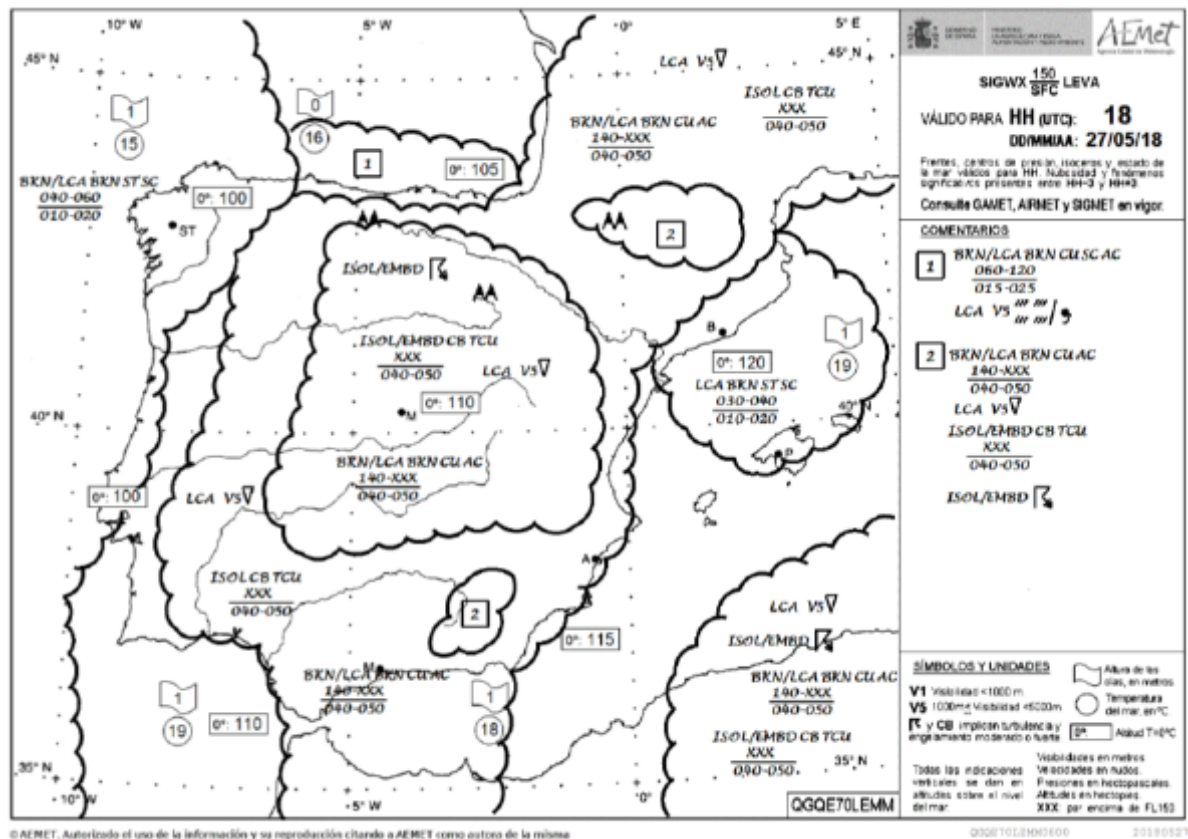
Ilustración 1: 18 UTC Low-level map

AEMET thinks it likely that given these conditions over the area, there would have been at least moderate turbulence associated with the proximity to the storm area. Therefore, turbulence could have contributed to the incident, according to AEMET.

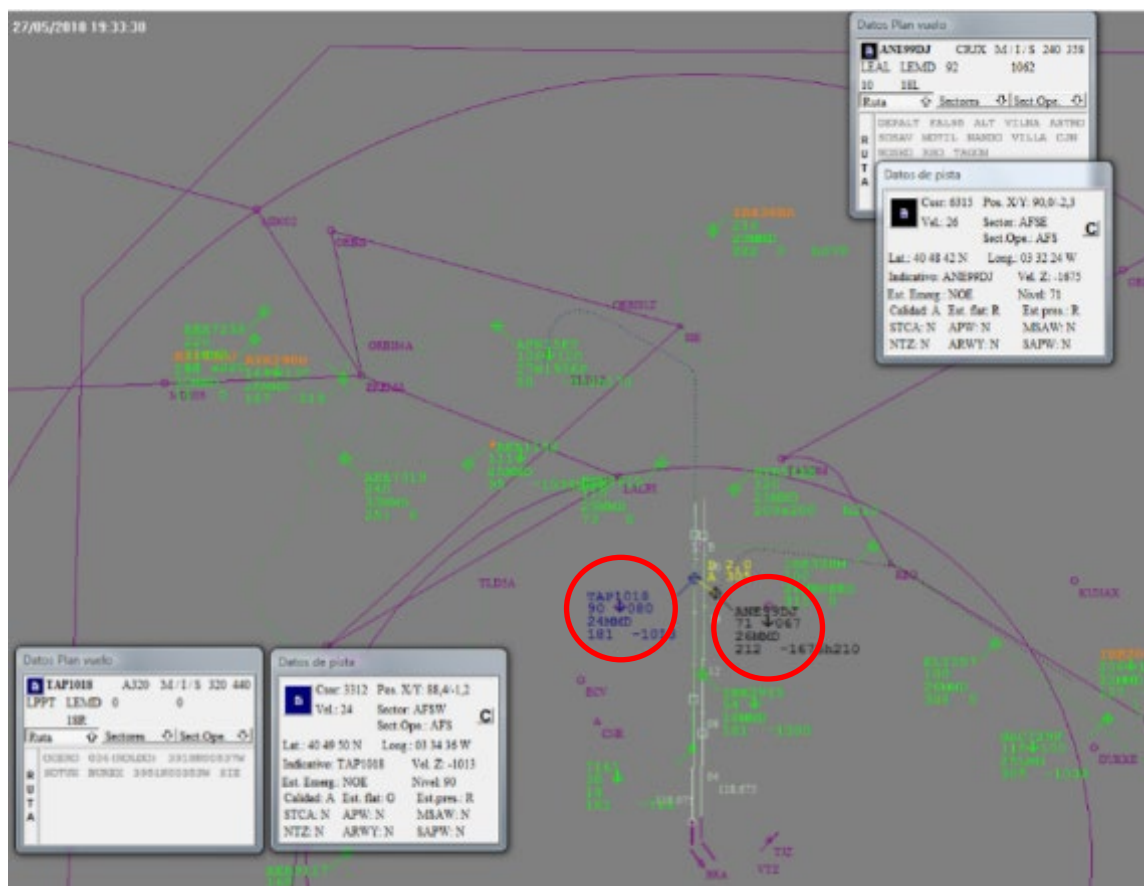
Illustration 2: Positions of the aircraft with callsigns TAP1018 and ANE99DJ at 21:33

The image below shows the position of the two aircraft at 21:33:30. At that time, both aircraft were descending to land, TAP1018 on runway 18R and ANE99DJ on runway 18L.

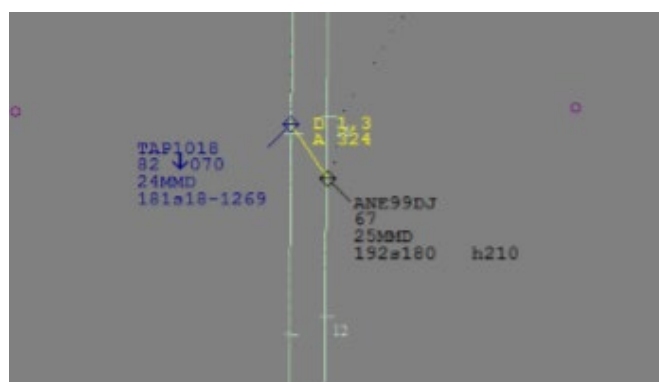
Illustration 3: Positions of the aircraft with callsigns TAP1018 and ANE99DJ at 21:34

At 21:34:06, the aircraft were still descending to land. The horizontal distance between them was 1.3 NM. The aircraft with callsign TAP1018 was flying at a ground speed of 240 knots, and the aircraft with callsign ANE99DJ had a ground speed of 250 knots. Both aircraft had been instructed to reduce their IAS to 180 knots.

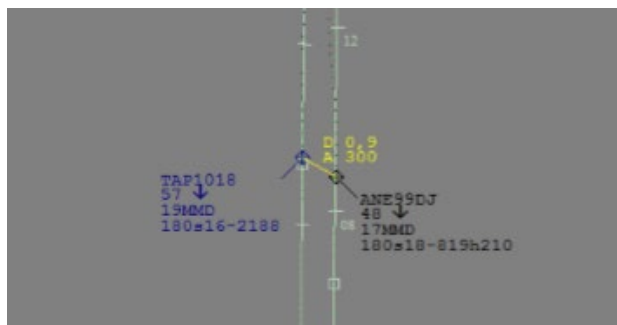
Illustration 4: Positions of the aircraft with callsigns TAP1018 and ANE99DJ at 21:35

By 21:35:58, the horizontal distance between the aircraft had been reduced to 0.9 NM and the vertical distance was 900 feet. The aircraft with callsign TAP1018 had a ground speed of 190 knots and the aircraft with callsign ANE99DJ had a ground speed of 170 knots.

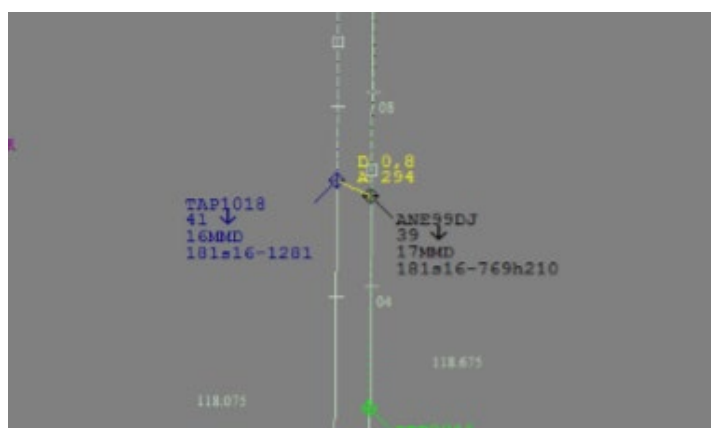
Illustration 5: Positions of the aircraft with callsigns TAP1018 and ANE99DJ at 21:36

At 21:36:59, the horizontal distance between the aircraft was 0.8 NM and the vertical separation was 200 feet. Both aircraft had been instructed to reduce their IAS to 160 knots. The aircraft with callsign TAP1018 had a ground speed of 160 knots and the aircraft with callsign ANE99DJ had a ground speed of 170 knots.

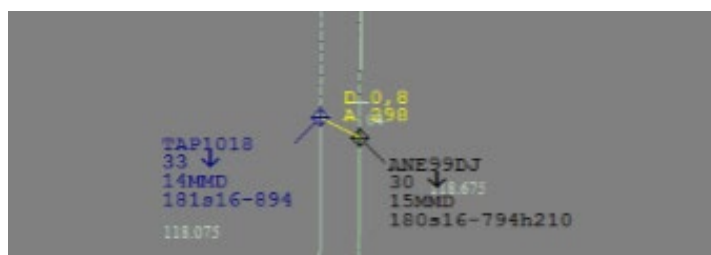
Illustration 6: Positions of the aircraft with callsigns TAP1018 and ANE99DJ at 21:37

Subsequently, the vertical distance between the two increased. At 21:37:58, seconds before landing, the positions of the aircraft were:

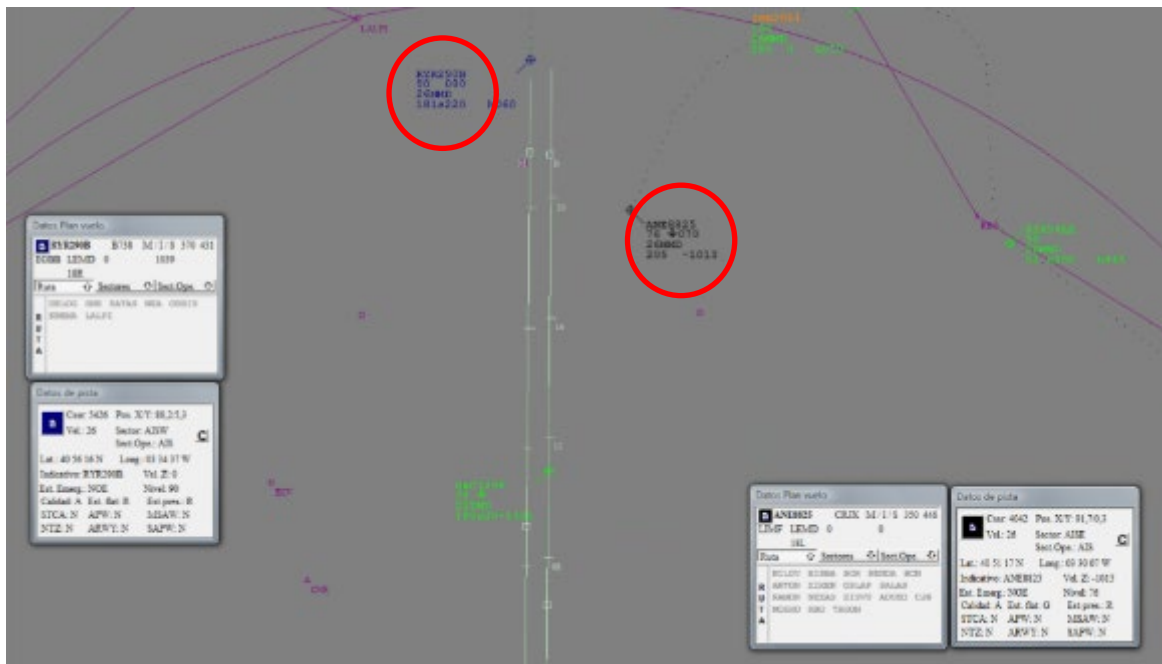
Illustration 7: Positions of the aircraft with callsigns RYR290B and ANE8825 at 21:46:11

The image below shows the position of the two aircraft at 21:46:11. At that time, both aircraft were descending to land, RYR290B on runway 18R and ANE8825 on runway 18L.

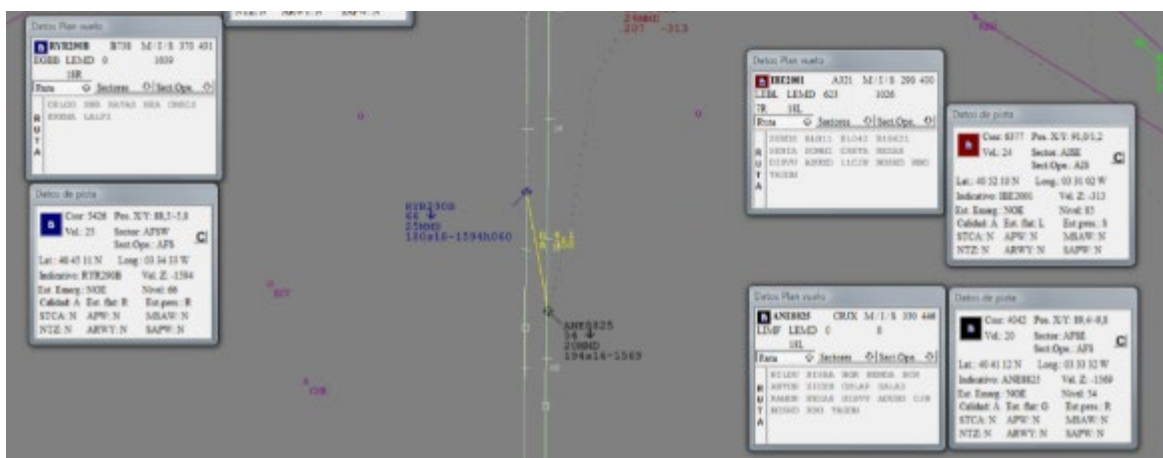
Illustration 8: Positions of the aircraft with callsigns RYR290B and ANE8825 at 21:48:48

At 21:48:48, the aircraft were separated horizontally by 4.1 NM. The ground speed of the aircraft with callsign RYR290B was 250 knots, and the aircraft with callsign ANE8825 had a ground speed of 200 knots.

The aircraft with callsign RYR290B had been instructed to reduce its IAS to 180 knots, and the aircraft with callsign ANE8825 had been instructed to reduce its IAS to 160 knots.

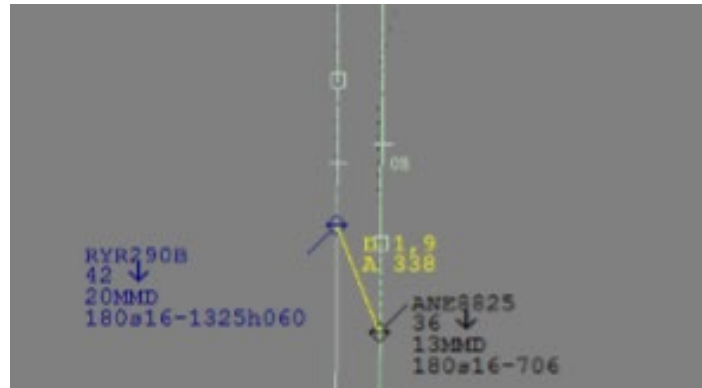
Illustration 9: Positions of the aircraft with callsigns RYR290B and ANE8825 at 21:50:33

Subsequently, by 21:50:33, the horizontal distance between the two aircraft had fallen to 1.9 NM and the vertical distance to 600 feet. The aircraft with callsign RYR290B had been instructed to reduce its IAS to 160 knots.

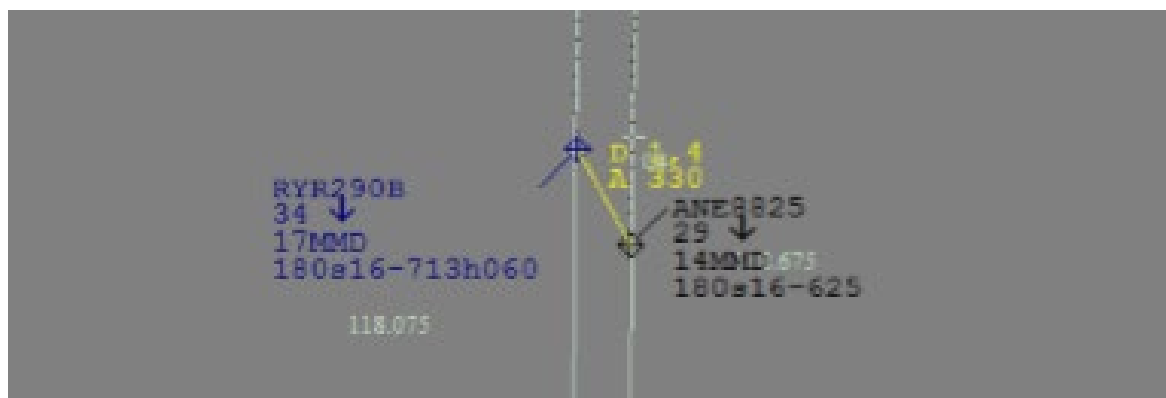
Illustration 10: Positions of the aircraft with callsigns RYR290B and ANE8825 at 21:51:38

At 21:51:38, the horizontal distance between the two aircraft was 1.4 NM and the vertical distance was 500 feet.

The separation between the aircraft continued to fall until seconds before the landing of the aircraft with callsign ANE8825, at which time the horizontal distance was 1.2 NM and the vertical distance was 325 feet.

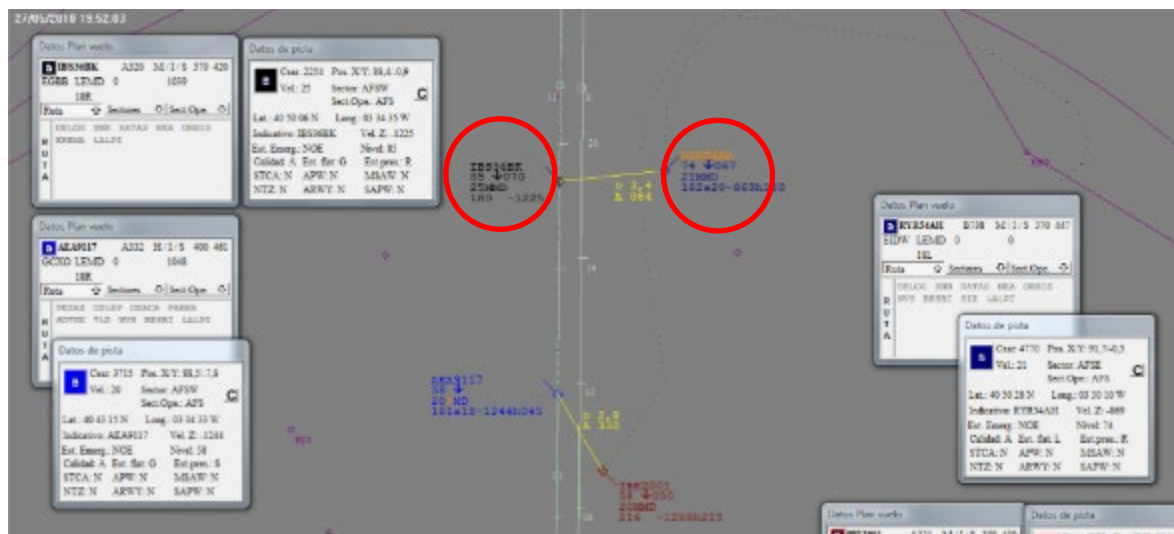
Illustration 11: Positions of the aircraft with callsign RYR54AH and IBS36BK at 21:52:03

The image below shows the position of the two aircraft at 21:52:03. A few seconds later, the aircraft with callsign RYR54AH had requested to change course from 205° to 180° for 6 NM. Both aircraft had been instructed to maintain an IAS of 180 knots:

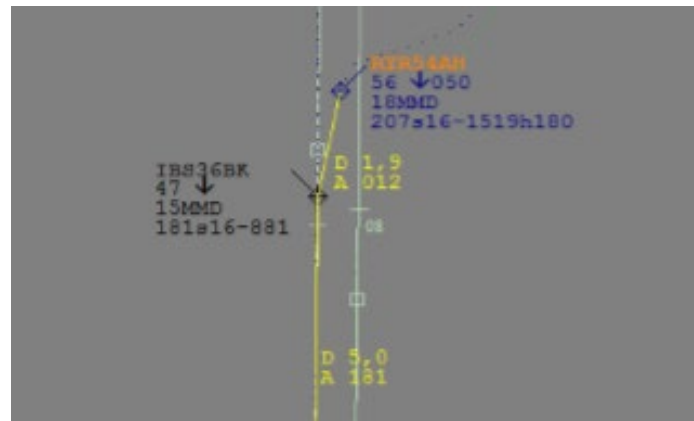
Illustration 13: Positions of the aircraft with callsign RYR54AH and IBS36BK at 21:55:19

At 21:55:19, the aircraft with callsign RYR54H, despite having been cleared to make the ILS-Z approach to 18L, had not yet intercepted the localizer. It was separated horizontally from the other aircraft by 1.9 NM. It had been instructed to reduce its IAS to 165 knots.

The aircraft with callsign IBS36BK had initially been instructed to reduce its IAS to 170 knots, and then to reduce it as much as possible to avoid the loss of separation with the preceding aircraft.

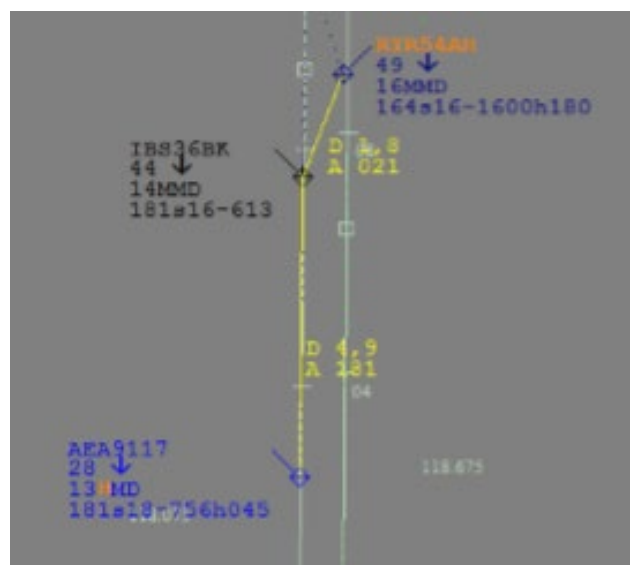
Illustration 14: Positions of the aircraft with callsign RYR54AH and IBS36BK at 21:55:45

By 21:55:45, the aircraft with callsign RYR54AH had intercepted the localizer for the 18L ILS-Z approach. The horizontal distance between the two aircraft had fallen to 1.8 NM.

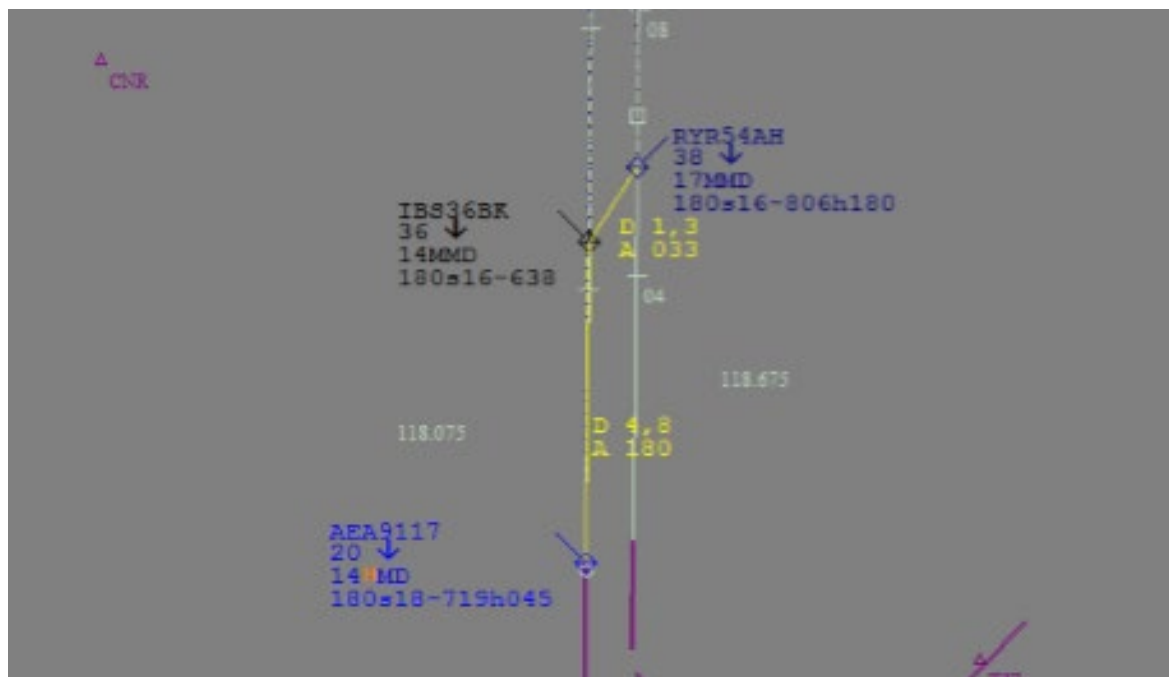
Illustration 15: Positions of the aircraft with callsign RYR54AH and IBS36BK at 21:56:54

By 21:56:54, the horizontal distance between the two aircraft had fallen to 1.3 NM.

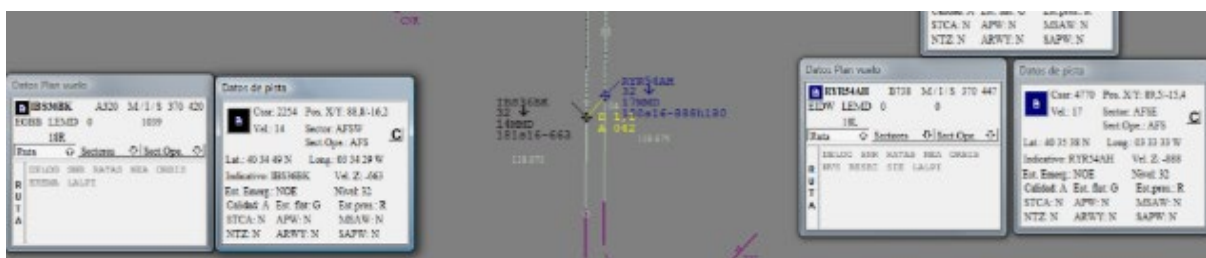
Illustration 16: Positions of the aircraft with callsign RYR54AH and IBS36BK at 21:57:31

By 21:57:31, the horizontal distance between the two aircraft had again fallen, this time to 1.1 NM.

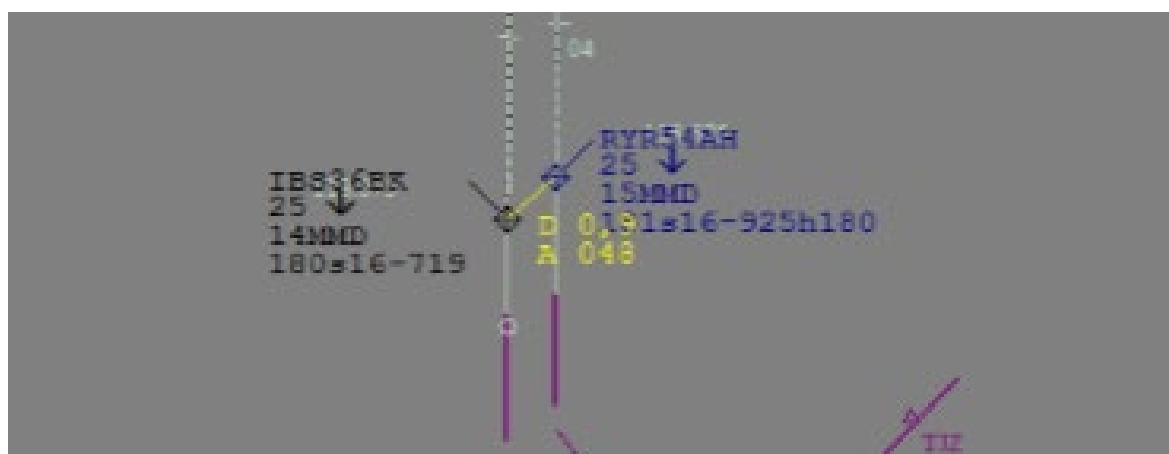
Illustration 17: Positions of the aircraft with callsign RYR54AH and IBS36BK at 21:58:24

Seconds before landing, at 21:58:24, the horizontal distance between the two aircraft was 0.9 NM. Both aircraft were at the same altitude.

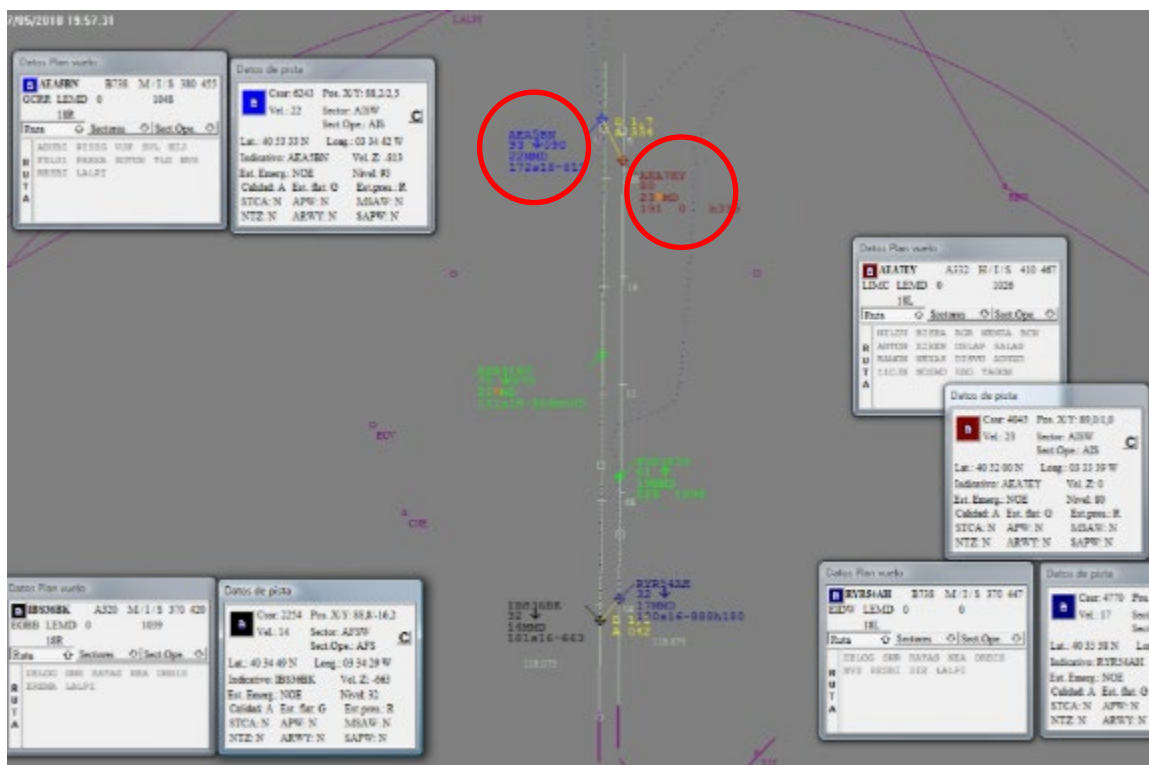
Illustration 18: Positions of the aircraft with callsigns AEA5BN and AEA7EY at 21:57:31

The image below shows the position of the aircraft at 21:57:31. The aircraft with callsign AEA5BN had been instructed to maintain an IAS of 180 knots.

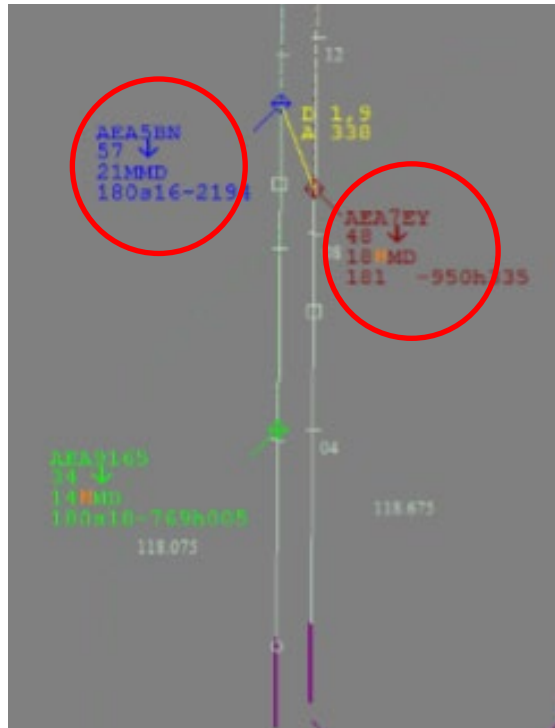
Illustration 20: Positions of the aircraft with callsigns AEA5BN and AEA7EY at 22:00:49

A few seconds later, the aircraft with callsign AEA5BN was instructed to reduce its speed, and subsequently, the aircraft with callsign AEA7EY was instructed to maintain its speed.

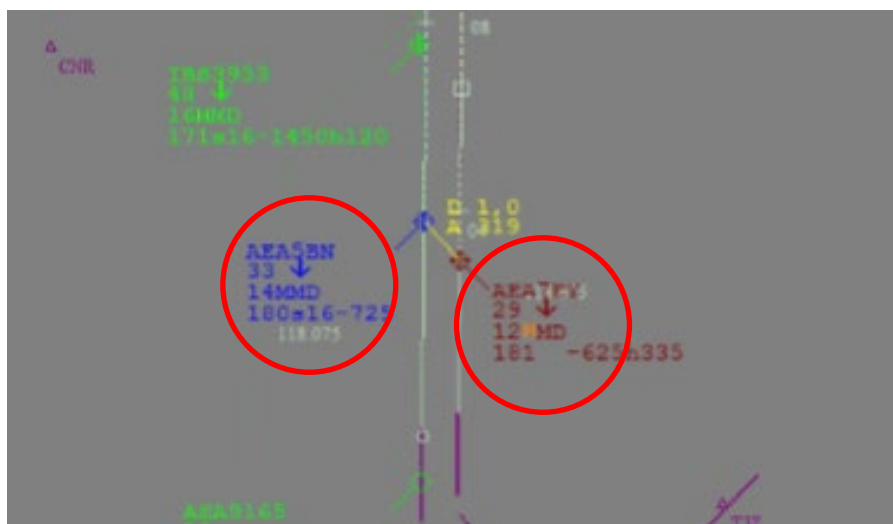
Illustration 21: Positions of the aircraft with callsigns AEA5BN and AEA7EY at 22:03:14

At 22:03:14, the two aircraft were separated by 1.0 NM horizontally and 400 feet vertically.

The separation between the aircraft continued to close until seconds before the landing of the aircraft with callsign AEA7EY.
