Report IN-031/2020

Incident involving a BOEING B737-800 aircraft operated by RYANAIR, registration EI-EFJ, and lighting vehicle 'Balizamiento 3' operated by AENA, on runway 24R at Palma de Mallorca Airport, on 19 July 2020

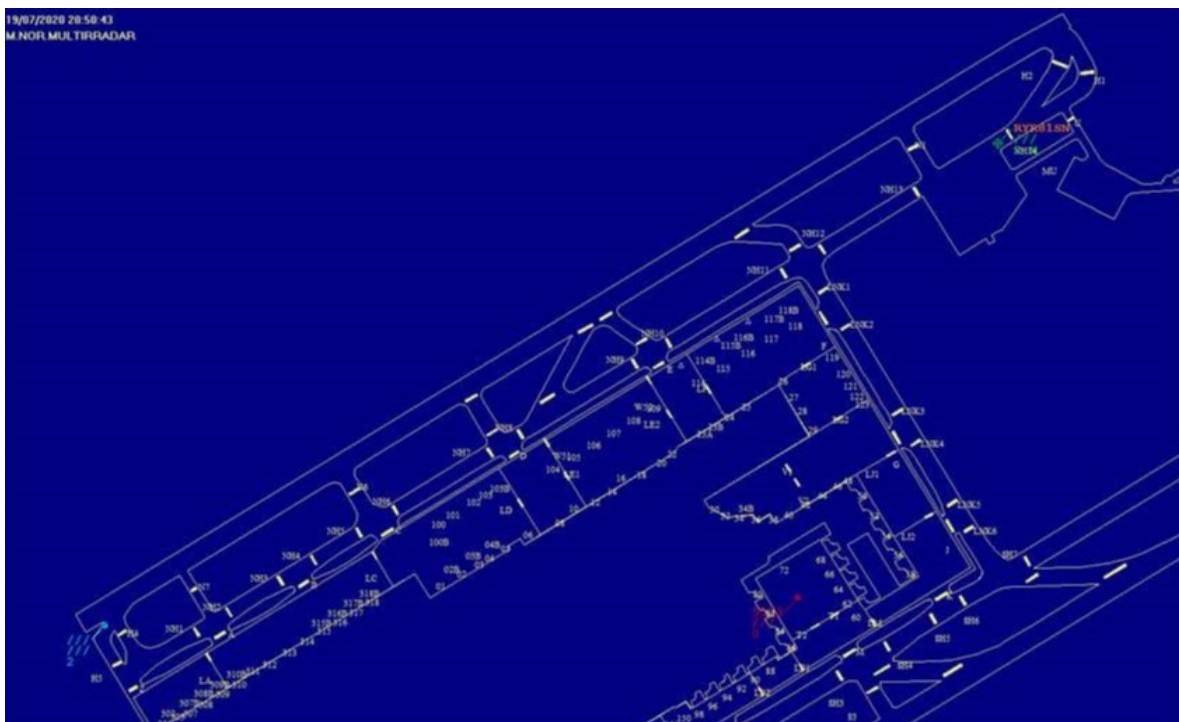
At 20:50:43, the RYR81SN aircraft established initial contact on the local controller frequency (TWR) of the Palma de Mallorca control tower and indicated that it was ready to depart. The Palma de Mallorca control tower local controller (TWR) replied: *RYR81SN good evening, wind 210°, 5 knots, runway 24R, cleared for take-off, traffic on final 8 miles out.* The crew of the aircraft read-back the instruction correctly. At this point, the radar shows the RYR81SN aircraft taxiing to the holding point on runway 24R and an uncorrelated label on the threshold of runway 06L, which corresponds to the Balizamiento 3 vehicle.

Fig. 2: Palestra image corresponding to 20:50:43

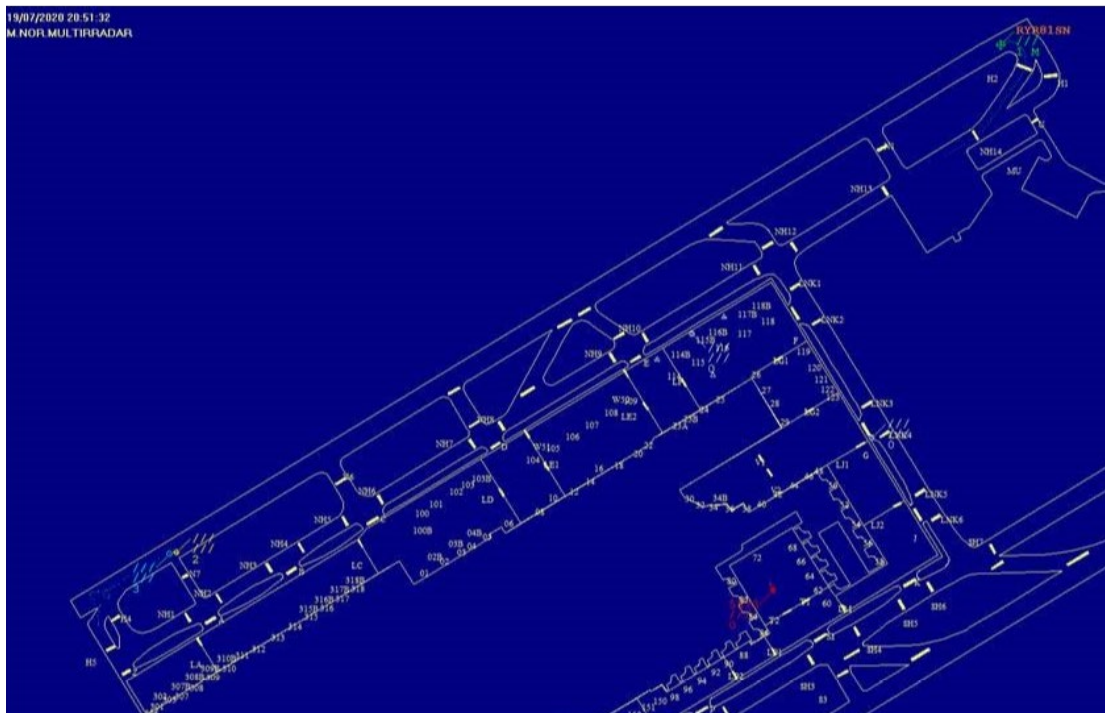
At 20:51:32, the driver of the Balizamiento 3 vehicle contacted the Palma de Mallorca control tower and reported the following: *tower from Balizamiento 3, I'm on the north runway, you cleared me to enter, exiting immediately.* The radar trace at that point in time shows aircraft RYR81SN aligned on runway 24R and travelling at a ground speed (GS) of 10 kt, while an uncorrelated label corresponding to the Balizamiento 3 vehicle (a duplication of the radar echo is visible) can also be seen at the opposite end of the runway, abeam on taxiway N7.

Fig. 3: Palestra image corresponding to 20:51:32

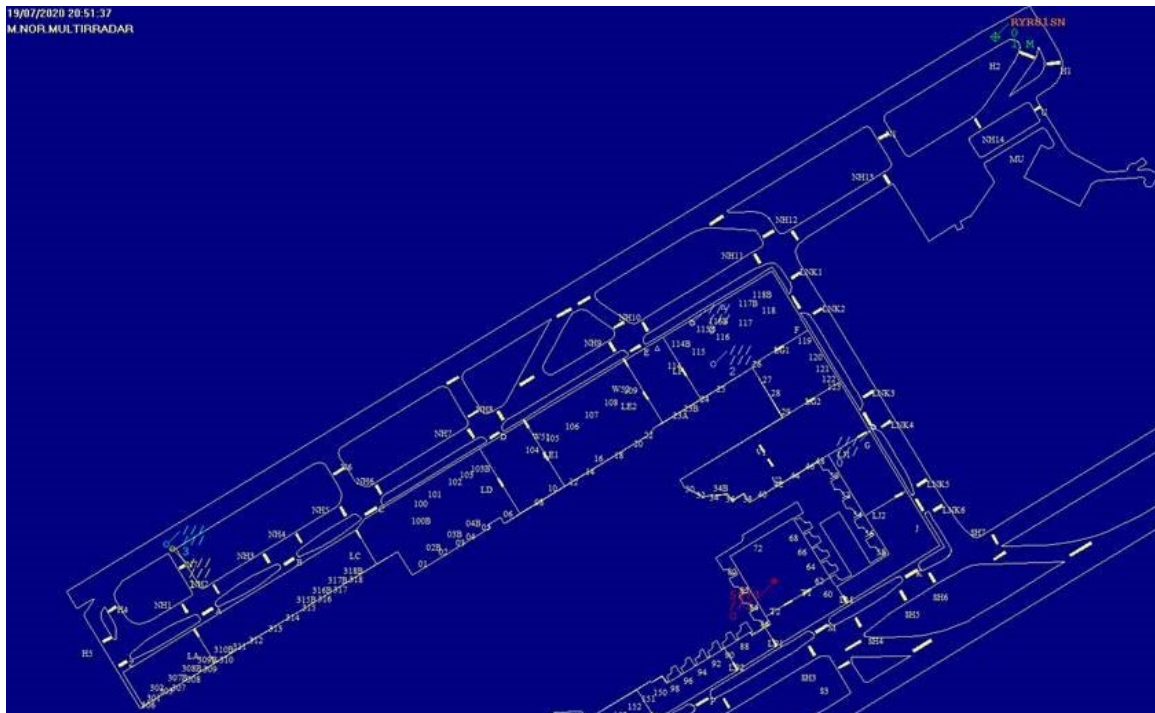
At 20:51:37, the local controller (TWR) replied: *Balizamiento 3, you told me you were on the south runway; vacate the runway immediately. Break, break. (20:51:39) RYR81SN hold position; I say again hold position.* The crew of the aircraft read-back *stopping RYR81SN*. At this point, the radar shows the RYR81SN aircraft aligned on runway 24R and travelling at a ground speed (GS) of 10 kt, while an uncorrelated label corresponding to the Balizamiento 3 vehicle (a duplication of the radar echo is visible) can be seen at the opposite end of the runway, abeam on taxiway N7.

Fig. 4: Palestra image corresponding to 20:51:37

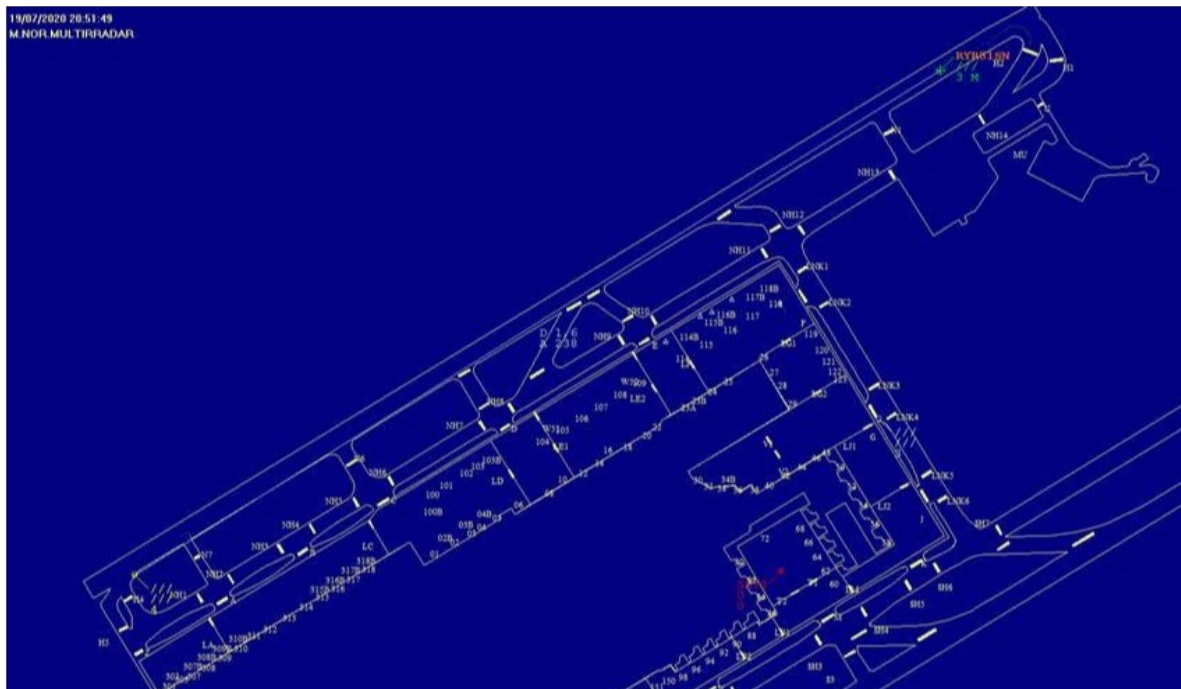
At 20:51:49, the radar shows the RYR81SN aircraft beginning its take-off roll on 24R at a ground speed (GS) of 30 kt, while an uncorrelated label corresponding to the Balizamiento 3 vehicle can be seen at the opposite end of the runway, close to exiting via H4. This was the point at which the distance between the aircraft and the vehicle was the shortest: 1.6 NM.

Fig. 5: Palestra image corresponding to 20:51:49

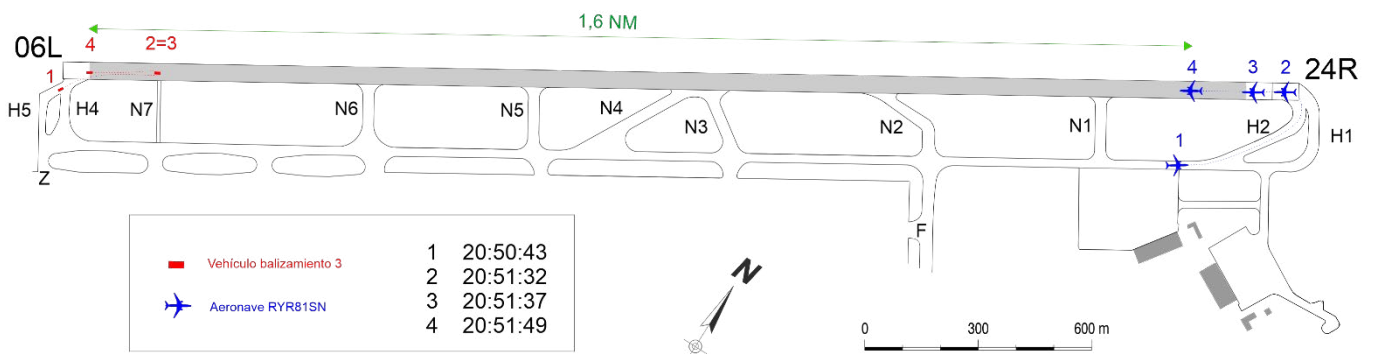
The following image shows the positions of the Balizamiento 3 vehicle (in red) and aircraft RYR81SN (in blue) at 20:50:43, 20:51:32, 20:51:37 and 20:51:49.

Fig. 6: Combined portrayal of the 4 previous images
