**COMISIÓN DE
INVESTIGACIÓN
DE ACCIDENTES
E INCIDENTES DE
AVIACIÓN CIVIL**

Report IN-033/2018

Incident involving
a LEARJET-45XR aircraft,
registration CS-TFQ,
at the Seville Airport
on 7 July 2018

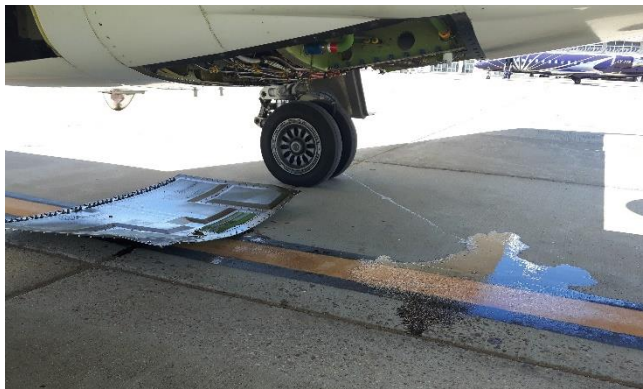
The landing did not cause any damage to the aircraft. The hydraulic fluid spills on the runway surface were only detected when the aircraft stopped. There were also stains left by the hydraulic fluid on the underside of the fuselage, as shown in photographs 2, 4 and 5.

Photograph 2. Spilled hydraulic fluid

- A visual check of the aircraft identified hydraulic fluid leaks on the runway and stains on the underside of the fuselage caused by the hydraulic fluid leaks during the flight.

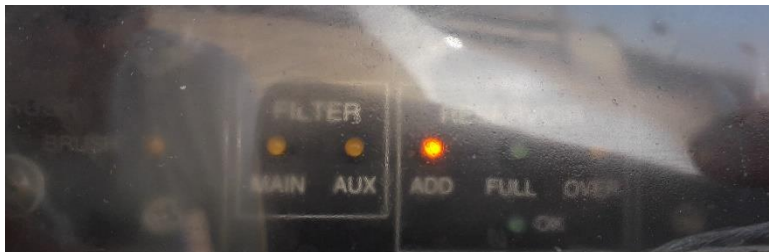
Photograph 3 shows the indication on the hydraulic system panel in the cockpit after the aircraft stopped on the runway, before it was towed. The light refers to the level in the hydraulic fluid tank, and the ADD indicates the need to refill the tank.

Photograph 3: Hydraulic system indicating panel

The main hydraulic system was confirmed to be depleted, as indicated by the HYD maintenance panel, where the amber ADD message was lit. As the aircraft was being checked and repaired, it was confirmed that the reservoir of the main hydraulic system was in fact empty.

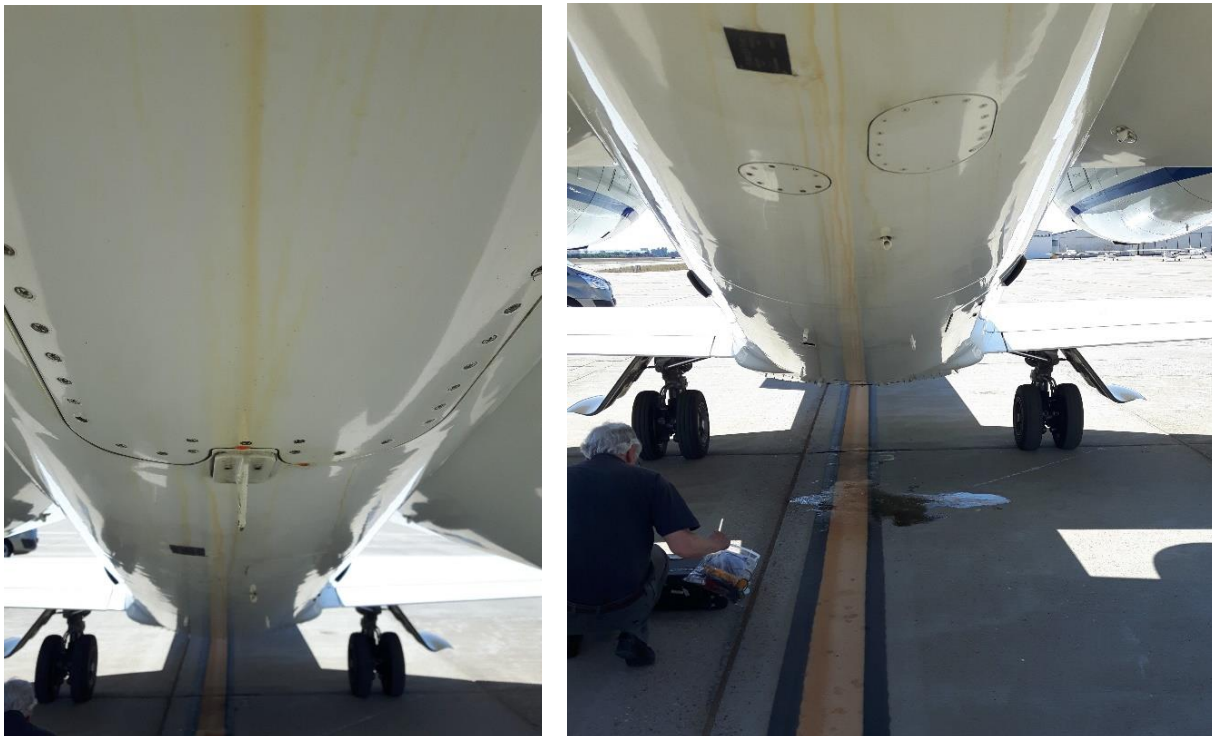
Photographs 4 and 5: Hydraulic fluid spills and stains on the fuselage

The visual inspection of the aircraft after landing identified fluid that was still leaking on the runway, thus confirming the leaks in the hydraulic system, although in smaller amounts since the system was practically empty. There were also obvious marks on the underside of the airplane's tail section, running along the surface from the belly, starting at the main gear fairing and toward the rear of the airplane, which provided evidence that hydraulic fluid had leaked out during the flight.

The location on the airplane's surface of hydraulic fluid stains and the spills on the runway after the landing were consistent with the location of the pressure switch identified as having caused the loss of hydraulic fluid.

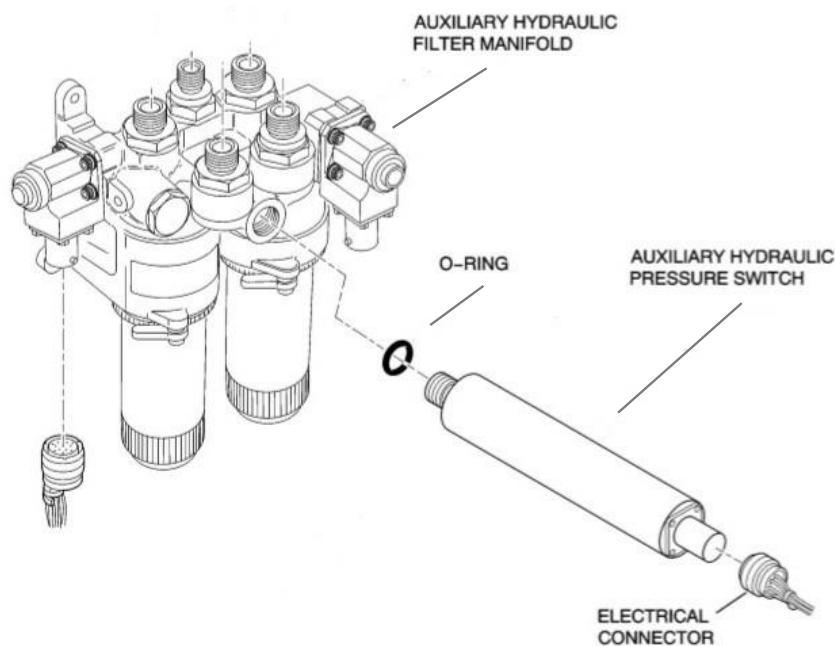
The reason for replacing it is that hydraulic fluid leaks had been found at the electrical connector of the low-pressure switches in the hydraulic system (main, auxiliary and for the spoilers). According to the manufacturer, implementing this SB would reduce the likelihood of leaks and pressure drops in the hydraulic system.

Figure 3. Hydraulic pressure switch (auxiliary and main)

The maintenance personnel confirmed that a hydraulic pressure switch that could not be repaired was the source of the hydraulic fluid leak, which had caused the total loss of fluid in the system.

- The investigation showed that the hydraulic fluid leaks that left the main system without any pressure were produced as a result of the faulty operation of the pressure switch with P/N 7629001004-001.

The technical investigation revealed that the incident was caused by the loss of fluid from the main hydraulic system as the result of leaks that occurred while in flight through the electrical connector of the pressure switch with P/N 7629001004-001.

The two pressure switches S8 and S9, p/n: 7629001004-001, were replaced by the p/n: 6629101004-001. The s/n: 1344 by the s/n: 1247, and the s/n: UNK (unknown) by the s/n: 1063.

Maintenance personnel replaced said pressure switch, both with the same P/N, S8 and S9, on the right and left sides of the aircraft respectively, with a new switch, P/N 6629101004-001. They then checked the entire hydraulic system, purged it, filled the hydraulic fluid reservoir and verified the absence of leaks.
