**COMISIÓN DE  
INVESTIGACIÓN  
DE ACCIDENTES  
E INCIDENTES DE  
AVIACIÓN CIVIL**

## **Report IN-033/2019**

Incident on 16 July 2019 involving a Boeing 737-800 aircraft operated by Air Europa, registration EC-LYR, and a Boeing 737-8AS aircraft operated by Ryanair, registration EI-FRP, to the south of Écija (Seville)

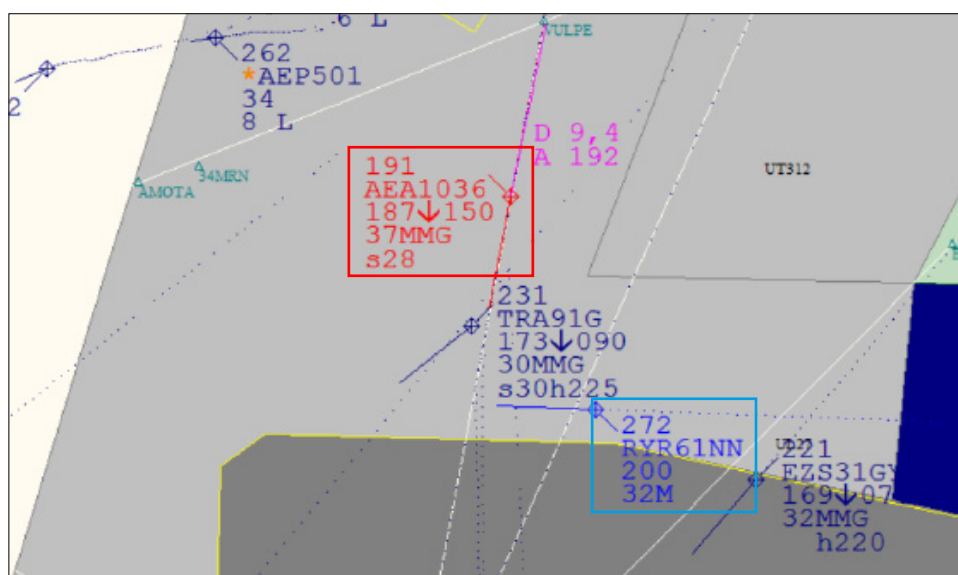
Illustration 4: Moment aircraft AEA1036 was transferred (boxed in red) to LEMGAPM (13:08:32)

At 13:08:32, the LECSMA4 sector controller transferred aircraft AEA1036 to the LEMGAPM sector, while it was still approximately 15 NM from the sector boundary. See Illustration 4.

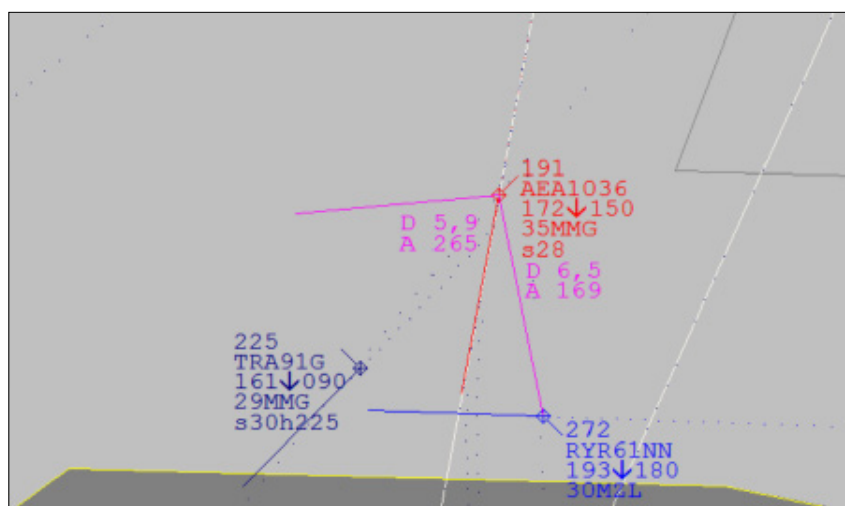
Illustration 5: Position of the aircraft at 13:09:25

At 13:09:25, the LEMGAPM sector contacted the AEA1036 aircraft and instructed it to turn to a heading of 265° and descend to FL 150. The aircraft had previously been on a 191° heading, which meant it had to adjust its course by 74°. The aircraft's speed at that time was 350 kt, and that of the aircraft ahead of it in the sequence (whose callsign was TRA91G) was 290 kt. This aircraft had also been instructed to turn west a few seconds earlier. See Illustration 5.

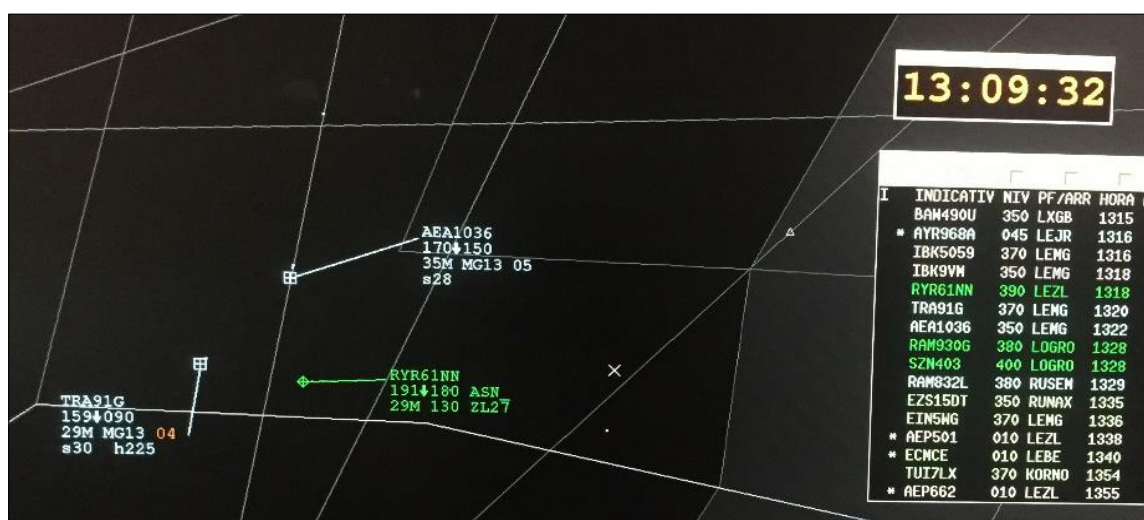
Illustration 6: Image of the LECSMA4 sector's screen at 13:09:32

Due to the way the SACTA system works, when the LEMGAPM sector controller accepted the AEA1036 aircraft and assumed its control, it changed from green to white on the LECSMA4 sector display screen (indicating a traffic not under their control), as you can see from the real-time recording of his screen at 13:09:32 (Illustration 6). This signifies that the aircraft is now under the control of another sector.

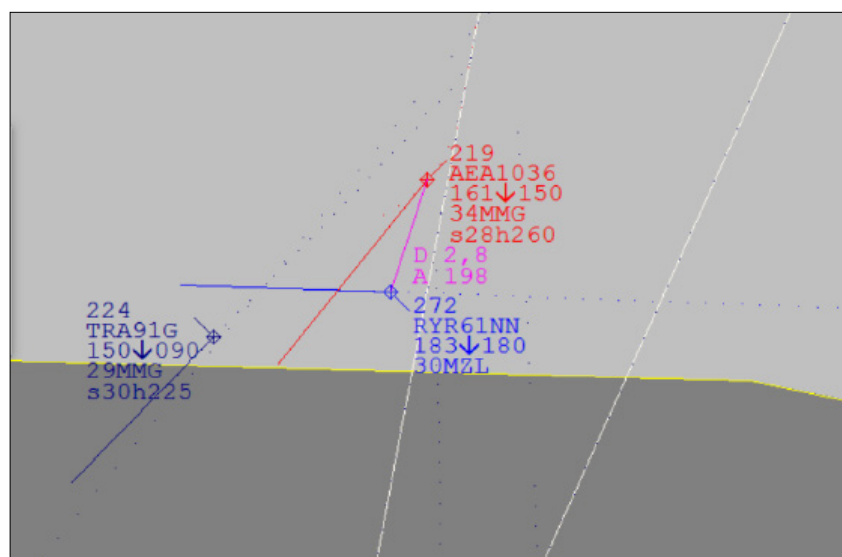
Illustration 7: Moment aircraft RYR61NN was transferred to LECSAPT (13:10:06)

At 13:10:06, the LECSMA4 sector controller transfers the RYR61NN aircraft to the LECSAPT sector while it's still approximately 20 NM away from crossing the sector boundary. At that moment, the distance between the aircraft was 2.8 NM and 2200 ft. Aircraft AEA1036 had already started its turn to the west. See Illustration 7.

In conclusion, we have determined the loss of separation was caused by the LECSMA4 sector controller's early transfer of the RYR61NN aircraft to the collateral sector before it was free for descent due to the prior turn of the AEA1036 aircraft.

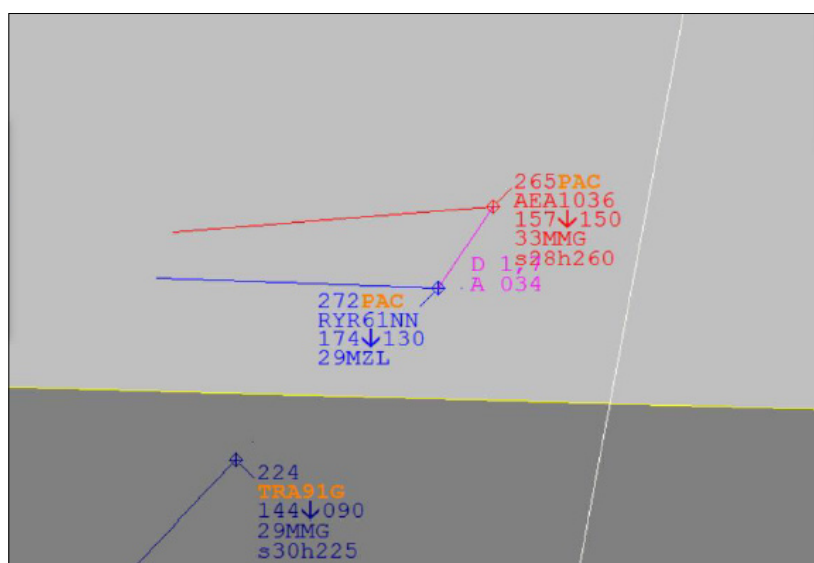
Illustration 8: Position of the aircraft when the STCA-PAC function was activated (13:10:33)

According to Palestra, at 13:10:33, the STCA-PAC function was activated. At that moment, the aircraft were separated by 1.7 NM and 1700 ft. The AEA1036 aircraft had started to reduce its ROD while the RYR61NN aircraft was continuing to increase it. See Illustration 8.

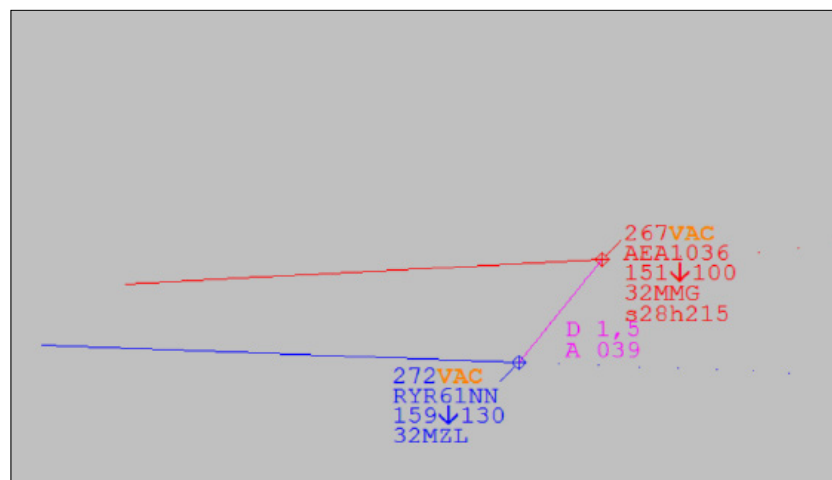
Illustration 9: Position of the aircraft at 13:11:02

At 13:11:02, the STCA-VAC alert was activated due to the prescribed separation being violated. At this point, the distance between the aircraft was 1.5 NM and 800 ft. See Illustration 9.

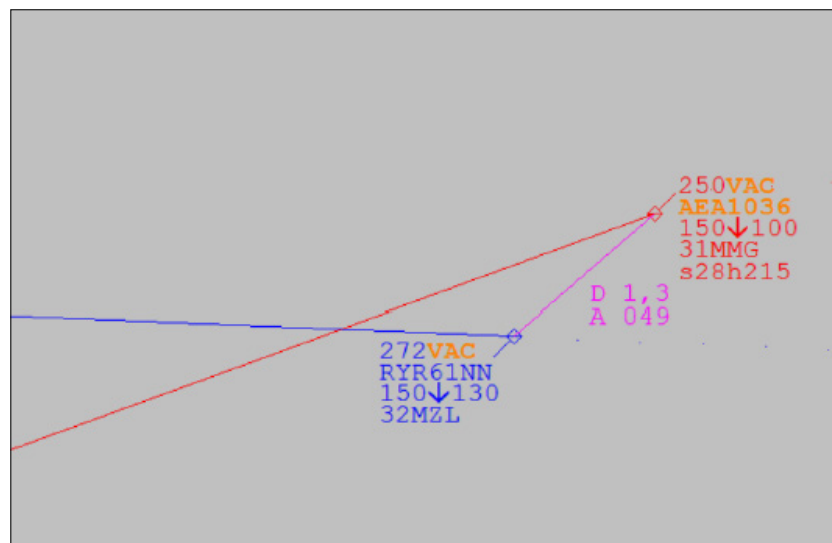
Illustration 10: Position of the aircraft at 13:11:17. Minimum distance (1.3 NM and 0 ft)

Finally, the aircraft reached the minimum recorded distance between them at 13:11:17, being separated by 1.3 NM and 0 ft. At that moment, aircraft AEA1036 had already started a turn towards 215°, as instructed by the LEMGAPM sector controller. See Illustration 10.

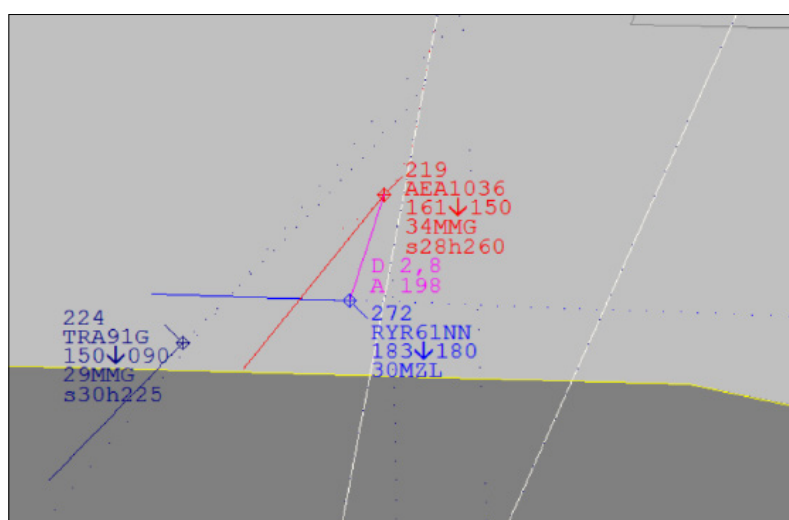
Illustration 13: Position at the beginning of the calculation (13:10:06)

However, this could be interpreted as specifying that the accepting unit should not instruct a turn of more than 45° on accepting an aircraft. To check whether this interpretation would have prevented the conflict, we performed a simple calculation to plot the trajectories the two aircraft would have followed if the AEA1036 aircraft only made a 45° turn and maintained that heading and speed. To do this, we used the Palestra image at 13:10:06, the time at which the aircraft had just started to turn (thirty seconds after acknowledging). For aircraft AEA1036, we used a heading of 236° (which is the original 191° plus 45°). The RYR61NN aircraft maintains its heading (272°).

With these calculations, a minimum horizontal distance between them of 1.17 NM is reached 44 seconds later. Therefore, even with a turn of only 45°, the minimum distance would still have been violated.
