**COMISIÓN DE
INVESTIGACIÓN
DE ACCIDENTES
E INCIDENTES DE
AVIACIÓN CIVIL**

Report IN-040/2018

Incident involving an Airbus A320, registration EC-MDZ, operated by Vueling Airlines, S.A., at the Bilbao Airport (Vizcaya, Spain) on 25 October 2018

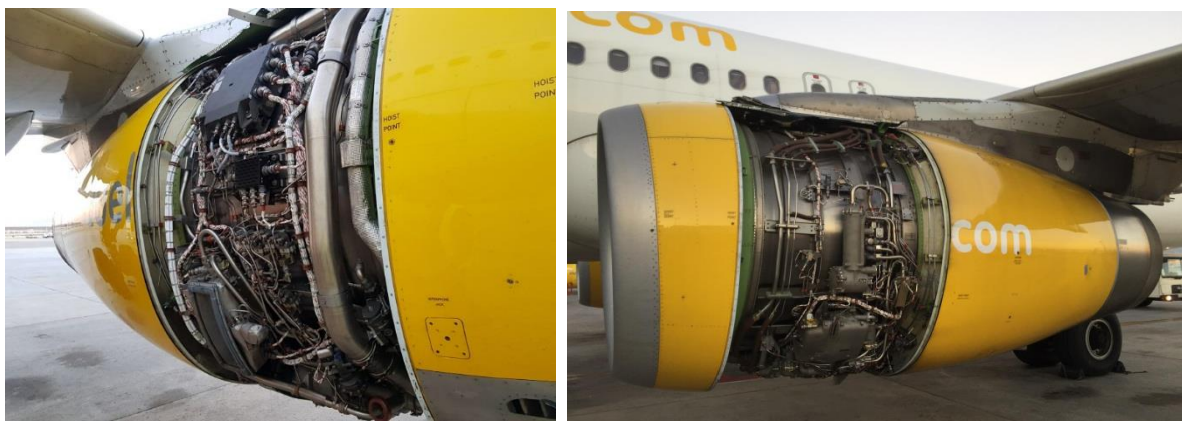
Fig. 1 and 2: side views of the aircraft's left engine after the incident

The aircraft sustained minor damage, namely the loss of the left engine (or engine 1) fan cowls and the damage that their detachment caused to the airplane:

- Fuselage (damages of varying extent², where the detached parts impacted)
- Left belly fairing
- The LH and RH fan cowls on engine 1
- Nose cowl on engine 1
- RH thrust reverser cowl on engine 1
- Left engine pylon (front structure and outer panels)
- Left wing: outboard flaps and inboard flap, and slat 1
- LH MLG fixed door
- Landing gear light torn out (located below left wing)
- Cabling for sensor 23GA disconnected, and damage to the connection that links LGAB3 with connector 4029VC (all located in the left leg of the MLG)³

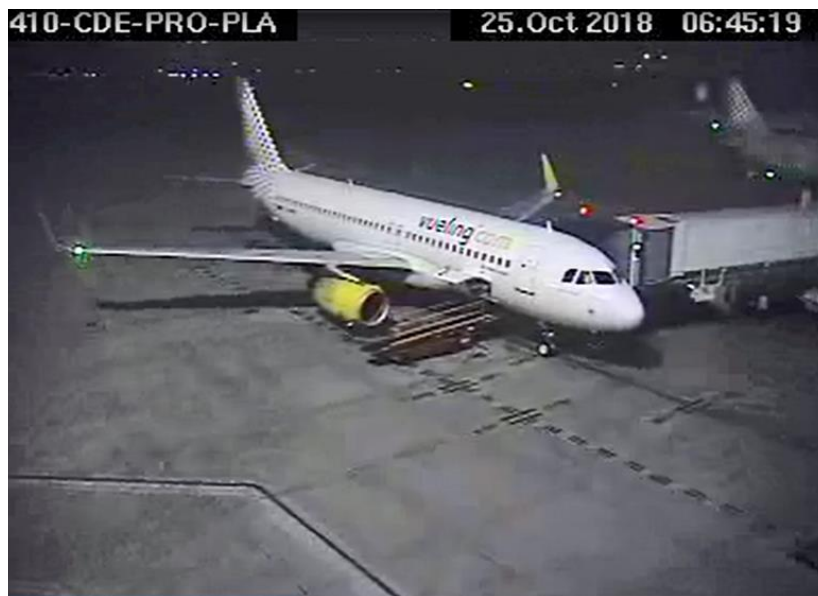
The image below, taken from a camera in the airport building (at 04:45 UTC on 25 October 2018), shows the visibility conditions at the stand where the aircraft was parked. Note that there were no problems with the visibility (at distances on the scale of the airplane's size) due to the presence of artificial lighting.

Fig. 10: Aircraft parked at the stand minutes before chocks off

Even though the sun was not yet up when the maintenance tasks and exterior inspections of the airplane were carried out, in light of the eyewitness statements and of the lighting conditions evident in Figure 10, the visibility conditions are not deemed to have been a limiting factor in conducting these tasks.

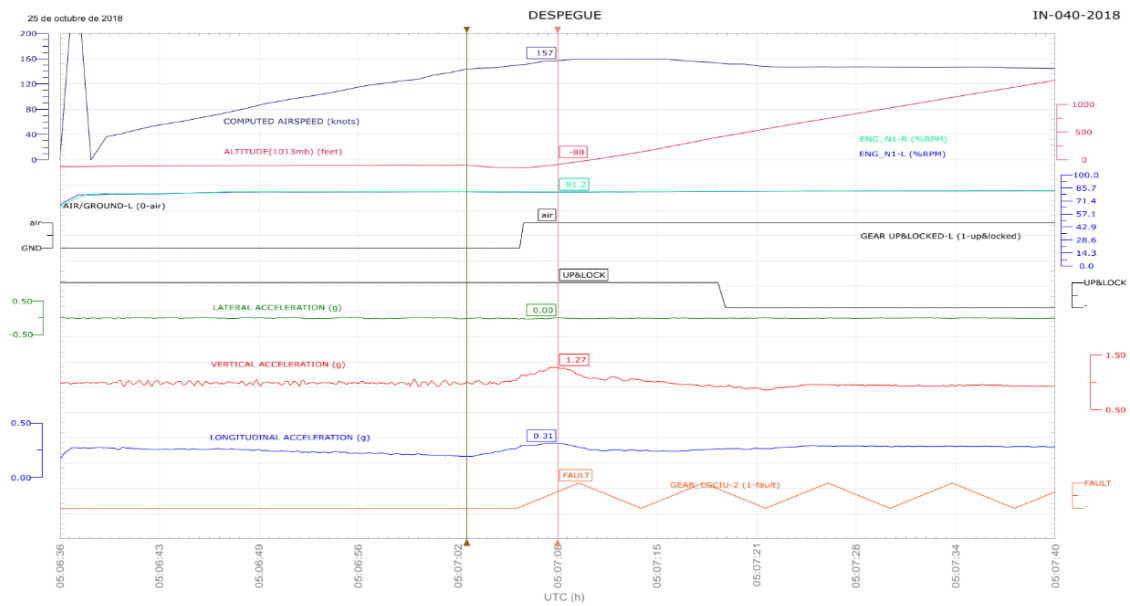
The graph below is for the takeoff phase, and show the time when the two fan cowls on the left engine were lost, triggering the LGCIU2 FAULT.

Fig. 11: Parameters of interest during takeoff phase

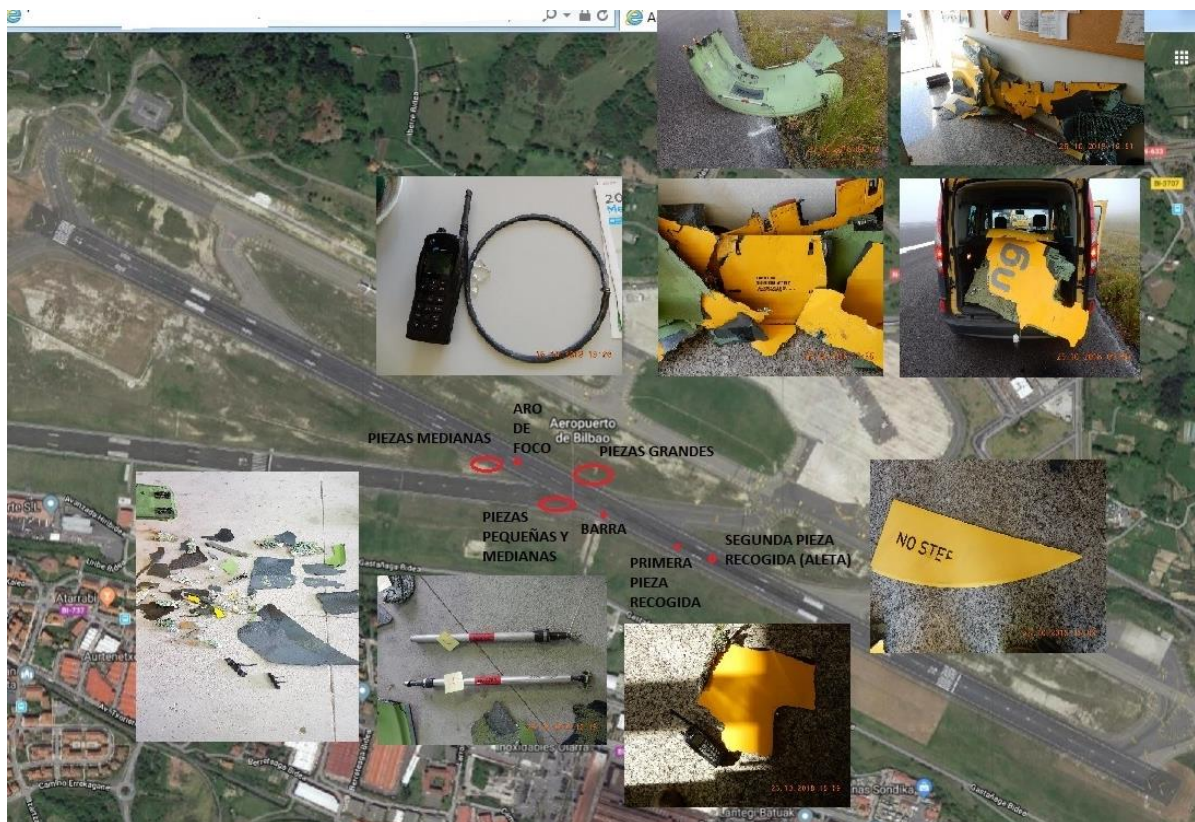
All the parts that detached from the aircraft came to rest on the sides and shoulder of runway 12 at the Bilbao Airport, with the exception of one cowl fragment, which was embedded in the structure of the left main landing gear leg, where it remained until Barcelona.

Fig. 13: Locations of largest fragments found at the Bilbao Airport

At 06:18 UTC, a marshaller at the Bilbao Airport double checked runway 12/30 (once in each direction) and only found two pieces on the runway, whose size was much smaller than that of a fan cowl (see previous figure, the sub images at the lower right corner).

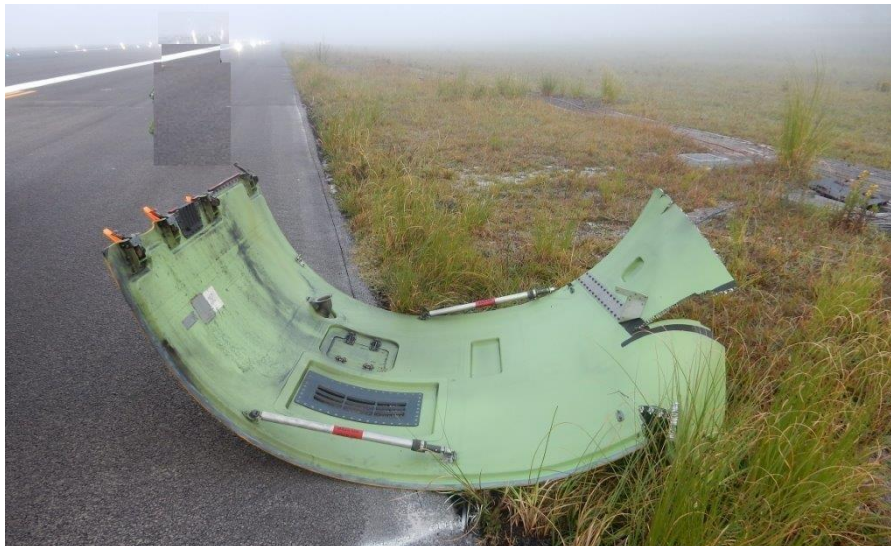
At 06:19 UTC, a marshaller at the Bilbao Airport again checked runway 12, and this time was able to locate large pieces (fan cowls) on the shoulders of runway 12. The runway was closed at 06:51 UTC.

Fig. 14: Location of one of the fan cowls

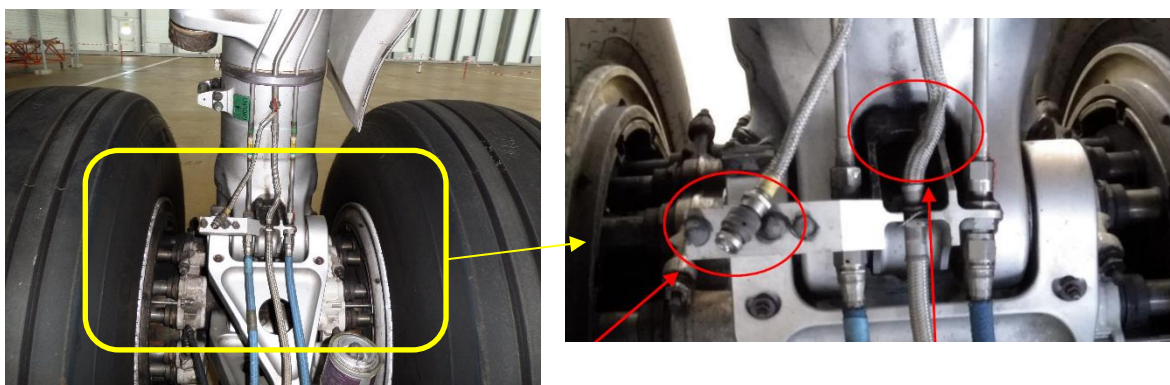
- The left engine did not have any dents.
- The structure of the left main landing gear leg exhibited damage, especially where the cowl fragment had been embedded.

- There was damage of varying extent⁵ in several areas that were impacted by detached pieces.
- Specifically, on the left main landing gear leg, sensor 23GA of LGCIU2 was disconnected (due to impact). This is what caused the fault message in phase 5 at 05:07 UTC (the proximity sensor L L/G EXT, SYS 2 (23GA) is connected to LGCIU2). There was also damage to the cable that connects LGAB3 to connector 4029VC, which remained attached. Both the tachometer 19GG and the brake cooling fan motor assemblies are connected to 4029VC (tachometer 19GG is connected to the BSCU, which exchanges information with LGCIU2, and the brake cooling fan motor assembly is connected to the hydraulic/BRK fan wheels through contactor 5GS, which sends a signal to LGCIU2 about the status of the connectors).

Fig. 15 and 16: Damage to connectors (close-up at right showing two impacts)

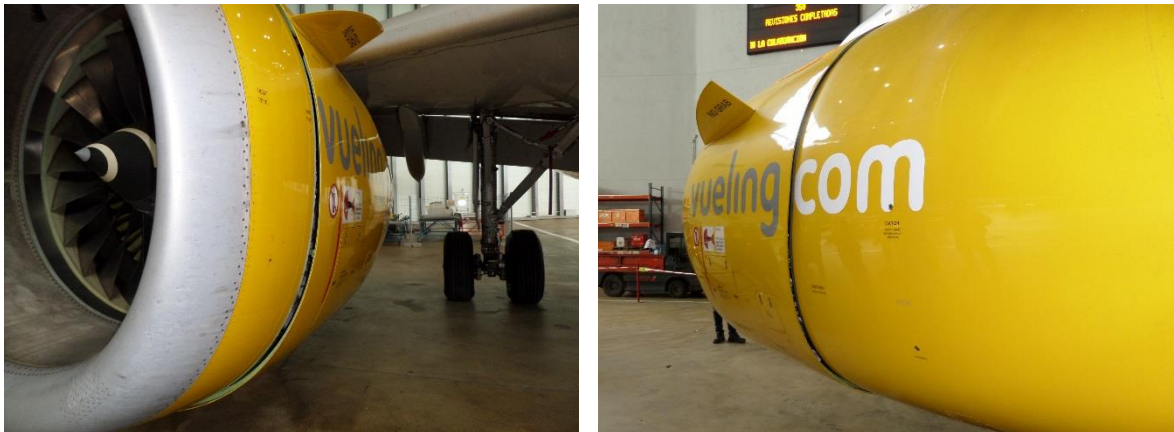
The sequence of steps to take is as described in the above sections. The images below show the condition of the cowls once lowered, before the screwdriver is used to push the pin and close the safety gap. Note the gap that remains visible.

Figs. 17 and 18: Cowls lowered, before pressing the safety pin

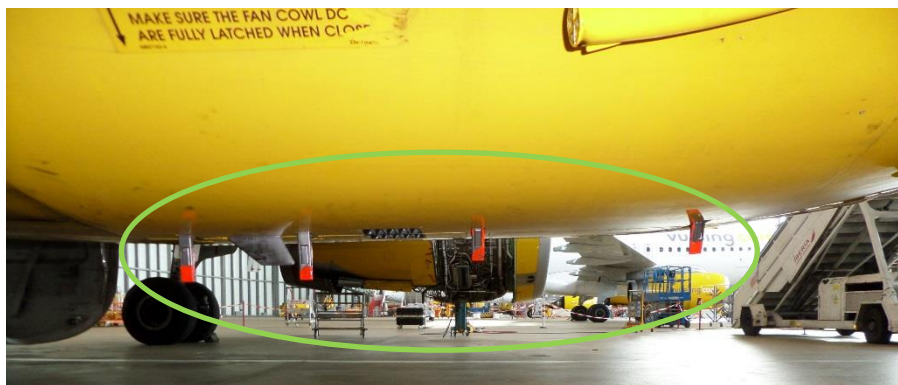
Fig. 19: Cowls lowered, four latches open

The second involves the crew checking the condition of the cowls during the exterior inspection. This inspection was done by the captain, who did not notice anything on the engines that made him question whether the latches on the cowls were properly secured. This reinforces the idea that the cowls, once lowered, left a very small gap with the engine fairing, being practically flush with it. However, if the pilot who did the exterior inspection had crouched to see if the latches were flush with the nacelle, he would have noticed that they were not (see Figure 19), and would have therefore realized that they were open.
