## Report IN-040/2019

Incident involving a Sikorsky  
S-76 C+ aircraft, registration  
EC-JES, over the Vigo estuary  
(Pontevedra) on 26 July 2019

On 26 July 2019 the SIKORSKY S76 C+ helicopter, registration EC-JES, was involved in an incident when the crew inadvertently descended the aircraft to an altitude of 22 ft above sea level during a training exercise over the Vigo estuary.

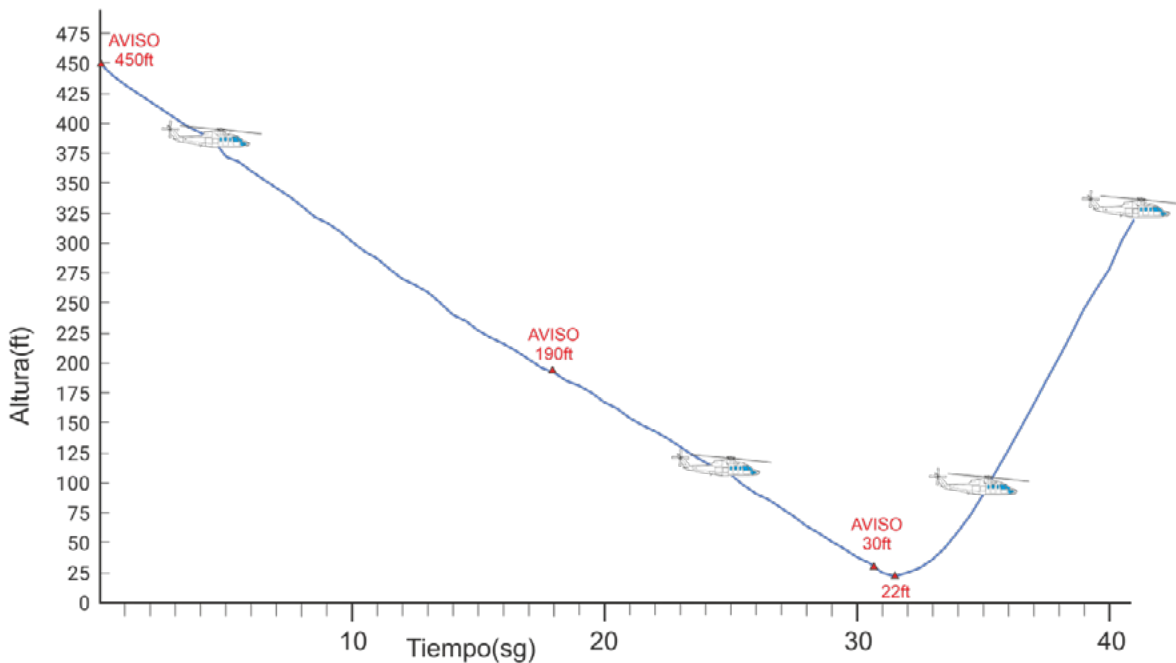
Fig. 2. - Profile of the flight path around the time of minimum altitude above the water

Immediately afterwards, the winch operator, sitting in the right rear seat, saw the sailing boat he had previously located with the FLIR through the window of the left passenger door. He noted that the helicopter was slightly above the boat's mainsail mast-head light. According to his testimony, he then turned his head to take note of references through his window (rear right-hand side) and in the darkness of the night saw what looked like the surface of the sea. He turned again to look for the sailing boat on the left side of the co-pilot, located it through the left rear window and realised that the helicopter was now just below the previously mentioned mast-head light.

In that instant, the various members of the rescue crew began to call out, shouting that they were going down, at which point the co-pilot exclaimed "50 ft" and put the aircraft into a steep climb by pulling the collective pitch control lever upwards.

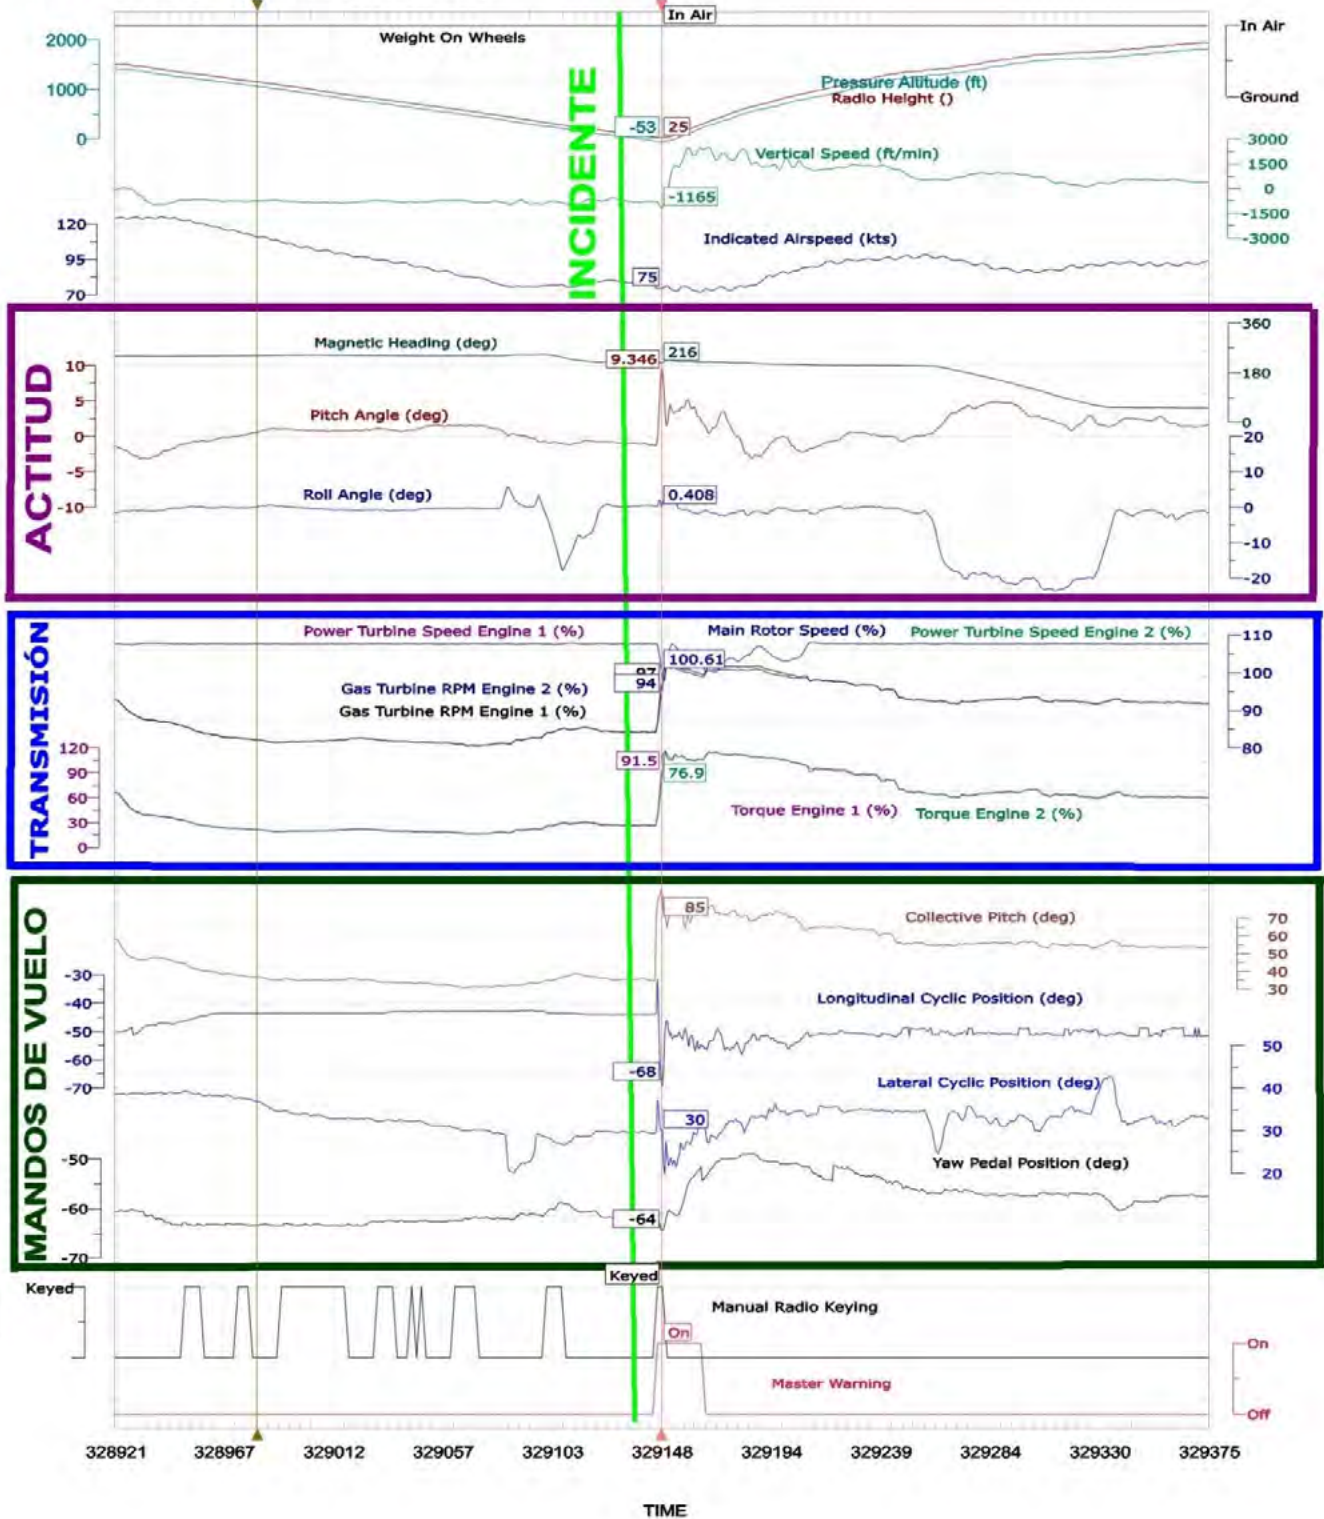
- (RPM Rotor y Turbinas y Torques)

The PIC felt the "sudden pull" on the collective pitch control lever and pulled it up as well, noting that the N1 was on red. They climbed to a safe altitude and, once straight and levelled, he asked the co-pilot to relinquish the controls, and they returned to the base.

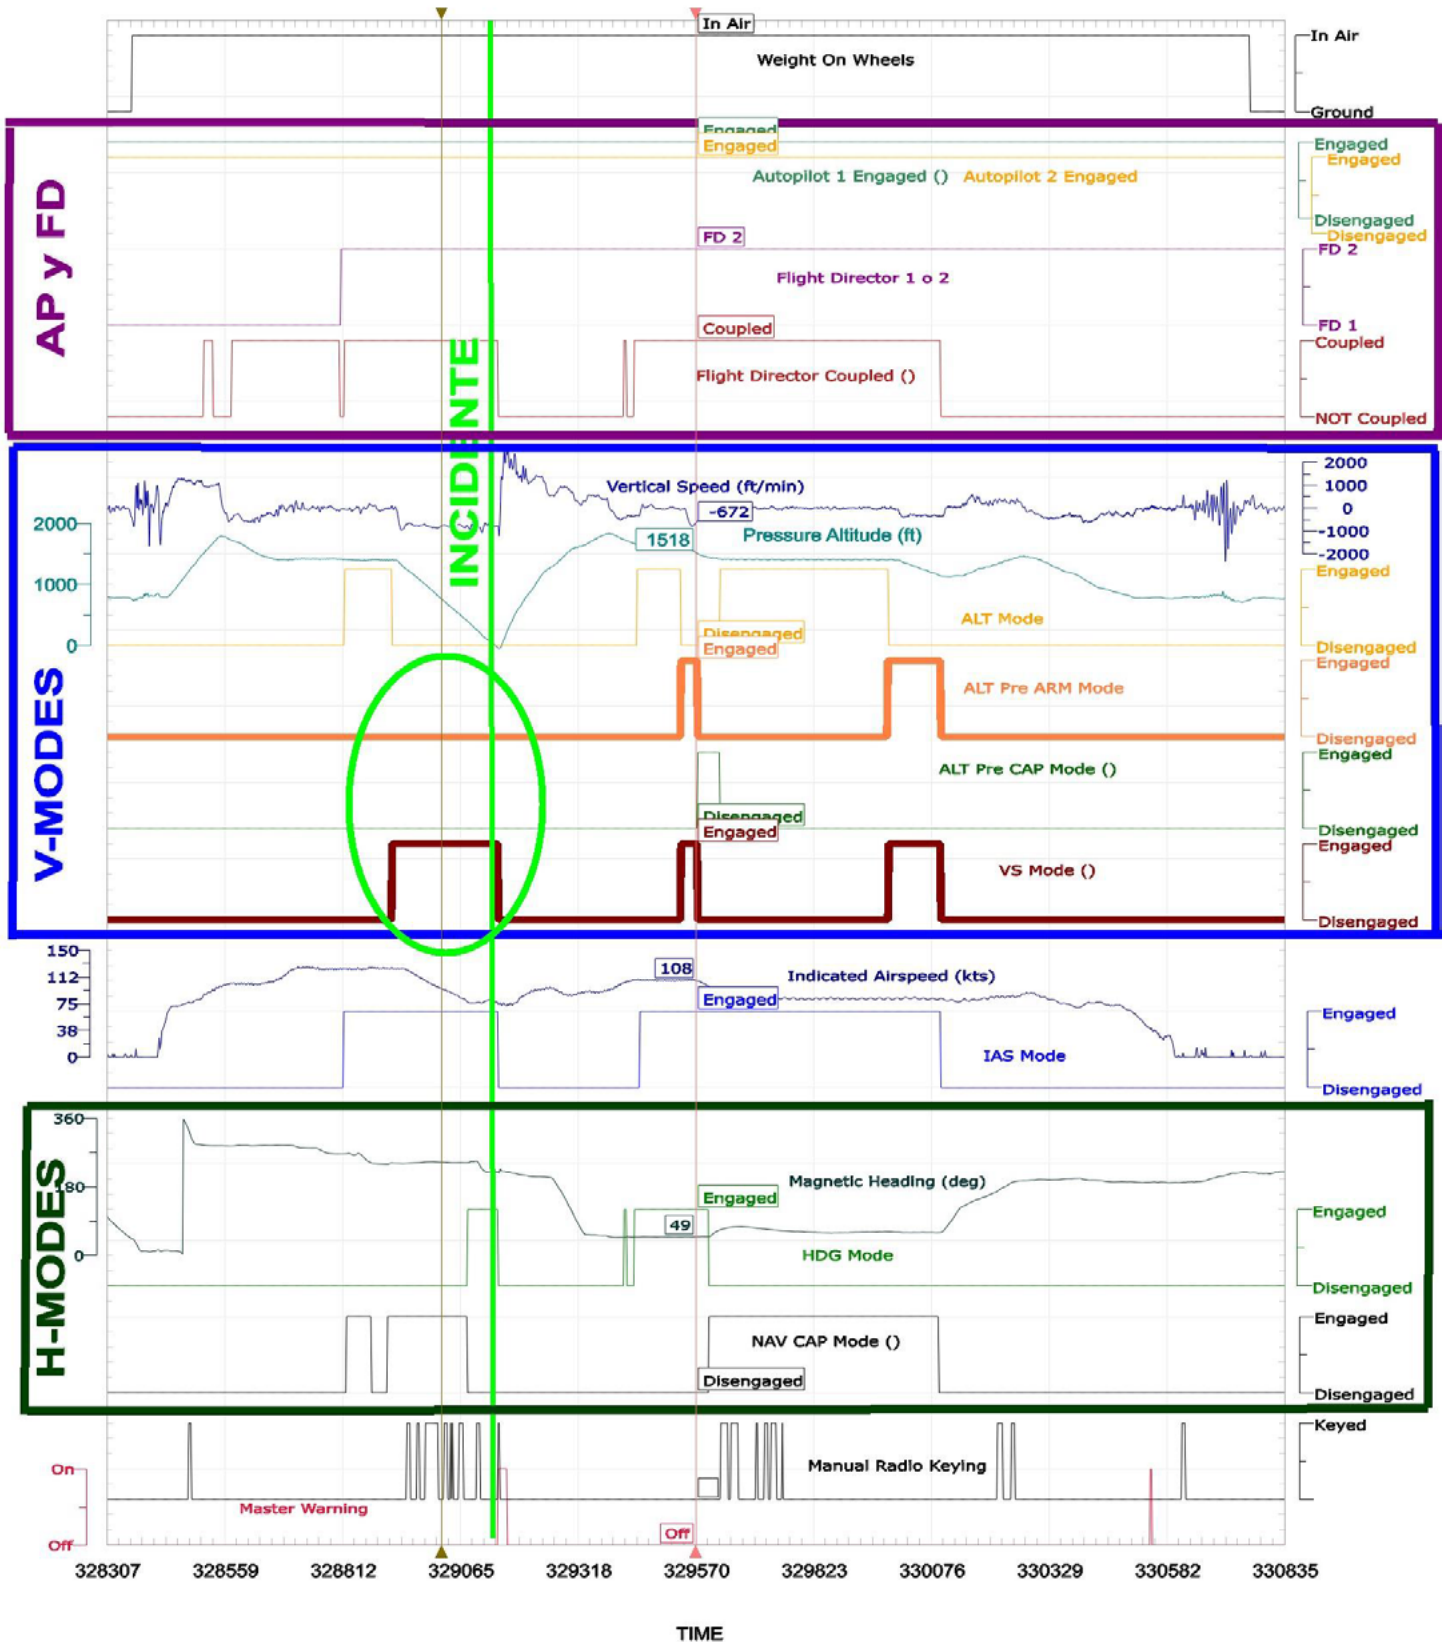
**Values of relevant FDR parameters**

This lack of awareness resulted from the crew's assumption that the aircraft was operating under altitude control, when, in fact, it was not because the corresponding system had not been activated. Excess confidence in the automatisms caused the crew to be complacent. They failed to carry out the mandatory monitoring of the descent, which led to a potentially life-threatening situation.

Parameters corresponding to the AP and FD at the beginning of the incident descent. The ALT-PRE MODE is not selected

REC 35/20: We recommend that the operator, Babcock, should implement the necessary measures to improve training on procedural adherence, response to warnings and alarms and, particularly, CFIT prevention during initial and recurrent crew training exercises.
