Report IN-051/2019

Incident involving an AIRBUS A320, registration EC-MKO, operated by VUELING, and an EMBRAER 145, registration F-HRAM, operated by AERO4M, 17.4 NM northeast of Barcelona-El Prat airport (Spain) on 27 September 2019

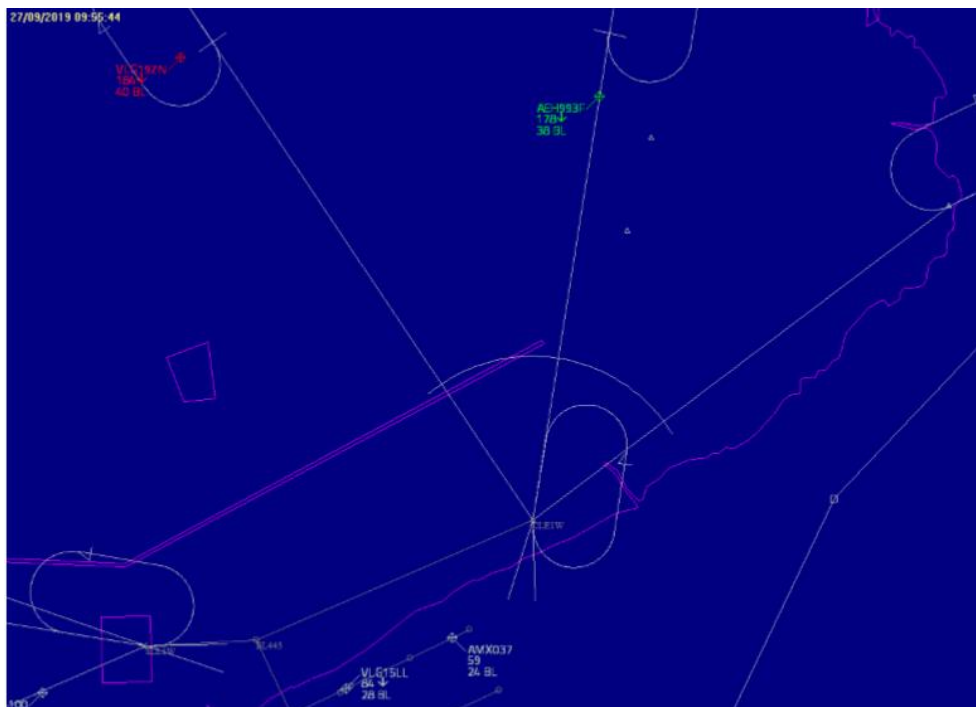
Fig. 2 Palestra image for 09:55:44

At 09:54:24, the controller in sector T1W instructed VLG19ZN to fly direct to point BL443. The crew correctly acknowledged the instruction. The controller then instructed AEH993F to “fly direct to the BL443 to continue with the transition”, but the crew only acknowledged “fly direct BL443”, which ATC did not correct.

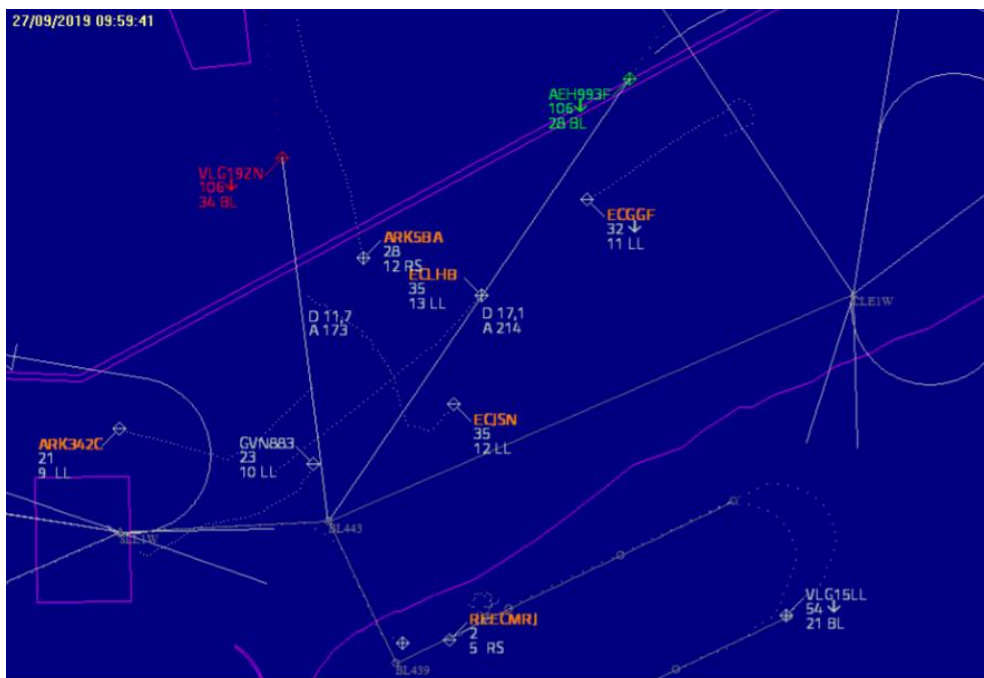
Fig. 3 Palestra image for 09:59:41

Then, the controller in sector T1W instructed VLG19ZN to descend to 5000 ft, which the crew acknowledged correctly. Afterwards, he instructed AEH993F to descend to FL080, which its crew acknowledged correctly.

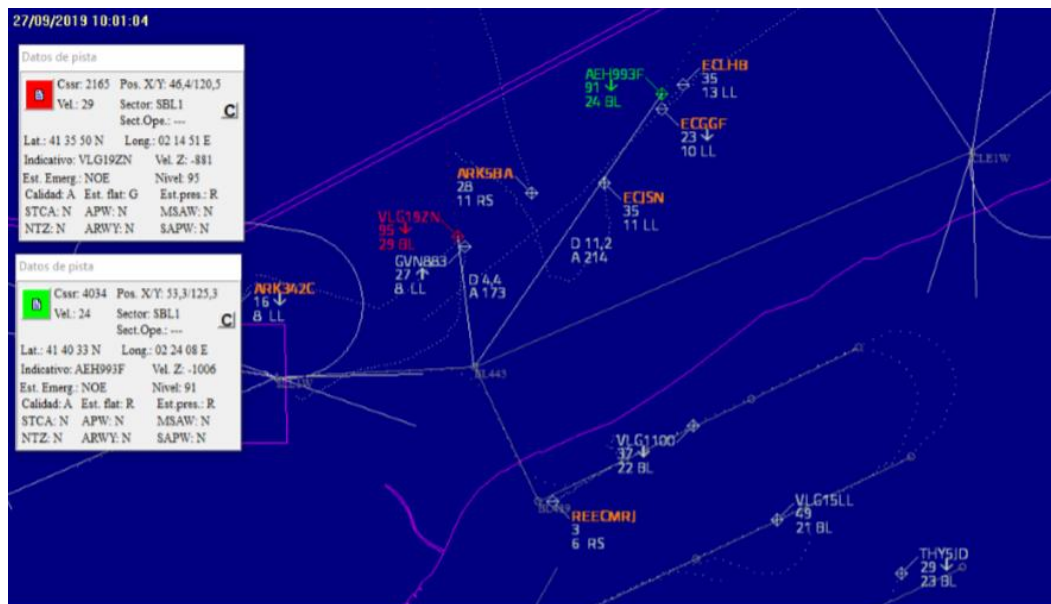
Fig. 4 Palestra image for 10:01:04

At 10:01:04, the controller in sector T1W instructed AEH993F to descend to 6000 ft. The crew acknowledged correctly.

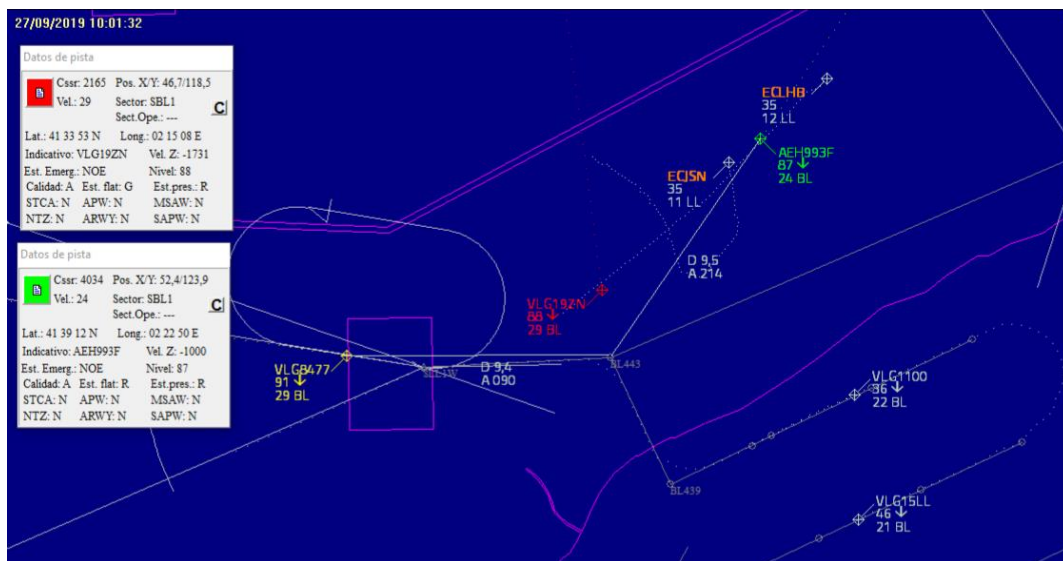
Fig. 5 Palestra image for 10:01:32

At 10:01:32, the controller in sector T1W instructed AEH993F to “fly direct to the BL435”, which the crew acknowledged correctly (see location of point BL435 in Figure 1).

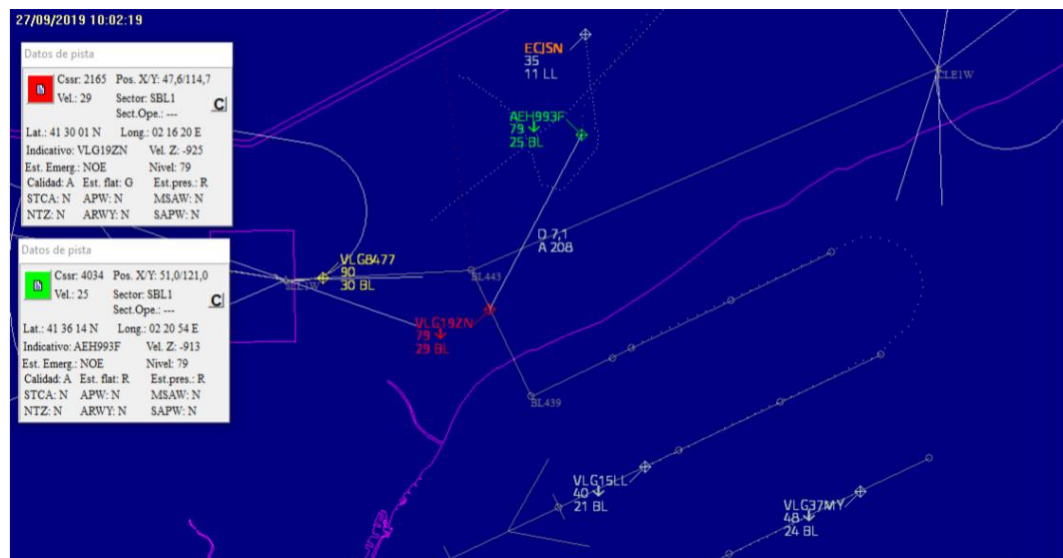
Fig. 6 Palestra image for 10:02:19

At 10:02:04, the controller in sector T1W instructed VLG19ZN to reduce to its minimum clean approach speed and transferred it to 119.105 MHz, which is the frequency for sector F25W. The crew of the aircraft acknowledged correctly.

The controller in sector F25W then instructed VLG19ZN to descend to 2300 ft and reduce to its minimum clean speed, which the crew acknowledged correctly.

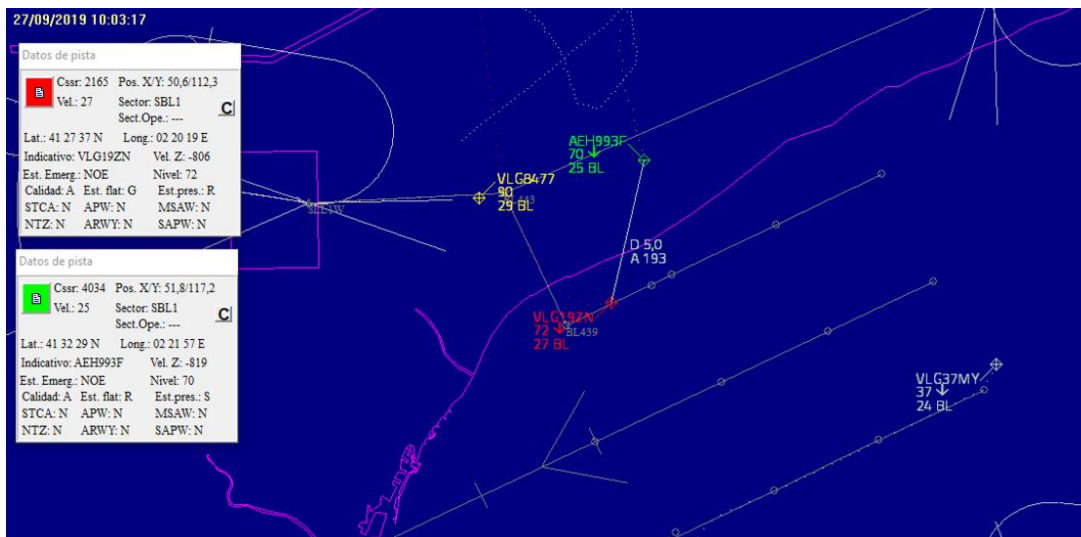
Fig. 7 Palestra image for 10:03:17

At 10:03:11, the controller in sector T1W coordinated with the controller in sector F25W and asked him to instruct VLG19ZN to increase its rate of descent. The controller in sector T1W then instructed AEH993F to turn right immediately to heading 070°. The crew asked for the instruction to be repeated, so the controller in sector T1W instructed AEH993F to turn left immediately to heading 070°. The crew requested confirmation that the turn was to the left, which the controller in sector T1W did. In response, the crew reported that they had VLG19ZN on TCAS and again requested confirmation of the left turn, since the other aircraft was proceeding toward its left. The controller in sector T1W instructed the crew to maintain its current heading.

The controller in sector F25W then instructed VLG19ZN to increase its rate of descent until it passed 5000 ft, which the crew acknowledged correctly.

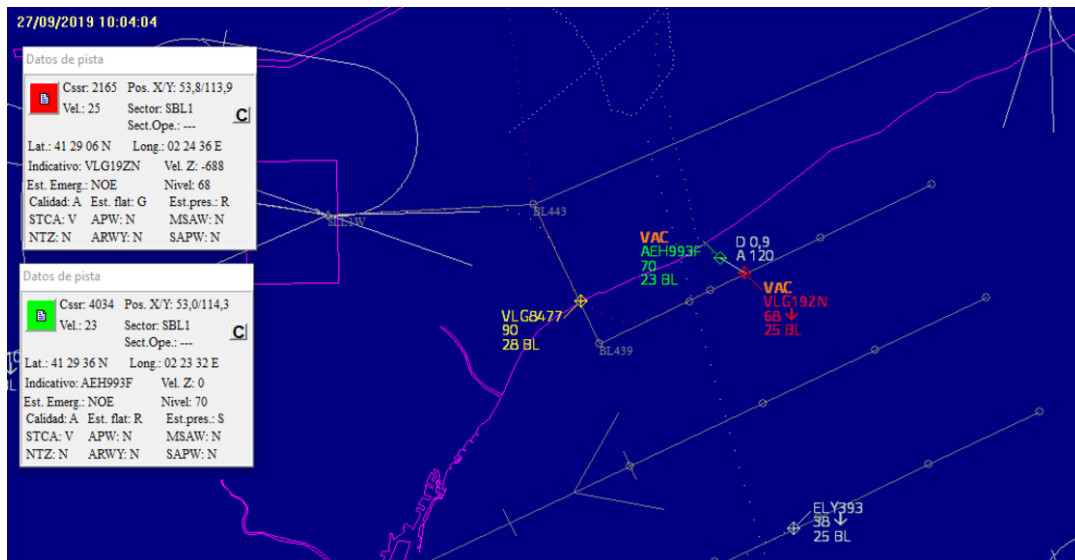
Fig. 8 Palestra image for 10:04:04

At 10:04:04, VLG19ZN reported a TCAS RA, which the controller in sector F25W acknowledged. The figure below, which is for that time, shows the activation of the STCA-VAC feature. At the time, the aircraft were separated by 0.9 NM and 200 ft.

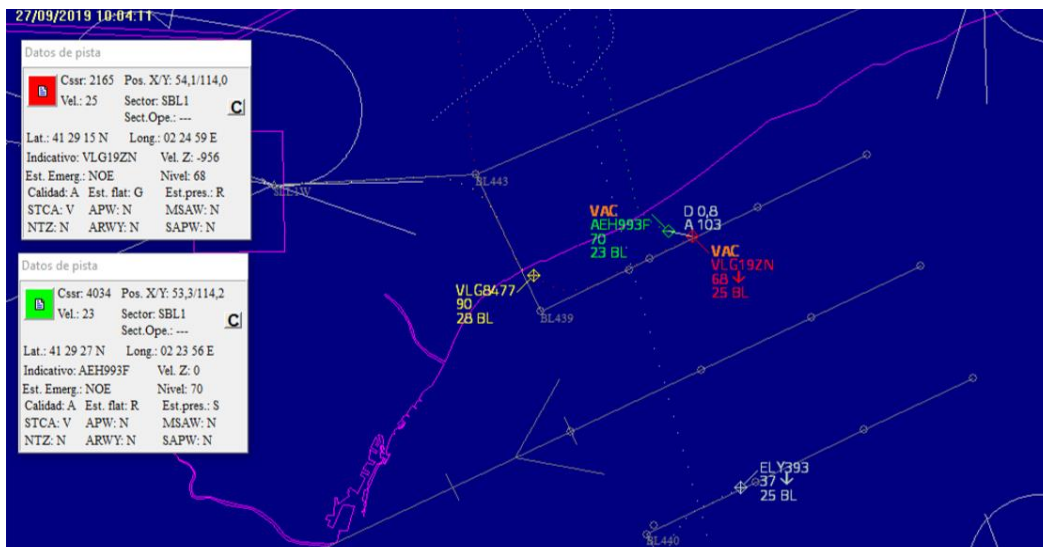
Fig. 9 Palestra image for 10:04:11

At 10:04:12, the controller in sector T1W instructed AEH993F to turn to heading 060°. The crew of the aircraft acknowledged correctly and reported they had received a TCAS RA, and that they had the traffic in question in sight. It was then that the aircraft were at their closest point of approach: 0.8 NM and 200 ft.
