Report IN-052/2019

Incident involving an ATR 72-212
A aircraft, registration EC-MPI,
operated by Canarias Airlines at
the Tenerife North Airport (GCXO)
on 15 October 2019

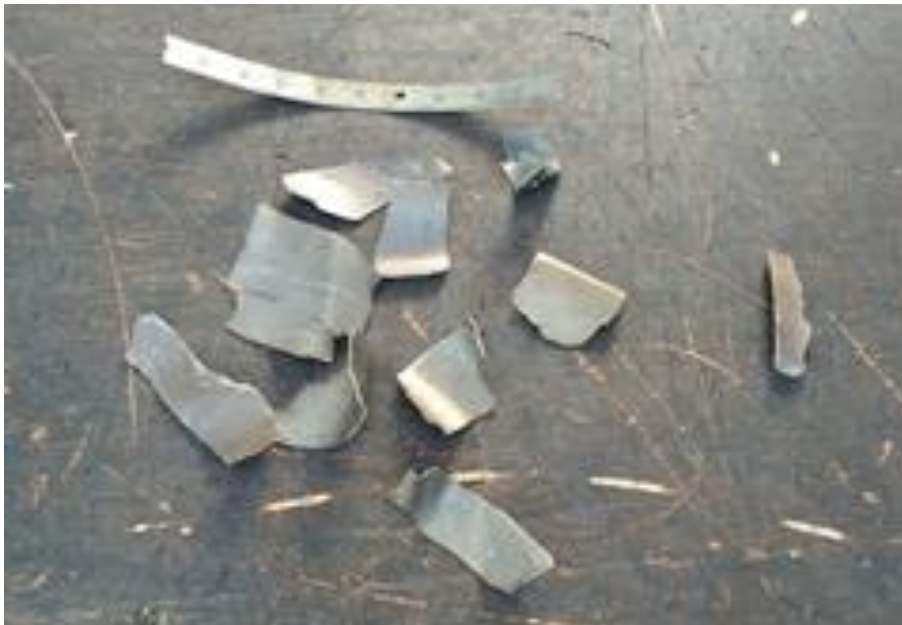
Figure 1. Fragments removed from the runway

Moments later, airport officials informed them that various metal fragments had been removed from the runway and from the vicinity of exit taxiways E1 and E2, which were later determined to have released from the right engine through the gas exhaust.

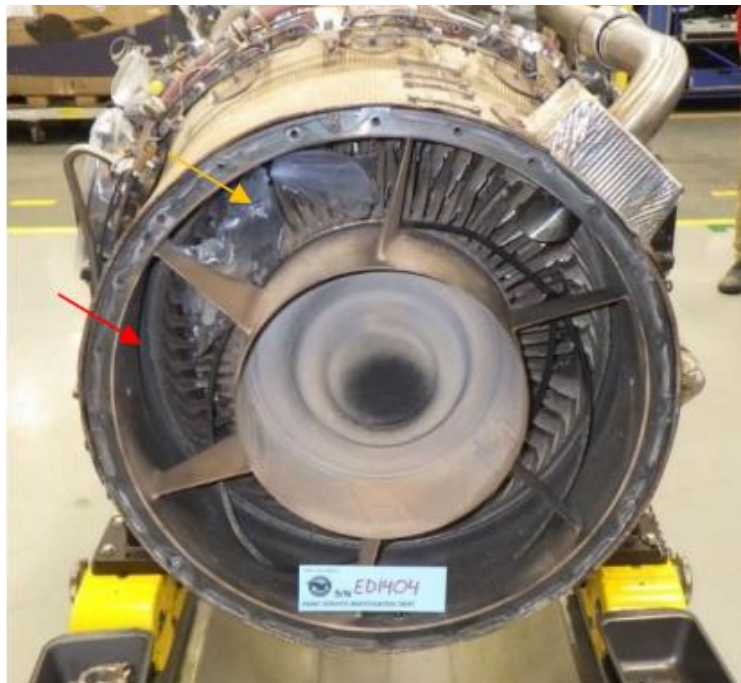
Figure 6. Engine seen from behind

The blades in the second stage of the power turbine (PT2) were found fractured, and multiple fragments were missing. The exhaust cover was fractured and deformed (red arrow, Fig. 4).

However, the turbine case was not perforated, meaning all the fragments exited via the same route as the exhaust gases.

As a result, the engine contained all the detached and projected components, which were collected and sent for analysis, along with the engine (the orange arrow points to the bag where the fragments found on the runway were placed). The purge valve was loose, attached only by one bolt, which was partially unscrewed. The valve connector and cable were damaged.

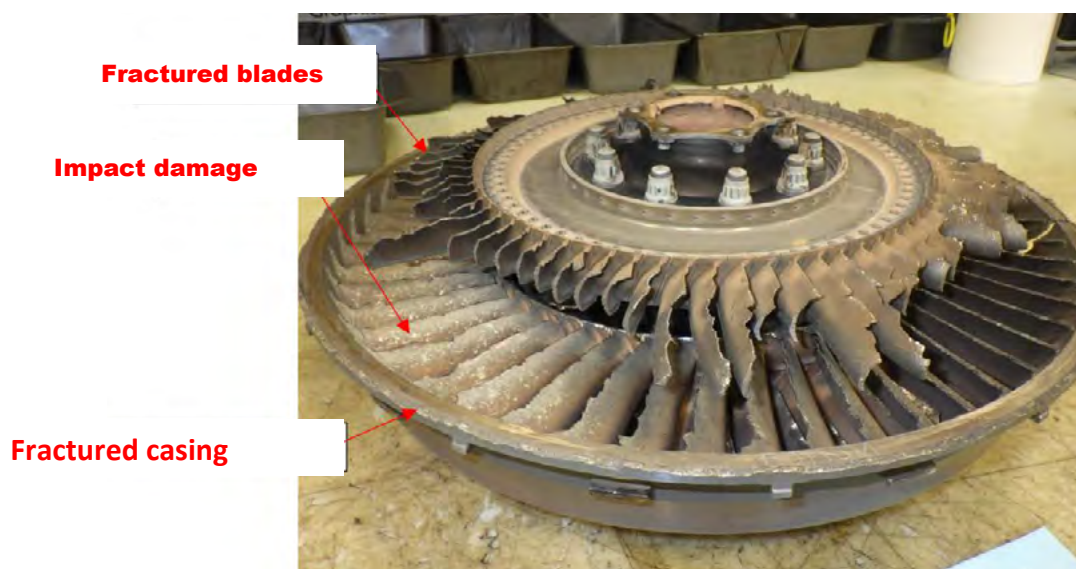
Figure 7. Damage to PT2

All the blades in the second stage of the power turbine (PT2 disk) were fractured at various lengths. The case on this stage of the turbine was also fractured, and multiple secondary damages were found on the trailing edge of the stator on the power turbine (PT2 vane).

The first stage of the power turbine (PT1 disk) showed damage from secondary impacts to the trailing edges of the blades. The deflector on this stage was fractured and dented, and some components were missing.

The tips of the blades on the low-pressure turbine disk exhibited wear due to friction associated with the wear observed on the segments of the LPT casing. The tips of the blades on the high-pressure disk were found to have considerable wear due to friction and loss of material. Most of the cooling holes on the blades were not visible.

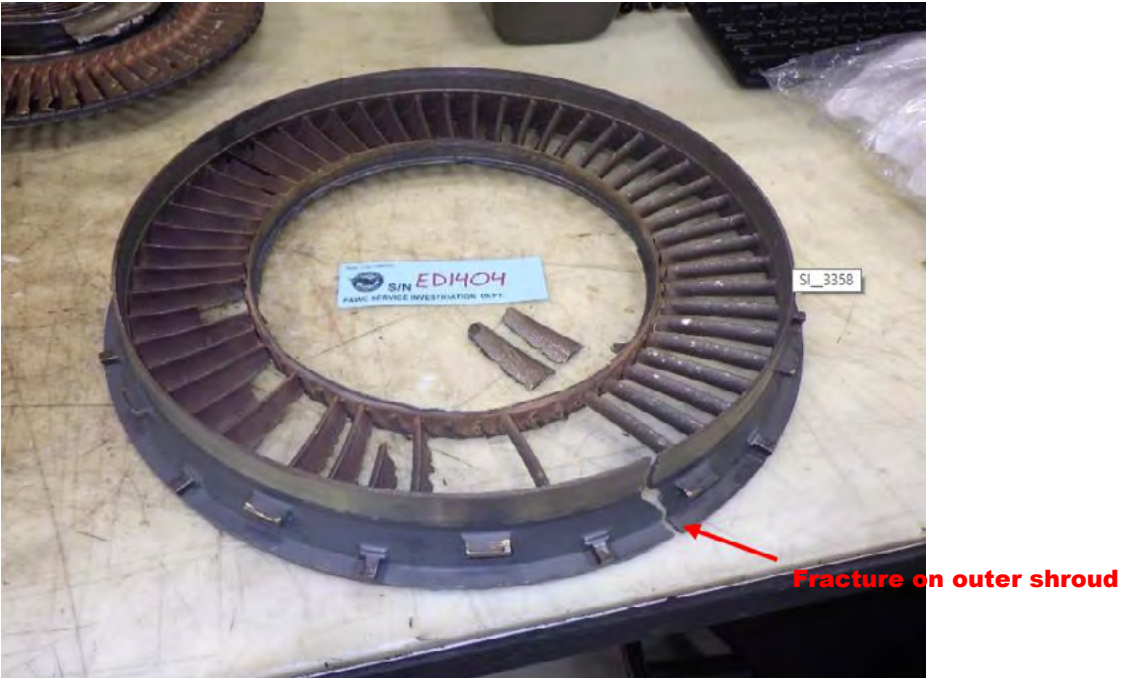
Figure 8. Damage to PT2 stator

The ring of blades on the second stage of the power turbine (PT2 vane) was fractured.

The HP vane exhibited damage due to excess temperature and cracks on the aerodynamic airfoils. In addition, the LP shaft contained marks from rubbing against the HP disk.

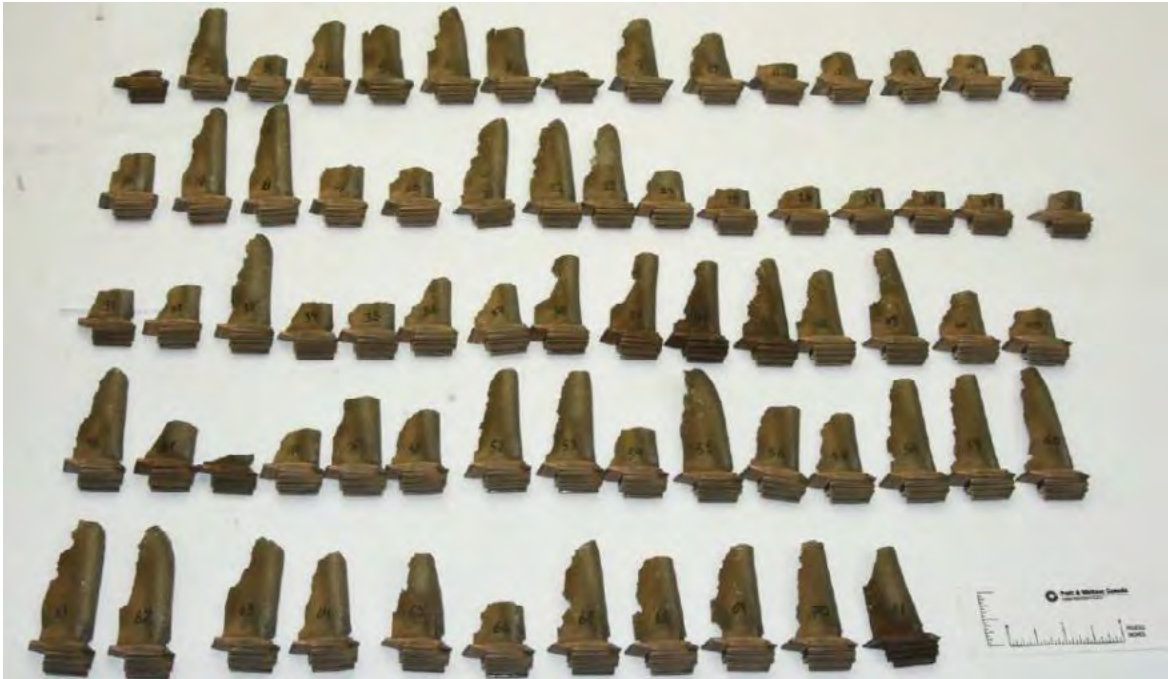
Figure 9. Blade fragments found

As noted earlier, numerous blade fragments were found that had a type of localized straight fracture either directly on or just above their respective platforms. Other blades exhibited impact damage and angled fracture planes that were consistent with secondary damage.

The analysis of all the PT2 blades that exhibited a plane fracture near the platform revealed that only one of them (#8) showed evidence of fatigue near the leading edge, exhibiting significant wear.

The remaining blades had fractures consistent with overload.

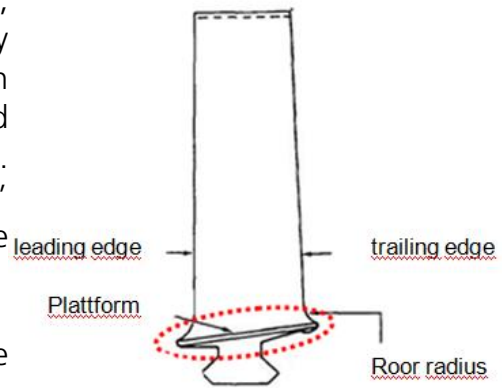
Figure 10. Parts of a blade

On the blade that showed signs of fatigue, most of the fracture was located approximately 0.25" above the platform, and the region where the fatigue characteristics were found was located about 0.125" above the platform. The fatigue characteristics were around 0.150" away from where the leading edge would have been.

The area with the fatigue crack exhibited more oxidation than the rest. Upon noticing that the fatigue crack on the only affected blade was small, it was decided to perform a metallographic test of another blade (#18), as its profile was in the best overall condition, although since its leading edge was also missing, its trailing edge was examined.

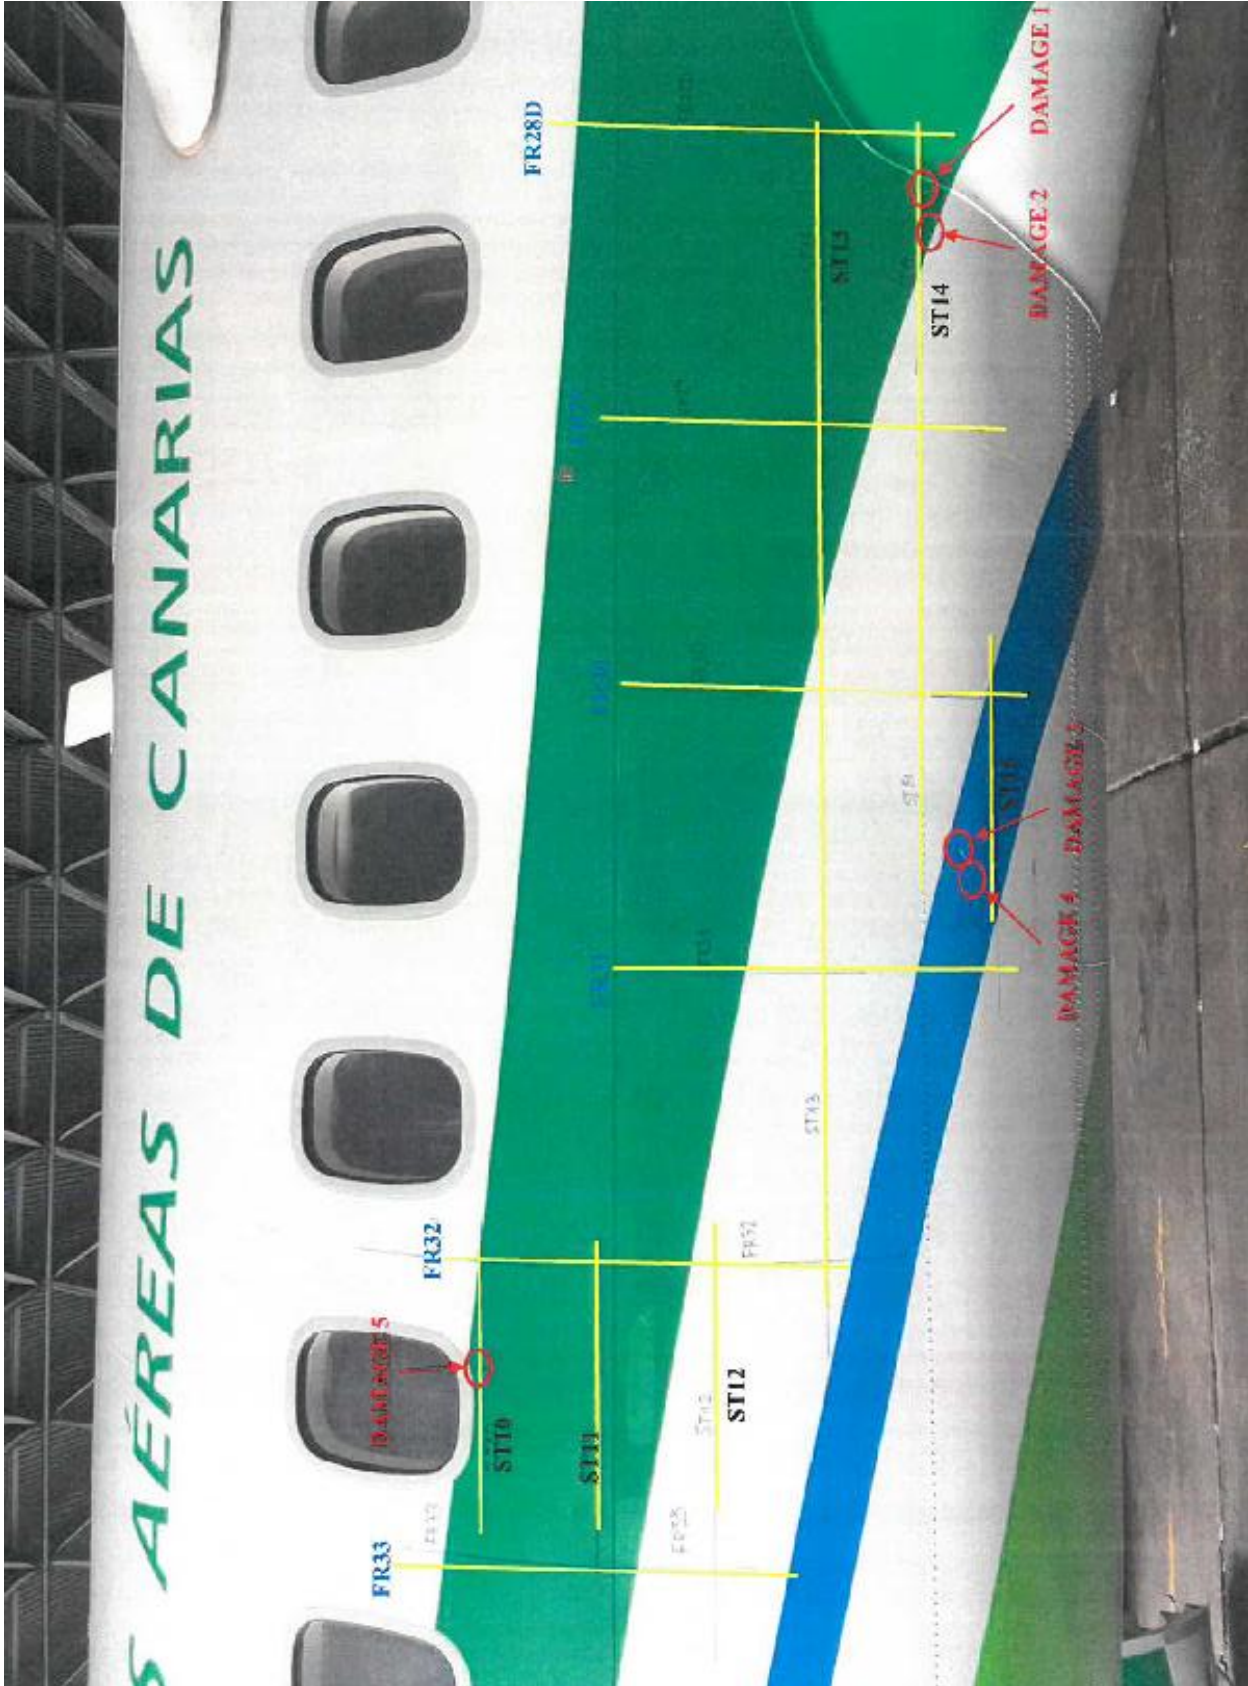
ANNEX 1. DAMAGE TO THE FUSELAGE

During the engine failure, several metal pieces detached that caused damage to the right side of the fuselage, between form ribs 28D and 33, and stations 9 and 15 (see Annex 1), as listed below:

6. Nick located 67 mm FWD FR 31 and 18 mm below ST 15.
7. Nick located 125 mm FWD FR 31 and 12 mm below ST 15.
8. Nick located 10 mm FWD FR 31 and 12 mm above ST 14.
9. Scratch located 125 mm FWD FR 32 and 20 mm below ST 13.
10. Scratch located 35 mm FWD FR 32 and 69 mm below ST 13.
11. Nick located 47 mm FWD FR 32 and 38 mm above ST 14.
12. Scratch located 168 mm FWD FR 33 and 19 mm above ST 14.
13. Nick located 95 mm FWD FR 33 and 19 mm above ST 14.
14. Nick located 62 mm FWD FR 32 and 30 mm below ST 13.
15. Nick located 140 mm FWD FR 3 and on ST 15.
16. A perforation was also found on the vertical stabilizer on the dorsal fin panel.
vertical.
