## Report IN-063/2019

Incident involving an AIRBUS A320-214, registration EI-IKL, operated by ALITALIA, and a BOEING B737-8AS, registration EI-ENN, operated by RYANAIR, 58 NM east-southeast (ESE) of the Madrid-Barajas Airport (SPAIN) on 7 September 2019

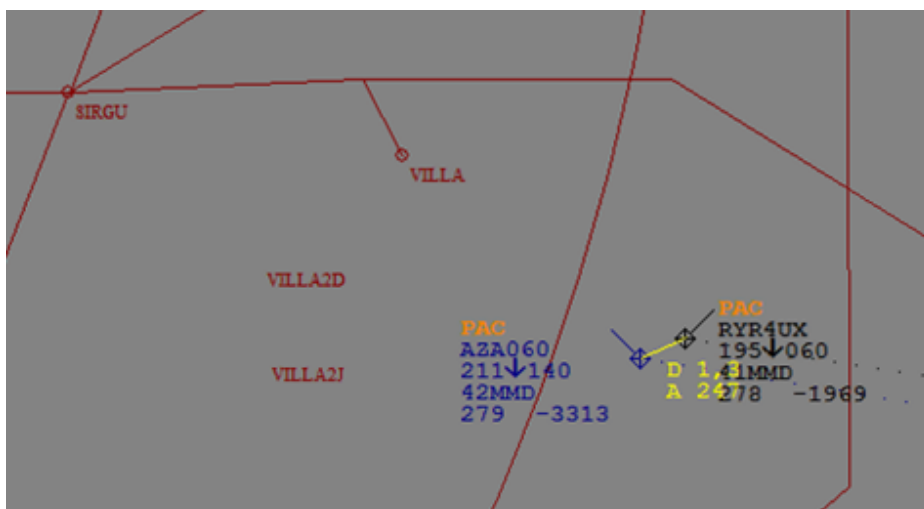
Fig. 12 Palestra image for 13:59:36

At the same time, AZA060 was en route to ASBIN point (IAF) at FL211 and descending to FL140 at a rate of descent of -3313 fpm. RYR4UX was en route to the same point at FL195 and descending to 6000 ft at a rate of descent of -1969 fpm. The two aircraft were 1.3 NM and 1600 ft apart. It was at this time that the STCA-PAC alert was issued.

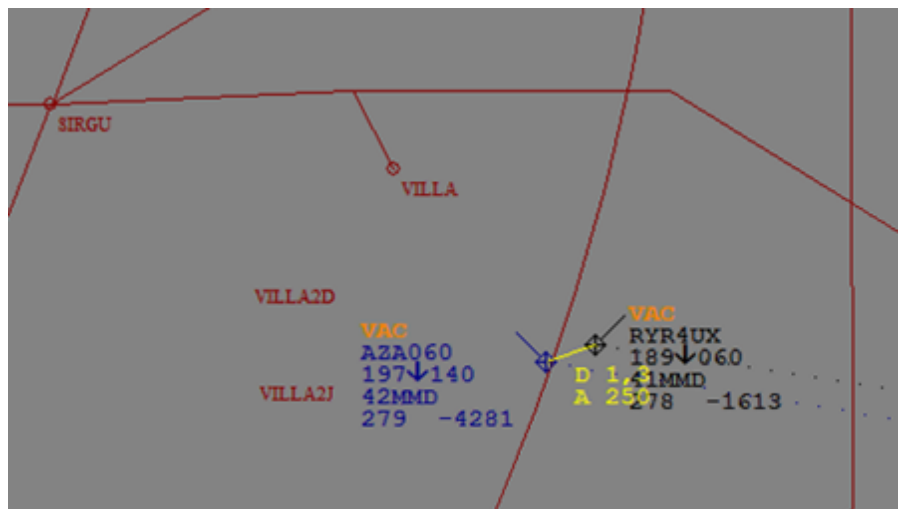
Fig. 14 Palestra image for 13:59:55

At 13:59:55, AZA060 was en route to ASBIN point (IAF) at FL197 and descending to FL140 at a rate of descent of -4281 fpm. RYR4UX was en route to the same point at FL189 and descending to 6000 ft at a rate of descent of -1613 fpm. The two aircraft were 1.3 NM and 800 ft apart. It was at this time that the STCA-VAC alert was issued.

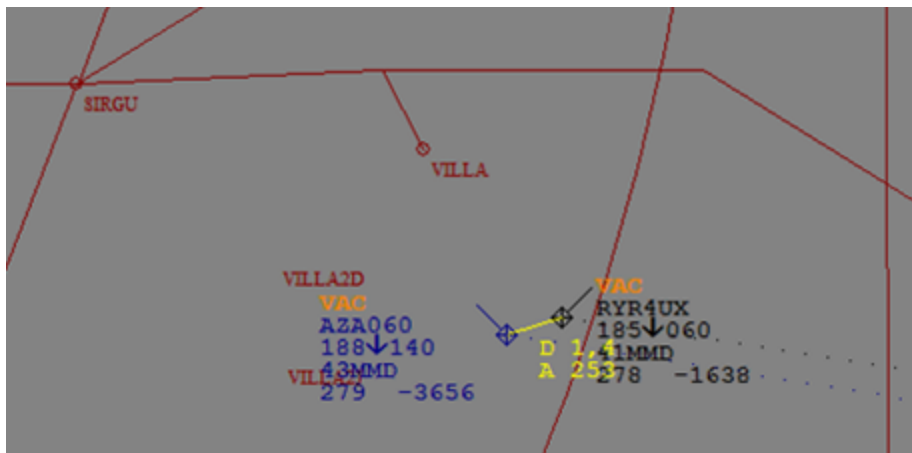
Fig. 15 Palestra image for 14:00:12

At 14:00:12, AZA060 was en route to ASBIN point (IAF) at FL188 and descending to FL140 at a rate of descent of -3656 fpm. RYR4UX was en route to the same point at FL185 and descending to 6000 ft at a rate of descent of -1638 fpm. The two aircraft reached their closest point of approach, 1.4 NM and 300 ft apart. The STCA-VAC alert remained active.

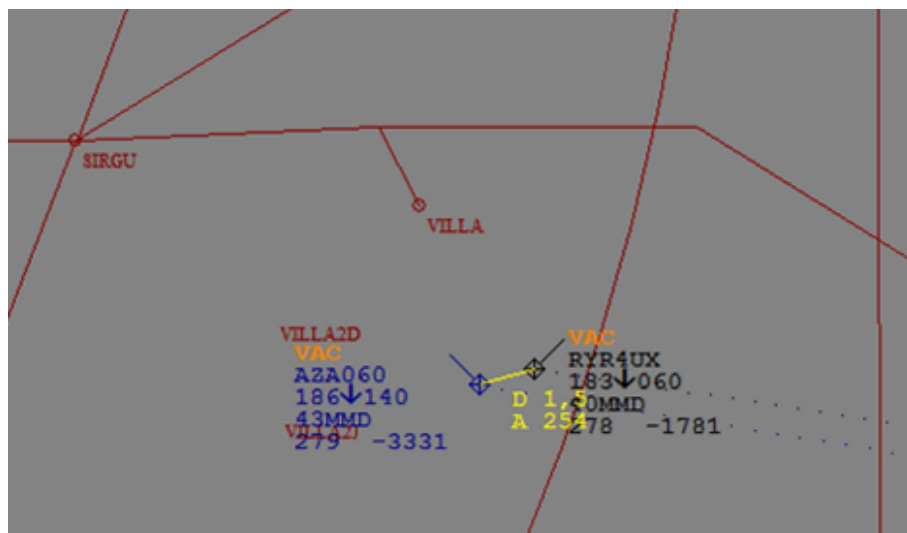
Fig. 16 Palestra image for 14:00:16

At 14:00:16, AZA060 was on course to ASBIN point (IAF) at FL186 and descending to FL140 at a rate of descent of -3331 fpm. RYR4UX was en route to the same point at FL183 and descending to 6000 ft at a rate of descent of -1781 fpm. At this time, the aircraft were 1.5 NM and 300 ft apart. The STCA-VAC alert remained active.

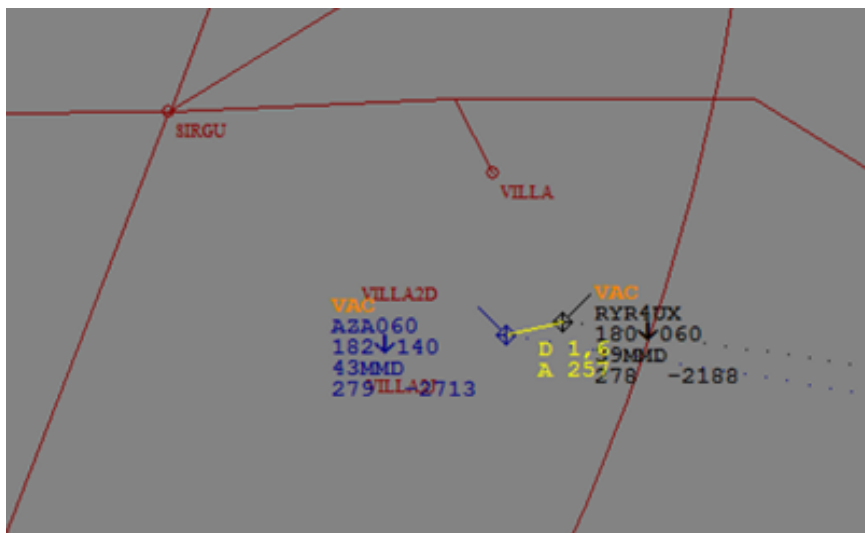
Fig. 17 Palestra image for 14:00:25

At 14:00:25, AZA060 was on course to ASBIN point (IAF) at FL182 and descending to FL140 at a rate of descent of -2713 fpm. RYR4UX was en route to the same point at FL180 and descending to 6000 ft at a rate of descent of -2188 fpm. At this time, the aircraft were 1.6 NM and 200 ft apart. The STCA-VAC alert remained active.

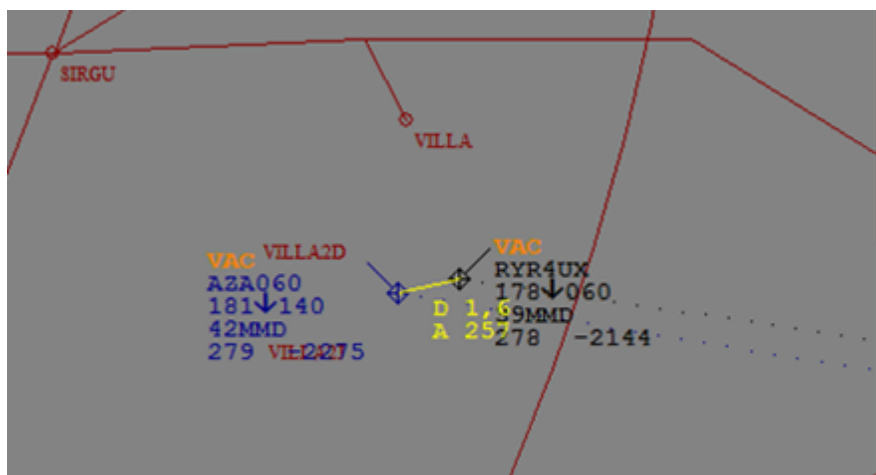
Fig. 18 Palestra image for 14:00:30

At the same time, AZA060 was en route to ASBIN point (IAF) at FL181 and descending to FL140 at a rate of descent of -2275 fpm. RYR4UX was en route to the same point at FL178 and descending to 6000 ft at a rate of descent of -2144 fpm. At this time, the aircraft were 1.6 NM and 300 ft apart. The STCA-VAC alert remained active.

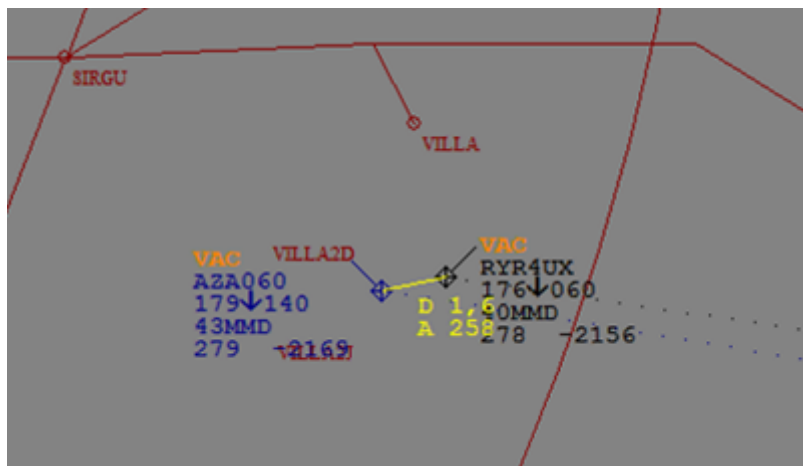
Fig. 19 Palestra image for 14:00:35

At the same time, AZA060 was en route to ASBIN point (IAF) at FL179 and descending to FL140 (note that the CFL had not been entered yet into the label) at a rate of descent of -2169 fpm. RYR4UX was en route to the same point at FL176 and descending to 6000 ft at a rate of descent of -2156 fpm. At this time, the aircraft were 1.6 NM and 300 ft apart. The STCA-VAC alert remained active.

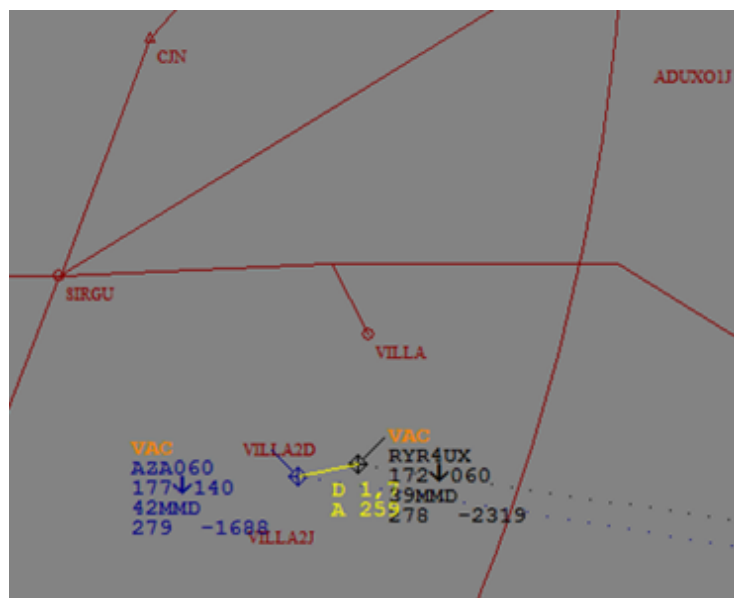
Fig. 20 Palestra image for 14:00:45

At 14:00:45, AZA060 was en route to ASBIN point (IAF) at FL177 and descending to FL140 (note that the controller had started issuing the clearance one second earlier, which is why CFL 170 had not yet been entered into the label) at a rate of descent of -1688 fpm. RYR4UX was en route to the same point at FL172 and descending to 6000 ft at a rate of descent of -2319 fpm. At this time, the aircraft were 1.7 NM and 500 ft apart. The STCA-VAC alert remained active.

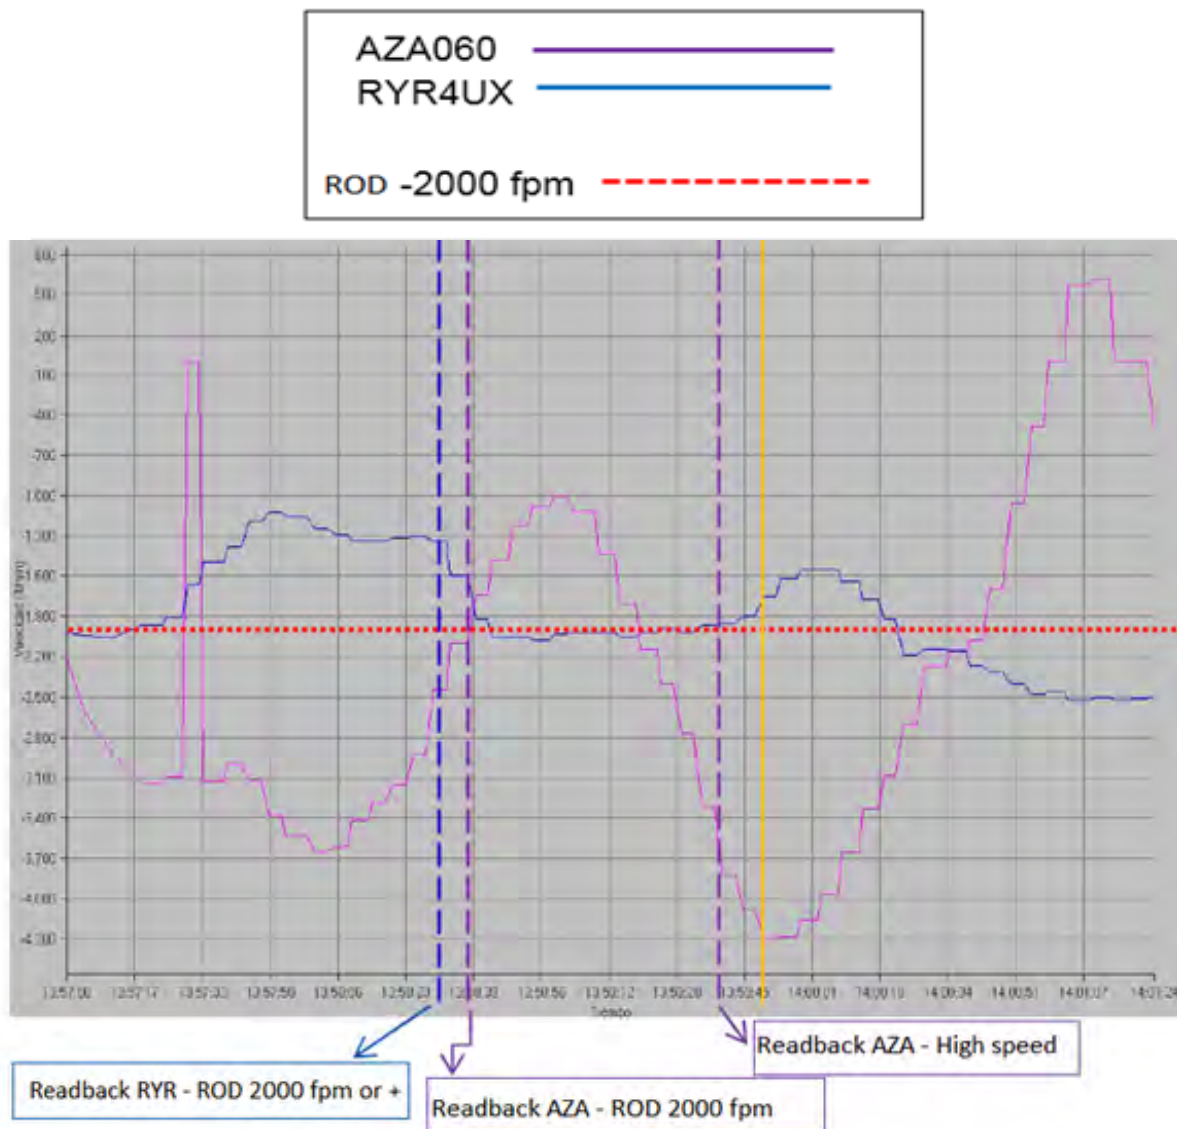
Fig. 26 Graph of rates of descent (ROD) of the two aircraft between 13:57:00 and 14:01:24

The graph shows that the rates of descent instructed by the controller, and readback by the crews, were not adhered to satisfactorily by the crews.

Aircraft RYR4UX did not maintain the requested rate of descent of -2000 fpm or higher. This caused a loss of separation, since being aware that the traffic ahead of it at a higher level was also going to the same destination (LEMD), it increased its speed upon entering the Madrid TMA in order to hamper (sic) its descent. He added that he supposed that the instruction to maintain a given rate of descent was recorded in the tapes, but that this instruction was not complied with.

The controller had instructed the higher aircraft to maintain a rate of descent of -2000 fpm, and to more than -2000 fpm to the lower aircraft. Neither aircraft observed these limits, which resulted in a gradual reduction of the vertical separation between them. Both instructions are deemed correct, but the controller's monitoring of the crews to enforce them cannot be considered correct, and this oversight failure led to the loss of separation.
