COMISIÓN DE
INVESTIGACIÓN
DE ACCIDENTES
E INCIDENTES DE
AVIACIÓN CIVIL

Report IN-010/2017

Incident involving an AIRBUS 330-243 aircraft, registration G-VYGL, operated by AirTanker Ltd at the Tenerife South airport on 27 June 2017.

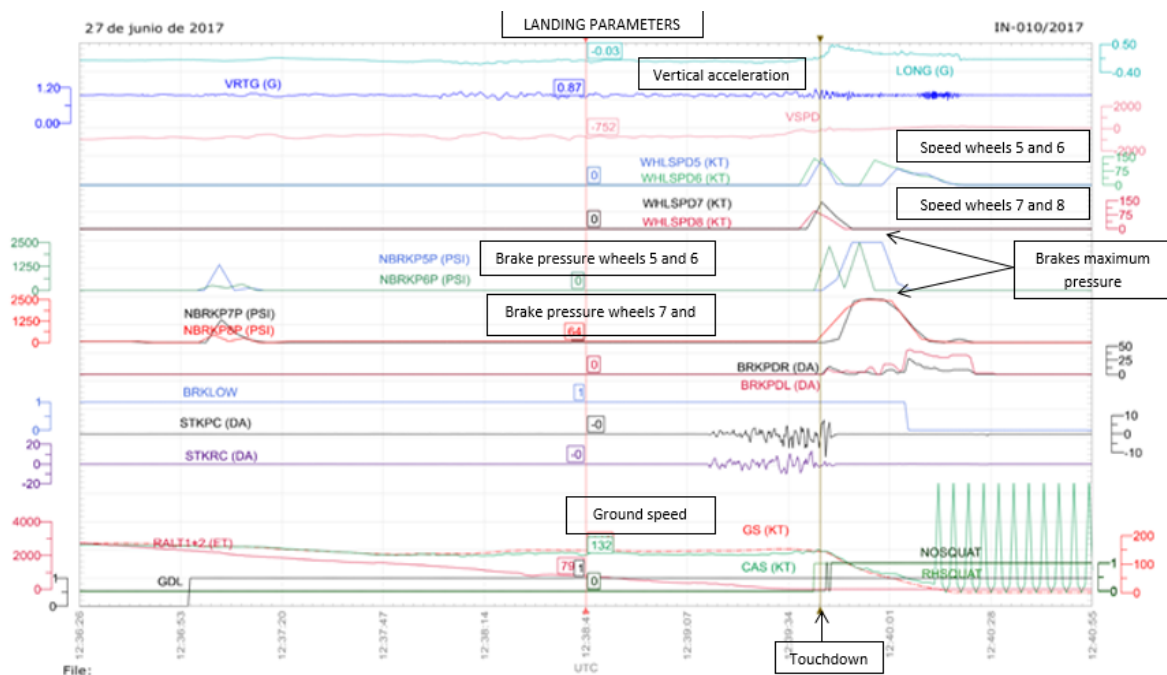
Figure 4. Landing parameters

- The pressure in wheel #5 rose continuously to its maximum value, where it remained for 22 s³.
- The pressure in wheel #6 swung rapidly between its maximum and minimum values, taking on a value of 0 at 16 s.
- The pressures in wheels #7 and 8 rose continuously to their maximums, providing a longer braking action (see graph).

The wheel speed parameter rose to values close to those of the aircraft's ground speed (GS) and then quickly decreased. Wheels #5 and 6 continued turning after locking up briefly. Wheels # 7 and 8 remained locked after the first speed increase.

This behavior of the brake system was caused by a command generated by the braking and steering control unit, which applied maximum braking power to the rear wheels after landing, even though the autobrake was set to LOW.

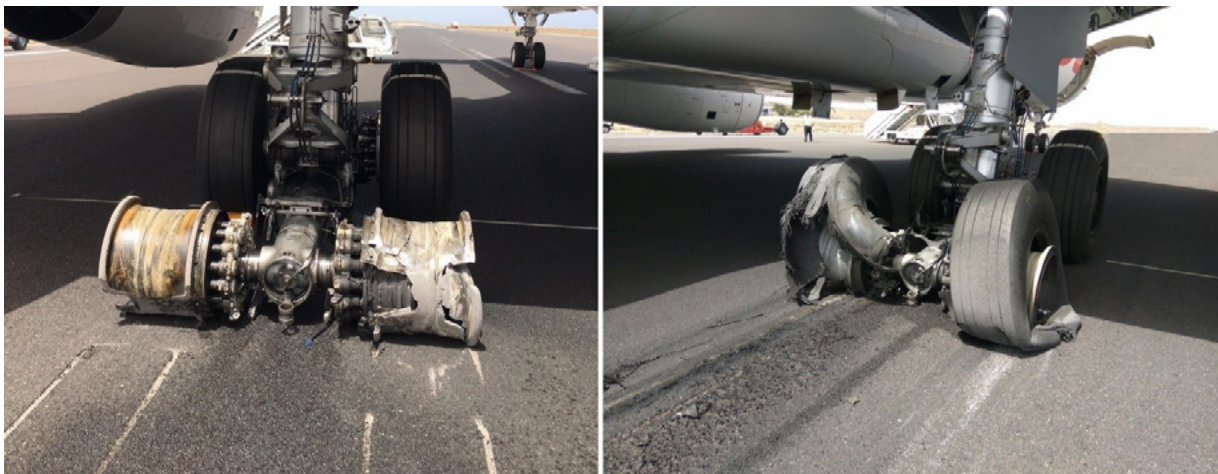
Figure 5. Condition of main landing gear after the incident

Figure 5 shows the final condition of the rear main gear wheels 5 and 6 (left) and 7 and 8 (right) after the aircraft came to a stop.

The damage to the aircraft undercarriage was significant with wheels 5,6,7,8 damaged and tyres burst. There was also damage to the torque links and some cosmetic damage to the left inner flap fairing and a small hole in the inner flap. Engineering support was on-site within minutes.

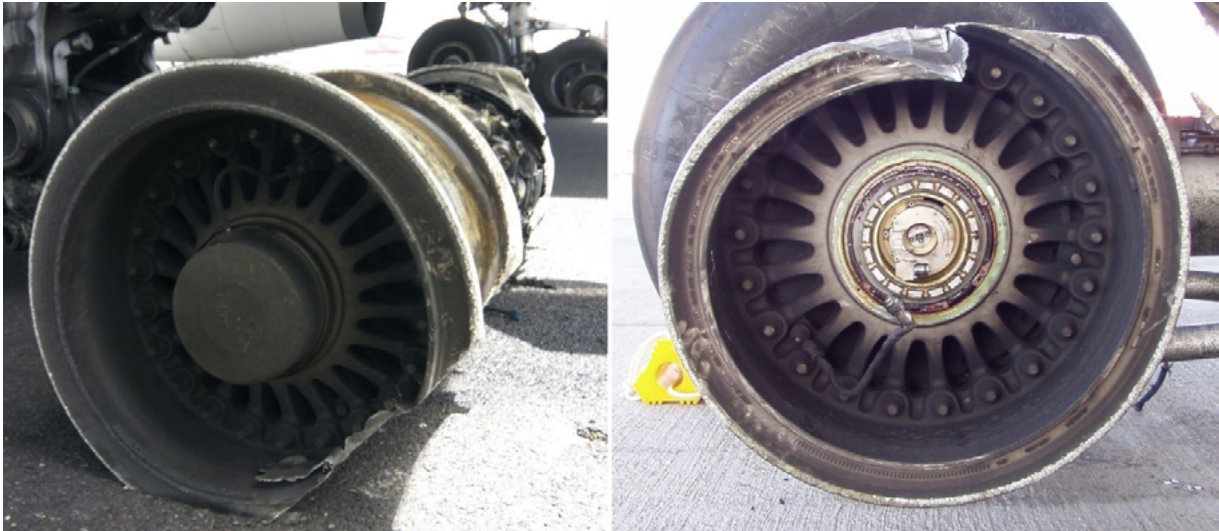
Figure 6. Rims of wheels 5 and 6

It was noted that wheels 5 and 6 locked after landing, and that at some later point they turned again, since they exhibited damage and marks along the entirety of the rims. Broken hydraulic lines were also discovered. Figure 6 shows the rims on wheels 5 and 6.

The graph in Figure 4 shows how when the gear touched down, without any input by the crew, the brake pressure in the four rear main gear wheels (5, 6, 7 and 8) rose to values close to 2500 psi, which initially locked all four wheels. Within a few seconds, the brake pressure decreased in wheels 5 and 6, which again began to turn until the aircraft came to a stop. Figure 4 shows how the rotational speed for these wheels increased again and then gradually decreased until the aircraft stopped on the runway. This was likely due to the damage caused to the hydraulic lines on these wheels as the wheels were dragging on the pavement, which released the brake pressure in the lines, unlocking the wheels. Figure 6 shows the damage along the entire circumference of both rims.

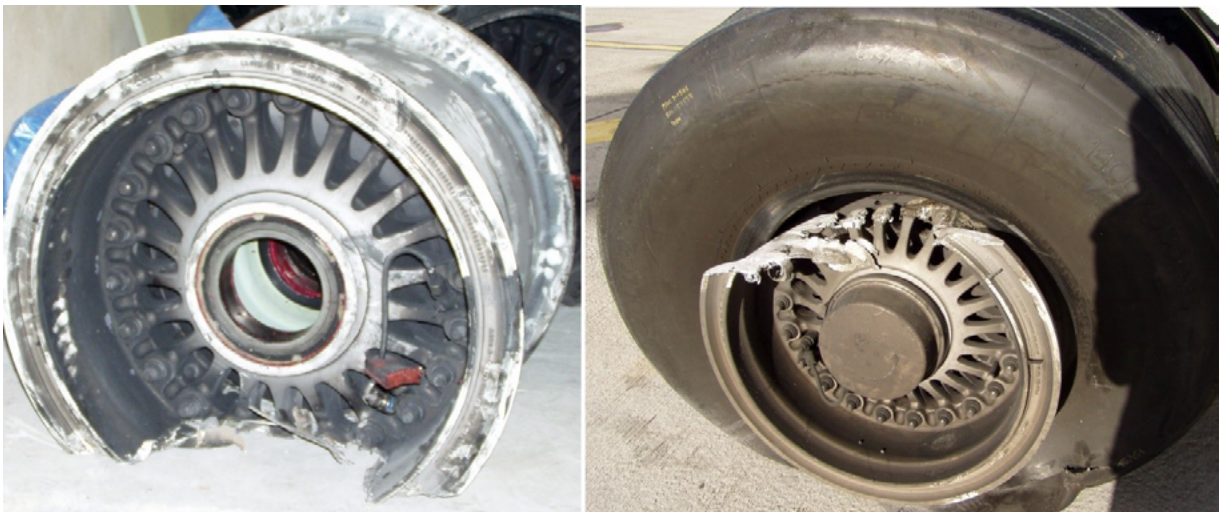
Figure 7. Rims on wheels 7 and 8

Wheels 7 and 8 also locked but they did not rotate at any subsequent point, since they exhibited wear and damage due to friction only along part of their circumference, while the rest of the rim on both wheels was intact. The blown out tires were still on the rims when the aircraft stopped. Figure 7 shows the condition of the rims on wheels 7 and 8.

As for wheels 7 and 8, they remained completely locked during the entire time the aircraft was decelerating. Figure 7 shows how only part of the circumference of the rims was damaged.

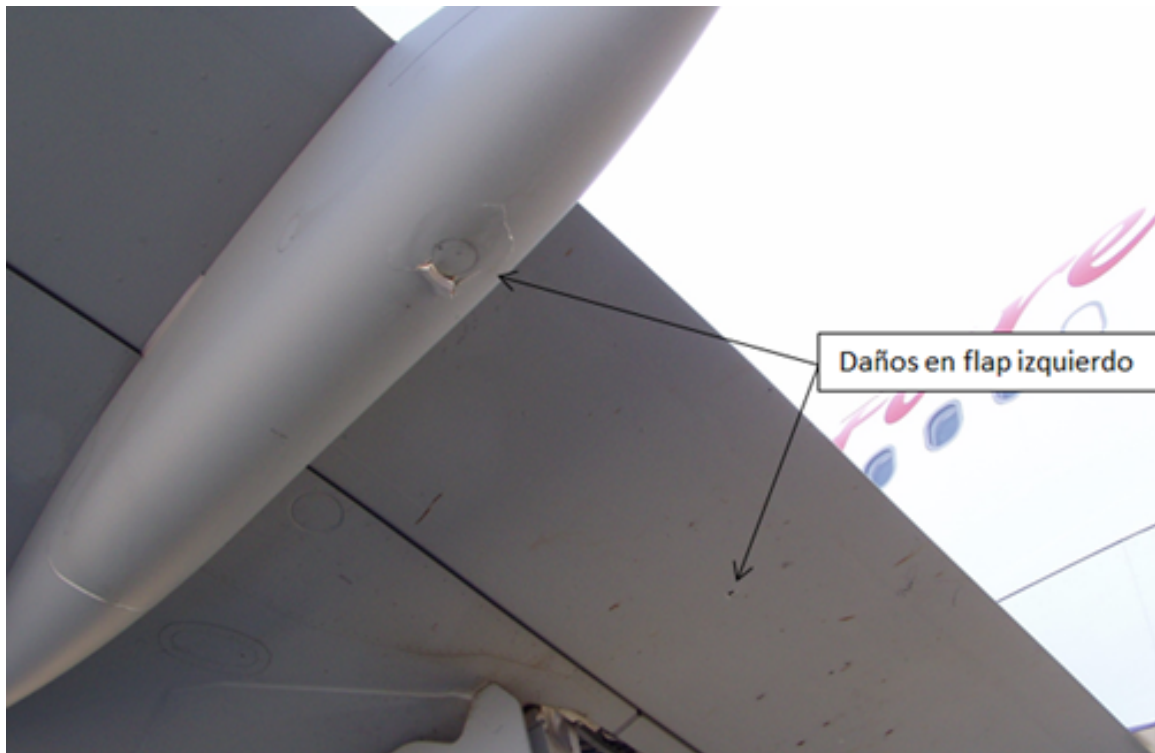
Figure 8. Damage to flap and fairing

There was minor damage to the inboard flap and its associated fairing on the left wing.

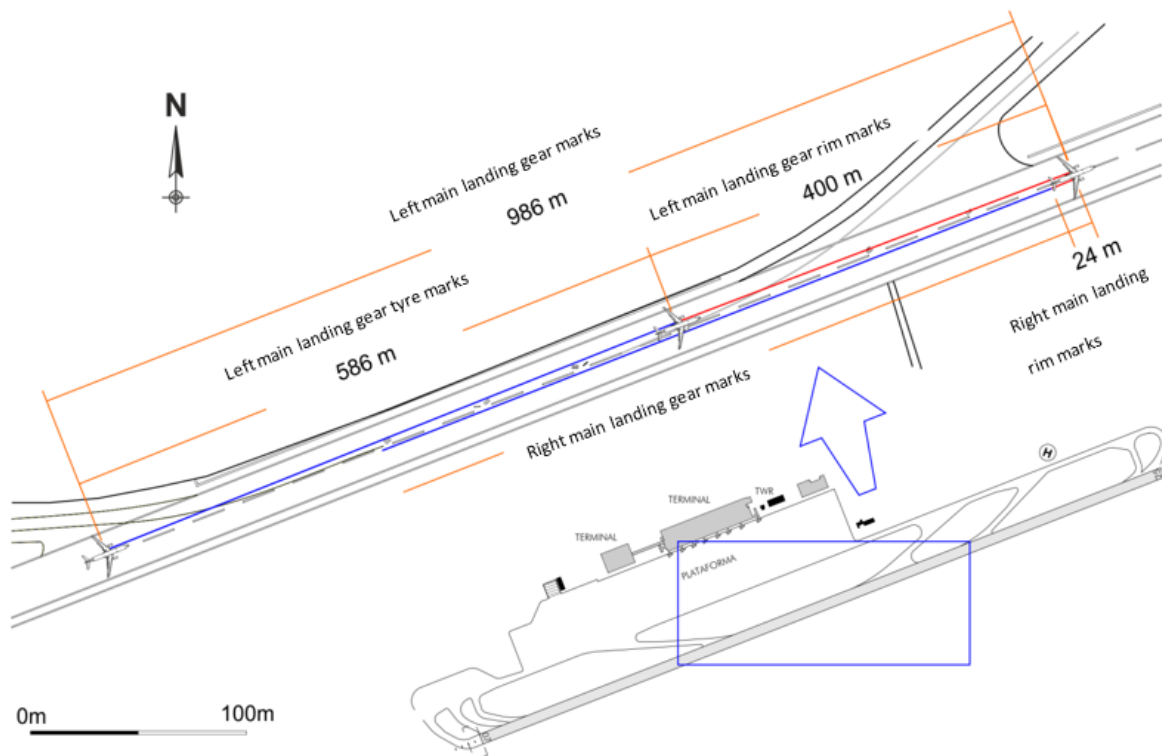
Figure 10. Diagram of marks on runway

The aircraft approached and landed on runway 07. Marks were found on the pavement made by the rear main landing gear wheels, consisting of the tracks left by the tires as well as the marks made by the rims. Figure 10 shows the approximate lengths of these marks.

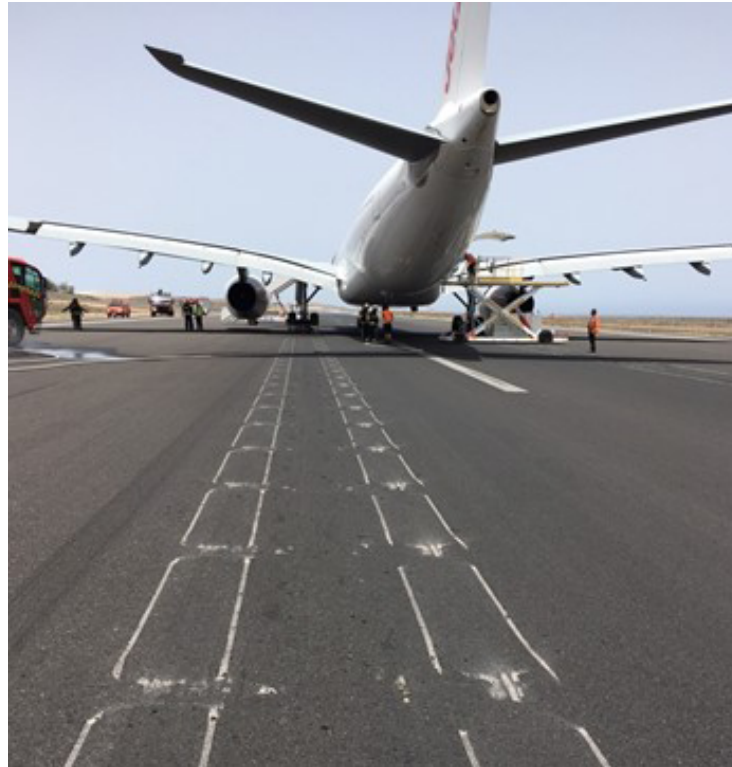
Figure 11. Marks left on pavement

The photograph below shows part of the marks left on the runway before the aircraft came to a stop.
