**REPUBLIC OF CYPRUS
MARINE ACCIDENT AND INCIDENT
INVESTIGATION COMMITTEE**

Investigation Report No: 91E/2017

Very Serious Marine Casualty

**Death of ORDINARY SEAMAN (O/S)
on M/V “DENIA CIUTAT CREATIVA”
on 18/07/2017
at Barcelona Port**

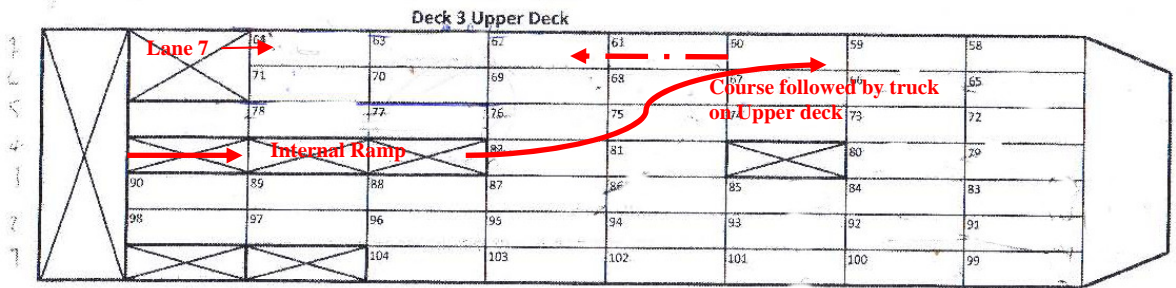
Figure 4: Course followed by the truck on Upper Deck (Deck 3)

4. The driver of the truck proceeded well forward to the Upper deck port side in order to line-up the truck on Lane 7 and manoeuvred the truck in reverse gear for the final parking position. The O/S proceeded aft to the port side of the Upper Deck towards the final parking position of the truck. The Bosun saw the truck going forward port side and he proceeded giving instructions to the following vehicle which arrived on Upper Deck (Lane 4 forward) and assisting its driver who was required to turn the large vehicle. The A/B was instructed by the Bosun to assist the second vehicle’s driver on the rear side and the Bosun was at the front side of the vehicle. Both the Bosun and A/B had no view of the proceedings for parking of the first truck (they declared that their vision between their position and the place of the accident was blocked). No eye witness of the accident was available.

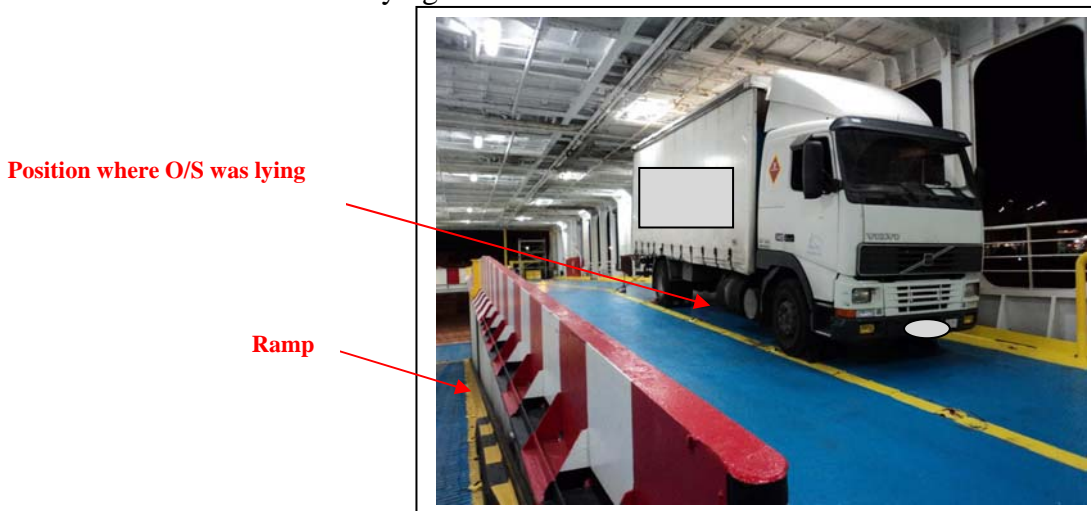
Figure 5: View of the accident from the top of the internal ramp

- The Bosun heard the driver of the truck who should park aft at Lane 7, yelling. He saw the driver running towards the internal ramp. While running after him to see what had happened he noticed the O/S lying under the truck.

The truck was approximately in the middle of the inclined deck of upper deck port side, within the two yellow lines. The A/B followed the movements of the Bosun. The time was approximately 21.20 LT.

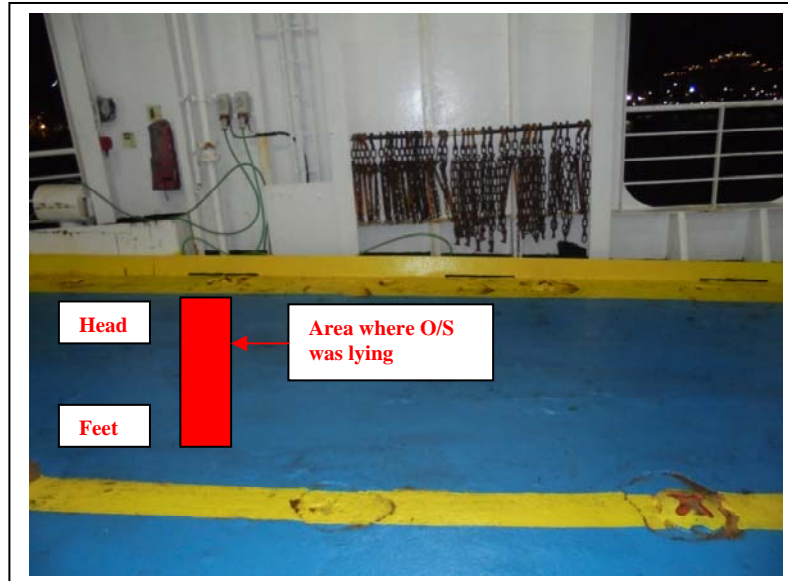
Figure 7: Position of deceased person

- The Bosun immediately informed via portable radio the Chief Officer. All holders of portable radios heard the notification.
- The truck had been left with the engine running, the driver's door opened, within the boundaries of Lane 7 in the middle of the inclined port side deck approximately on frame 55.
- The O/S was found unconscious lying in almost transverse direction to the longitudinal axis of the truck, within the yellow border lines of lane 7 with the head on the port side and the feet on starboard side. His position was between the left front and rear wheels of the truck. He

was wearing boiler suit of blue colour, orange safety vest, safety shoes. His helmet was found lying next to him. (Police Statement)

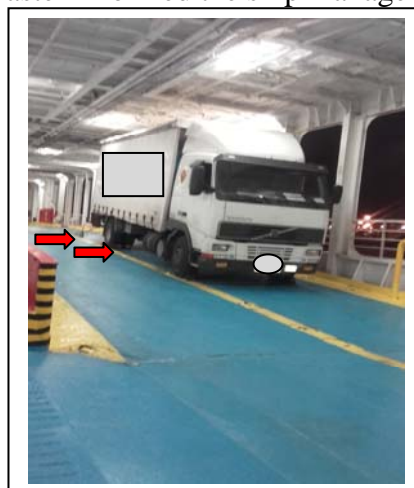
Figure 8: Securing of the truck after the accident

13. The medical personnel declared the O/S dead (18/07/2017-21:39) (Master's Statement)
14. When attended the scene, the Master instructed the attending personnel to lash the truck at the position as found, put brake guides at the rear wheels (due to the deck inclination) and turn-off the truck's engine. Master informed the ship management company.

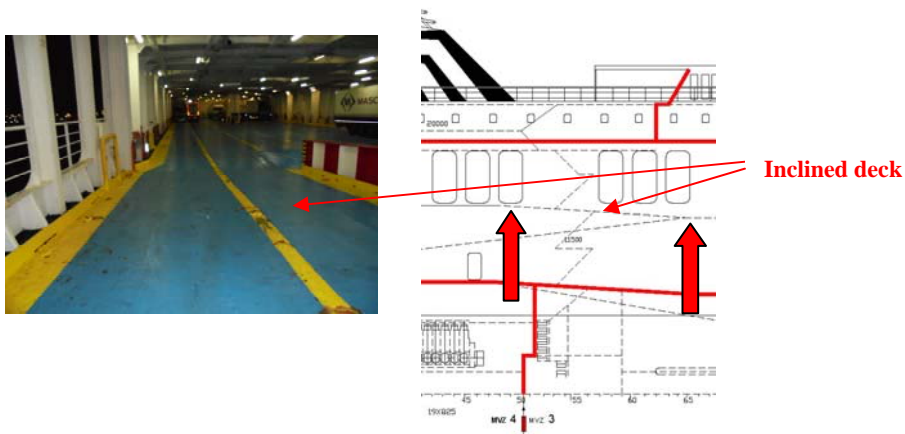
Figure 11: Upper Deck (Deck 3) inclined deck

On Upper deck, port and starboard of the internal ramp, the deck is inclined (rising aftwards) between the frames 47 and 65. The accident occurred approximately in the middle of the inclined deck on the port side.

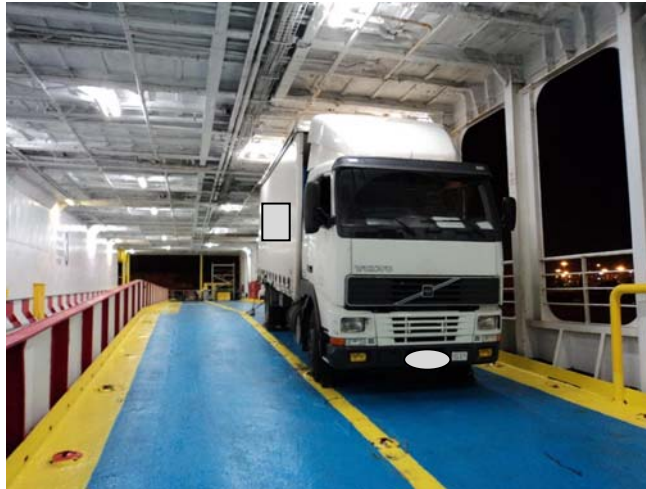
Figure 15: Vehicle involved in the accident

The truck involved in the accident was a medium sized truck

After detailed analysis of the photos presented to the investigator, it was evident that the final position of the truck was within safety (yellow) lines of Lane 7, however, the front wheels were slightly turned to the left.

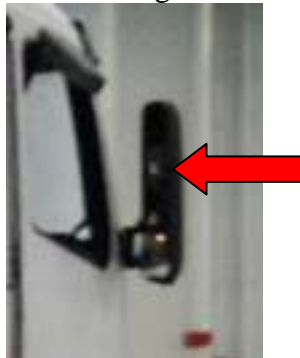
Figure 16: Damaged mirror

The right upper mirror (“plain rear view mirror”) of the truck was found broken, which may lead to restricted visibility of the driver during reverse manoeuvring.

- he did not see the O/S at any time of the operation;
- he was aware of the broken right upper mirror (“plain rear view mirror”) and he informed the foreman of the fact before getting into the vessel. The foreman asked him if he had any problem with that and he let him go ahead after he confirmed that he had no problem.
- In order to control the right side of the truck during manoeuvring, he utilized the intact lower right mirror (“wide angle rear view mirror”) which is a small mirror showing objects closer. That was adequate to get the right side of the truck controlled.

There was no evidence to suggest, that, the truck condition was contributory factors to the accident, except of the damaged mirror which could be considered that may have been a contributing factor.

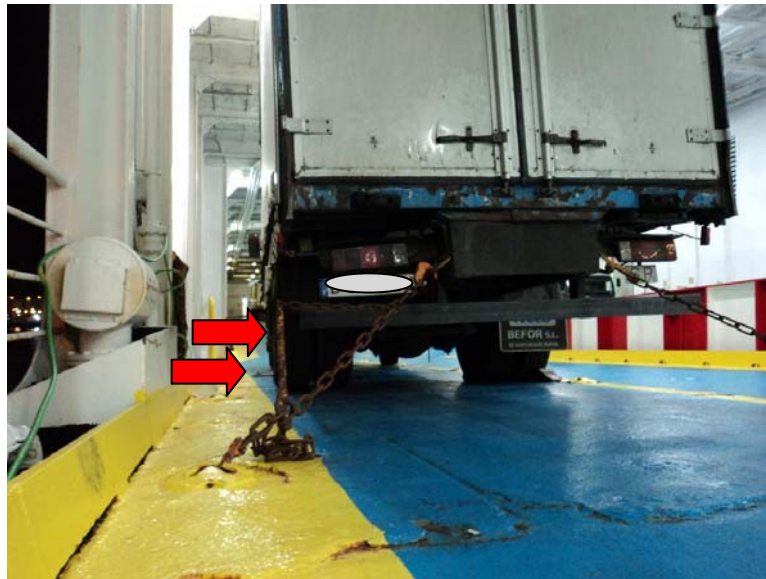
Figure 18: Fallen off plastic mud flap

The truck ran over the O/S with the left rear wheels. The plastic mud flap of the truck which was found to have fallen off between the front and rear wheels left side indicates that the truck ran over the O/S with the left rear wheels.

The truck ran over the O/S with the left rear wheels. Although there was no objective evidence available from the gathered information that the truck hit the deceased person (e.g. statement or photo - signs of blood, broken lights cover) prior to running over him or that the deceased person may have lost consciousness (and was not hit by the truck) with due consideration to the possible effects caused from his blood ethanol (alcohol) content of 1.93 g/l, the plastic mud flap of the truck which was found to have fallen off between the front and rear wheels left side indicates that the truck ran over the O/S with the left rear wheels.
