MARITIME ADMINISTRATOR

LADY ISIK (ON 3457 / IMO No.9445423) **Collision with Fishing Vessel YY (Spanish Registration No. 3-ST-4-1-01)** **Bay of Biscay off Spain on 15 October 2010**

Summary

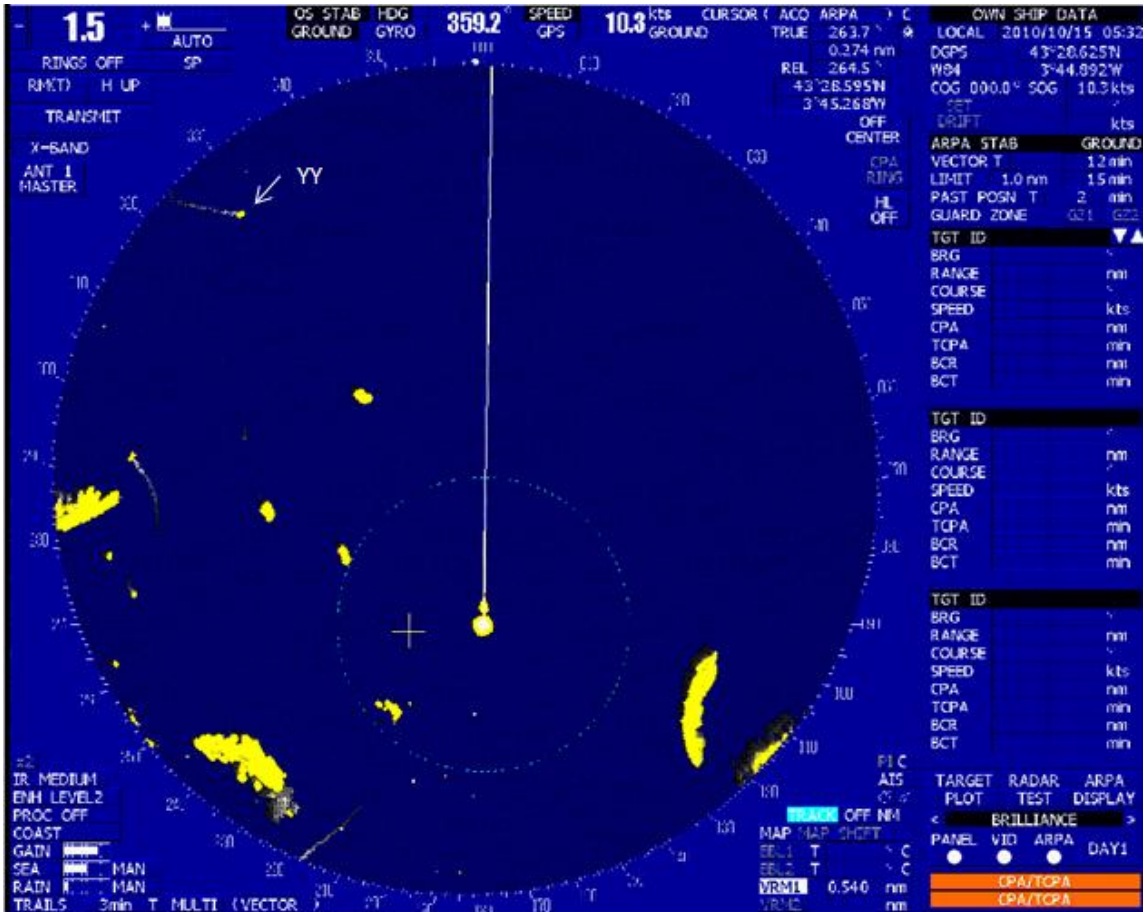
Figure 1: LADY ISIK radar image at 0732 local time / 0532 UTC

5. At approximately 0732 the Master and 2/O became aware of a fishing vessel (the YY) at a range of less than 1.5 nautical miles. According to the Master the relative bearing to this vessel was 45 to 60 degrees off the port bow. Based on the recorded radar image the YY was approximately 30 to 40 degrees off the LADY ISIK's port bow. The radar trail shows the vessel's true course for the previous three minutes.

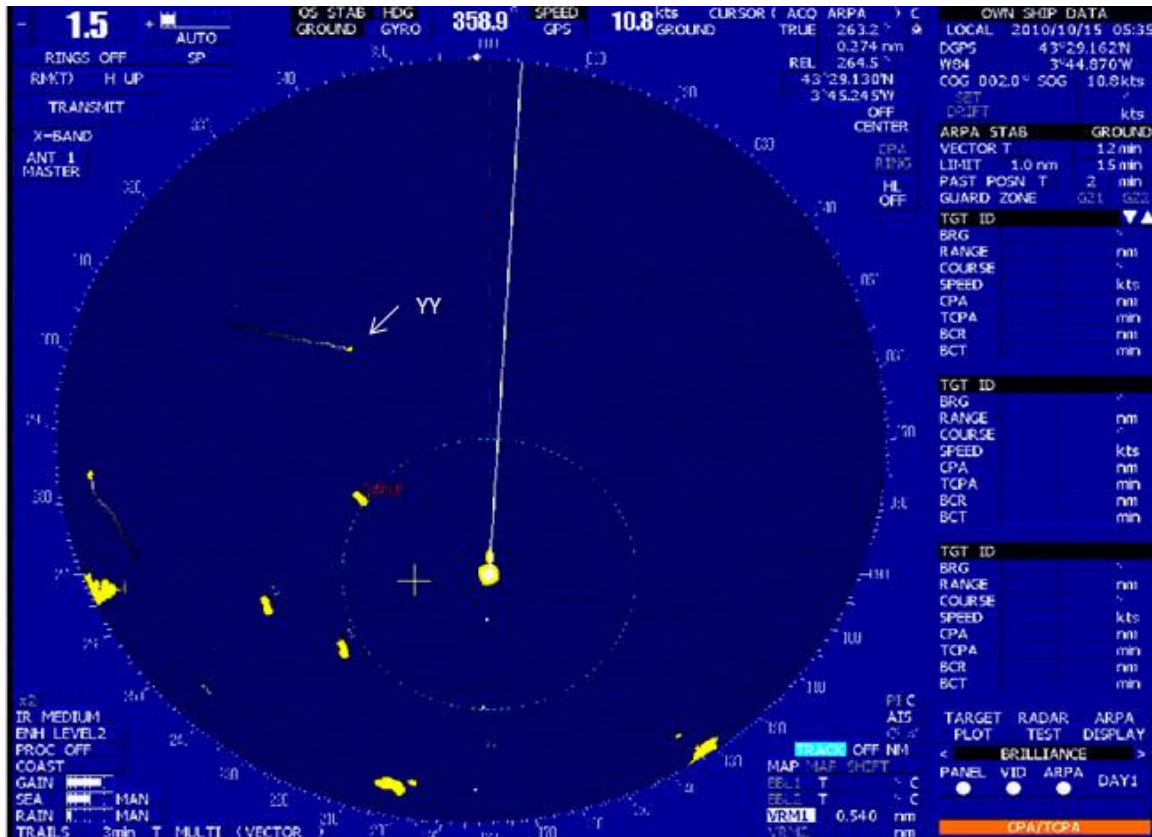
Figure 2: LADY ISIK radar image at 0735 local time / 0535 UTC

6. The Master reported that the fishing vessel was showing a single green side light and white masthead light.³ The 3/O was ordered to plot the vessel by radar using the ARPA. The target was reported to show an initial CPA of 0.3 miles. The Master reported that the course of the vessel appeared to fluctuate. The Master considered LADY ISIK the stand on vessel and maintained course and speed as required by Rule 17 of the International Regulations for the Prevention of Collisions at Sea, 1972 (COLREGS).
7. Based on the recorded radar image, at 0735 the range to the YY was less than 1 NM with a relative bearing of approximately 30 degrees off the port bow.⁴ The radar trail indicates the vessel has been maintaining a steady course over the past three minutes.

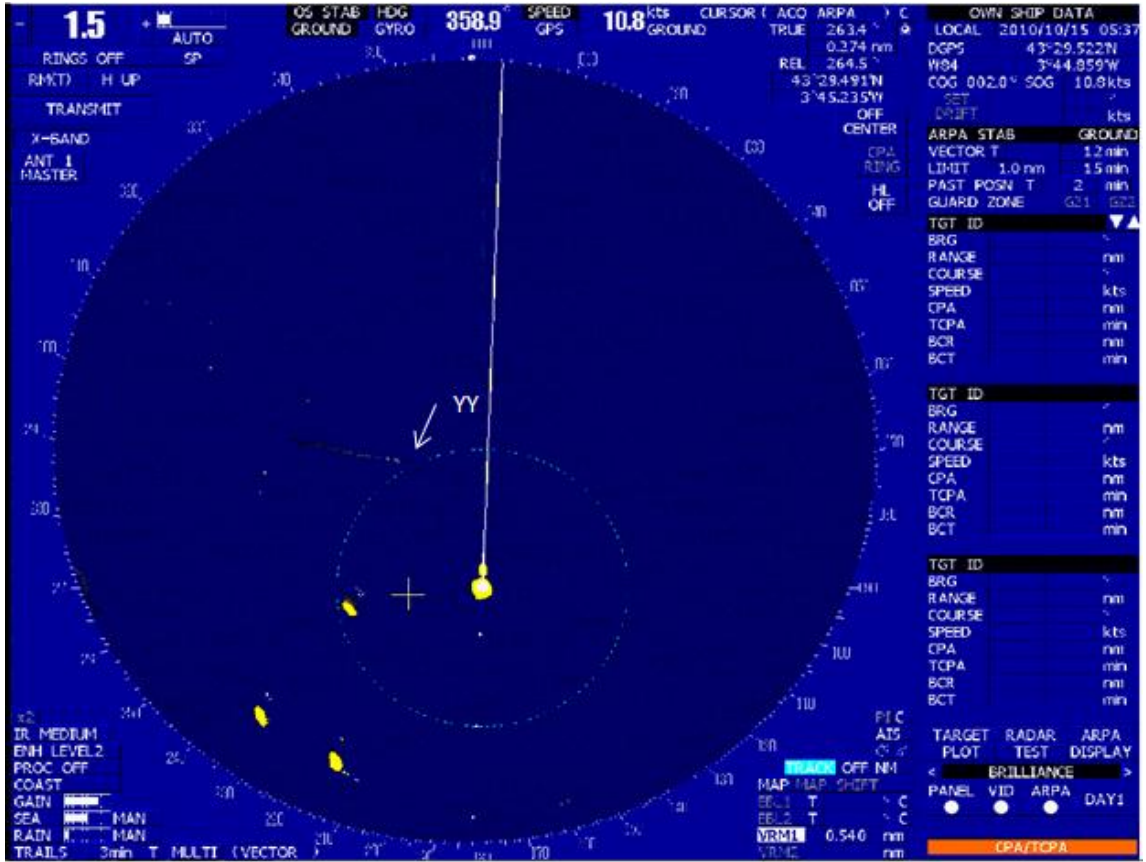
Figure 3: LADY ISIK radar image at 0737 local time / 0537 UTC

11. At 0737 radar trail from the YY can be seen on the radar image; the radar return from the vessel is not visible. Based on the location of what would be the forward end of the trail, the range to the vessel was between approximately 0.25 to 0.3 NM; the bearing was

approximately 30 degrees off the port bow of the LADY ISIK. The radar trail for the fishing vessel indicates it was maintaining a steady course for the previous three minutes.
