# SUMMARY REPORT

**TORM REPUBLICAN**  
**Occupational accident on 3 December 2013**

**This marine accident summary report is issued on 10 July 2014**

**Case number: 2013026421**

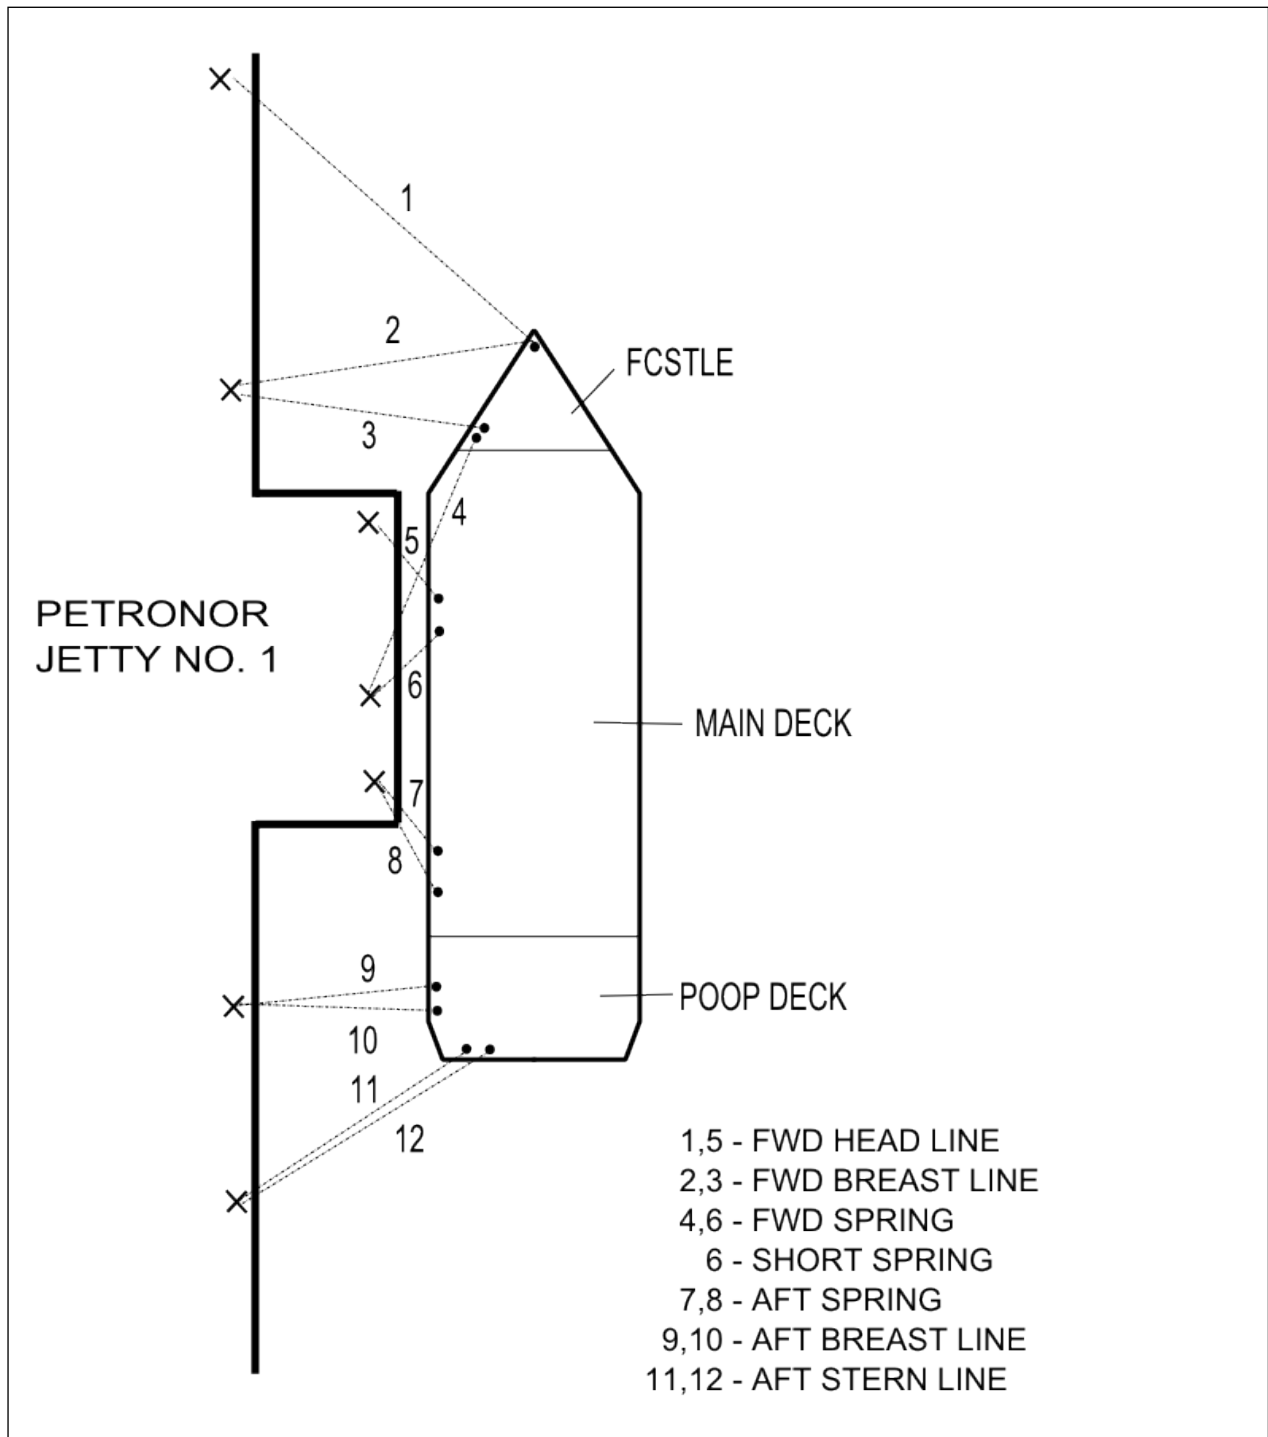
*TORM REPUBLICAN* took pilot on 1 December 2013 at 0136 hrs. and entered the port of Bilbao. The ship was moored at Petronor Terminal, Jetty No. 1 with port side alongside with a total of 12 mooring lines (figure 3).

Figure 3: Sketch of mooring setup at the time of the accident. The broken spring line is no. 6  
Source: DMAIB

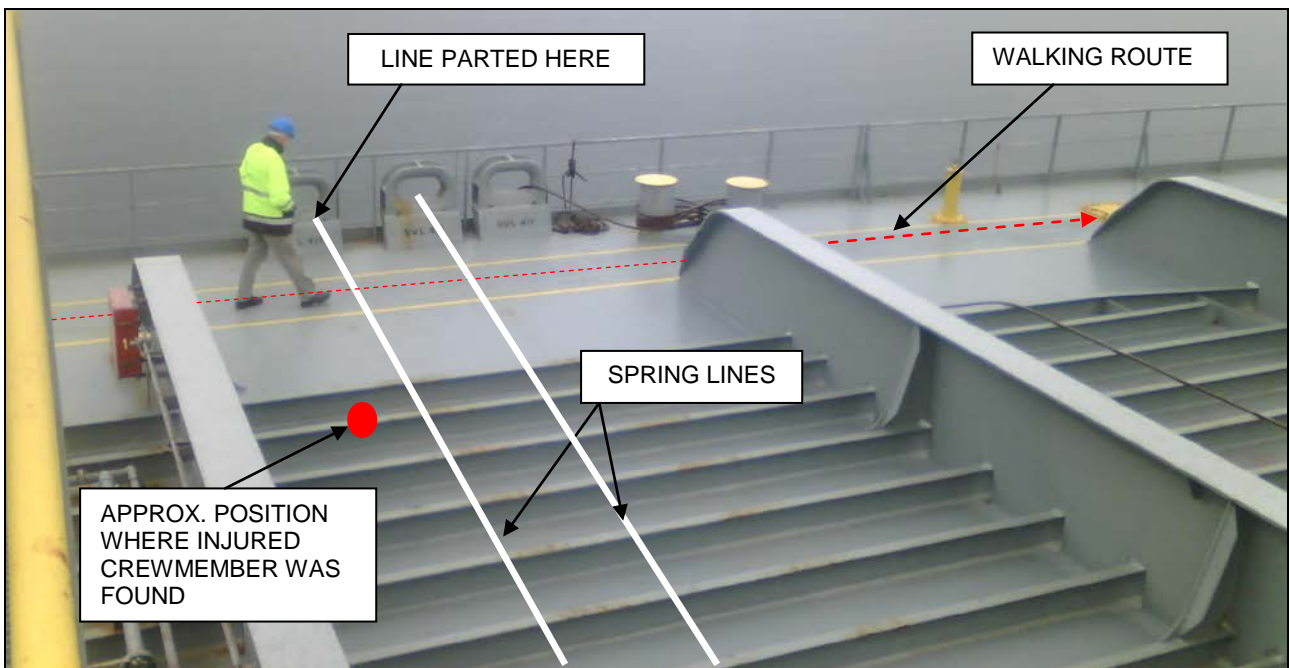
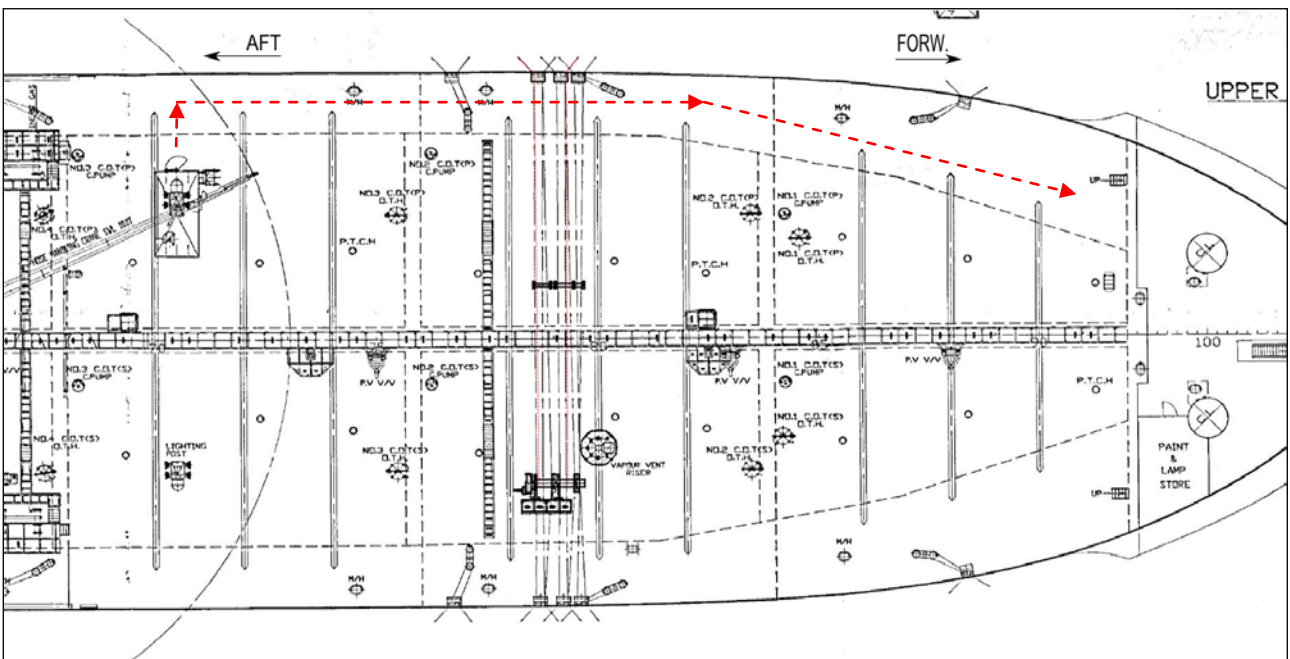
Two crewmembers, an able seaman and an ordinary seaman trainee, were doing a regular inspection round on deck checking moorings, gangway etc. During the round, they took the opportunity to finish an earlier task of moving a paint drum from the deck store at the manifold to the paint store under the forecastle deck (figure 4). After picking up the drum, they walked on the port side of the

deck, thus having to pass the forward spring line and one of the head lines which both led from the forward starboard mooring winch to the fairleads at the side. The trainee passed first underneath both lines, pushing the bucket in front of him. When he had passed the lines, he heard some noise, looked back and found his colleague lying injured on the deck and the mooring line broken. The able seaman was severely injured, but conscious. The parted mooring rope was located some 3 metres from the railing at the side.

Figure 4: Bottom: Sketch of main deck seen from above. Crewmembers' walking route marked in dashed red  
Top: Photo from scene of accident

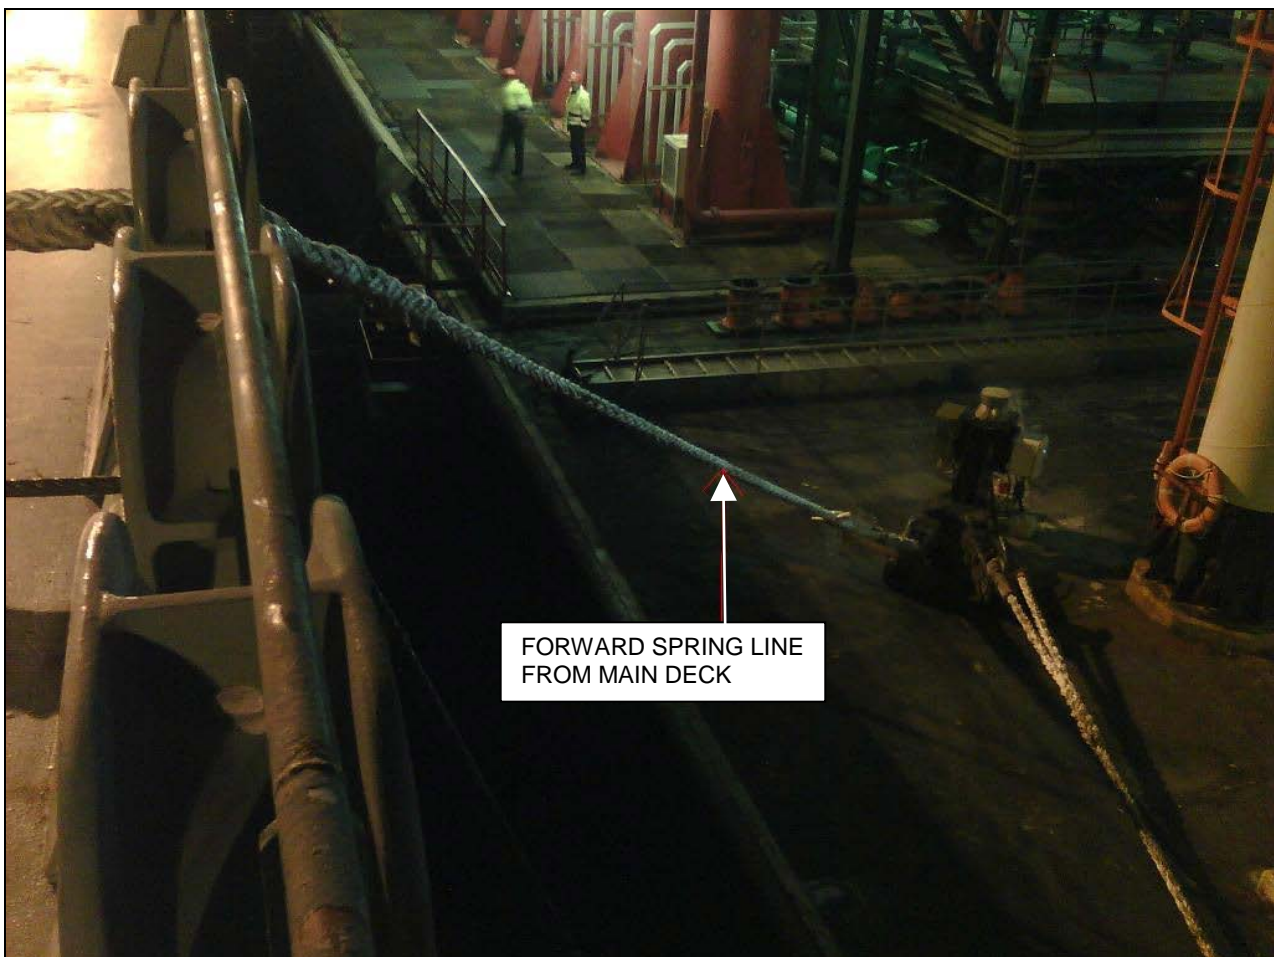
The spring mooring lines shown in figure 3 above (nos. 5 and 6) were led from the mooring winch placed on the starboard side of the cargo deck, forward of the manifold area. Because of the inexpedient match between the particular jetty and the ship, the forward spring lines had a very short lead and a steep angle which is not desirable as it has a negative effect on the strength and flexibility of the mooring line (figure 5).

Figure 5: Spring line similar to the parted one. Photo taken on the night of the accident  
Source: *TORM*

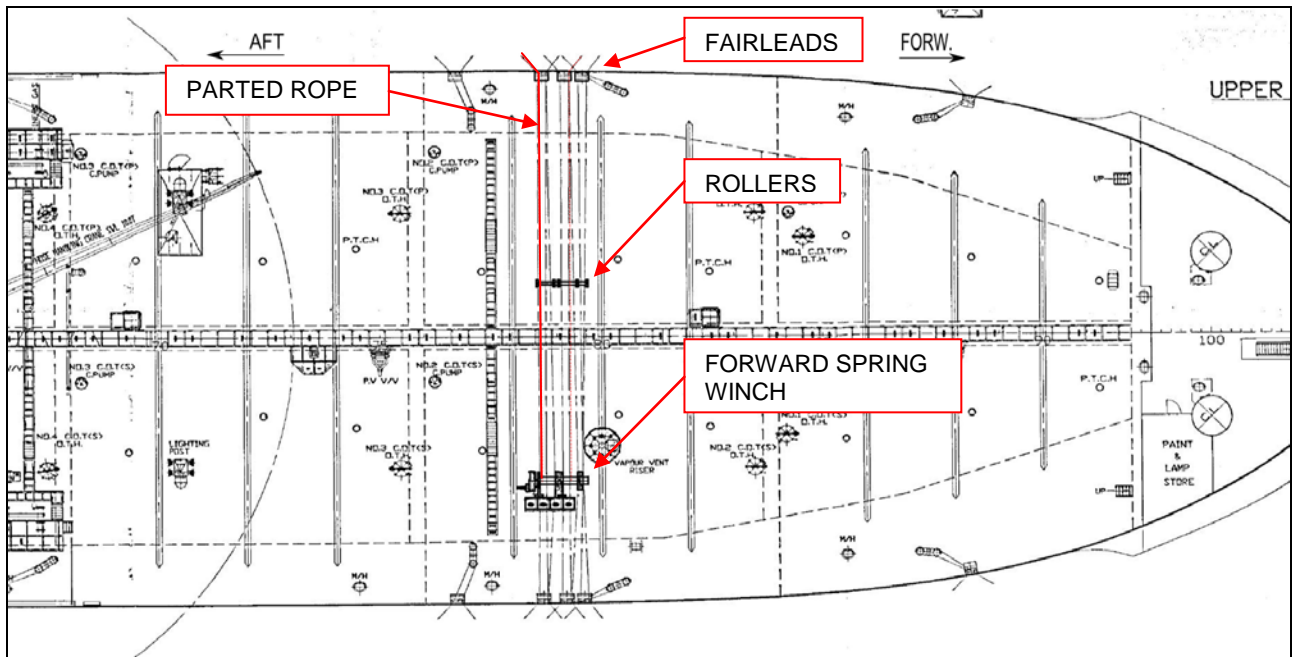
When the ship was moored with the port side alongside, as it was in this case, the lines were led across the cargo deck to the port side fairleads (figure 6). The spring lines consisted of a 220 metre mooring wire and an 11 metre rope tail attached to it. Normally the wire part of the line would rest in the fairlead, but in cases like the present with very short moorings the rope part was in the fairlead.

Figure 6: Sketch of forward spring mooring arrangement  
Source: DMAIB

The mooring setup on *TORM REPUBLICAN* was such that the weakest link in case of overload should be the winch brake (set at 30.6 t) followed by the wire (nominal breaking strength 55.8 t), the rope tail (nominal breaking strength 73.5 t) and lastly the fixed structures such as the winch foundation and the fairleads. This setup is the standard and is intended to minimize the consequences in case of overload. Contrary to the intended functionality, on the day of the accident the winch brake was not released and the rope burst.

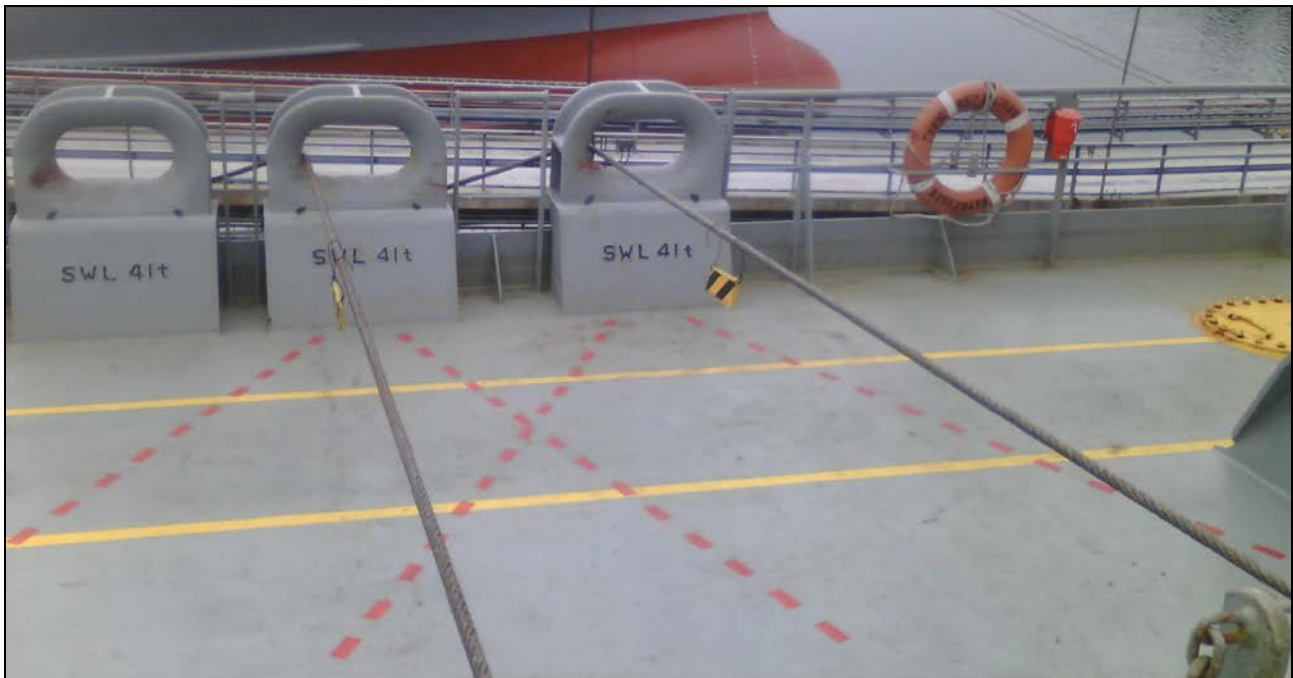
TORM REPUBLICAN had snap back zones marked on the deck. In the area where the accident happened, no zones were marked on

the deck. Figure 8 shows the snap back zones at the similar position in the starboard side.

Figure 8: Snap back zones at starboard side forward, TORM REPUBLICAN  
Source: DMAIB

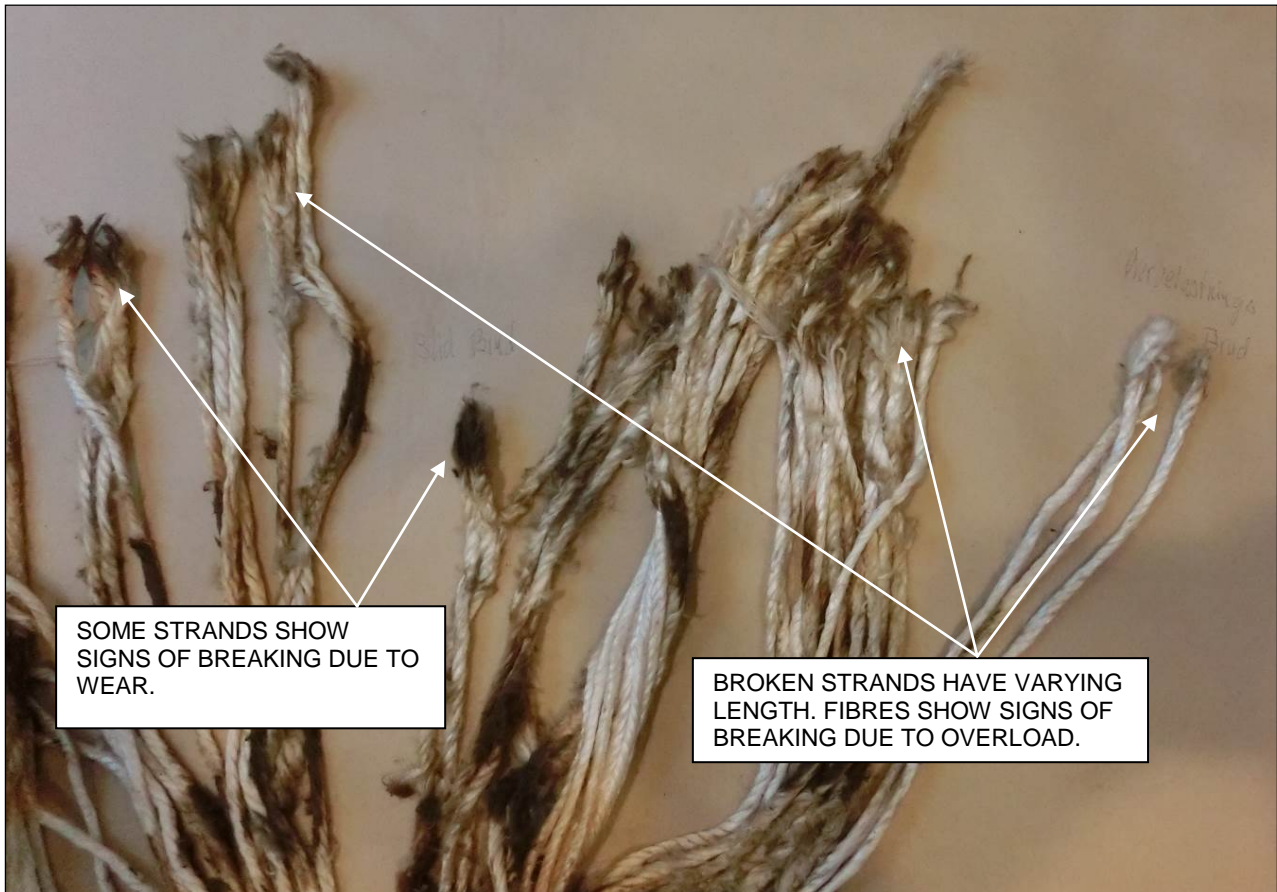
- The rope tail burst as a result of overload. Most cords showed signs of breaking due to overload (figure 9).
- The breaking strength of the rope may have been reduced by as much as

Figure 9: Details of the parted rope end  
Source: DMAIB

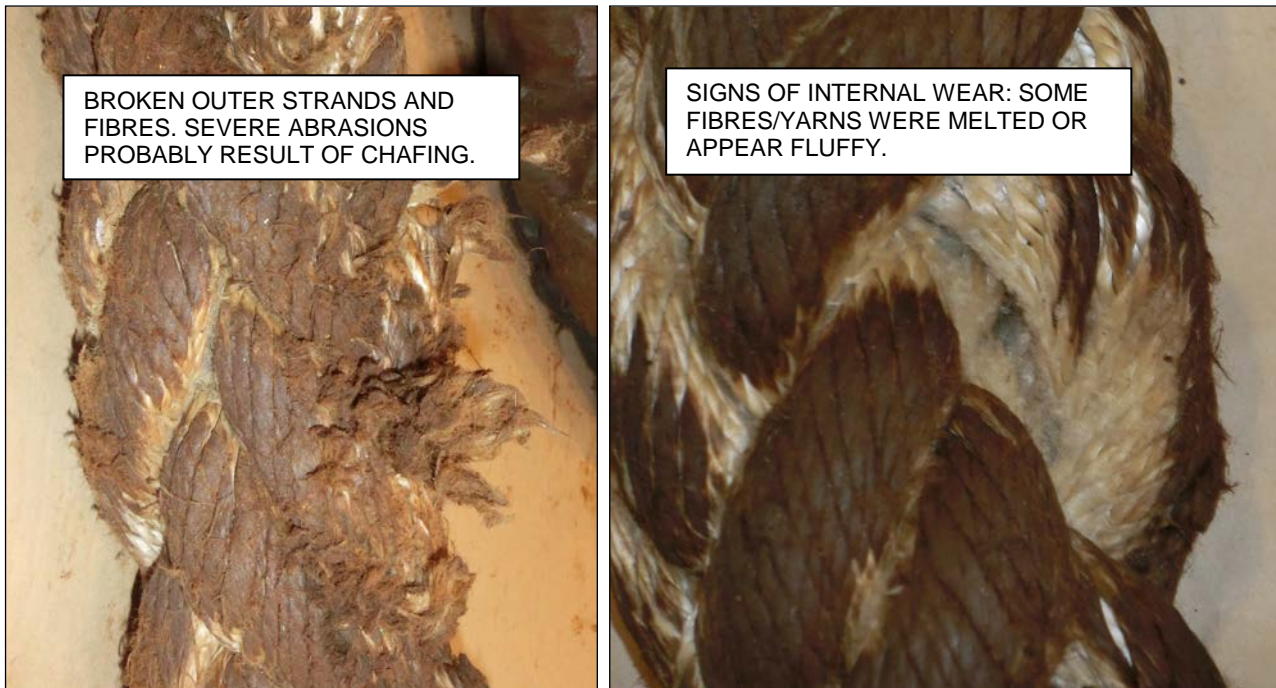
30% due to wear (chafing). Many strands and cords showed general signs of wear and chafing, especially around the location of the break (figure 10).

- While the use of grease on ropes in itself probably did not reduce the strength, the grease did make it difficult to establish the condition of the mooring ropes.

Figure 10: Details of parted rope. Both pictures show discolouration from grease  
Source: DMAIB
