Technical report

ULM A-002/2023

Accident on 27 January 2023 involving a TECNAM P-92 ECHO aircraft, registration EC-KNB, operated by Ignagua Center, S.L., at Casarrubios del Monte Aerodrome (Toledo, Spain)

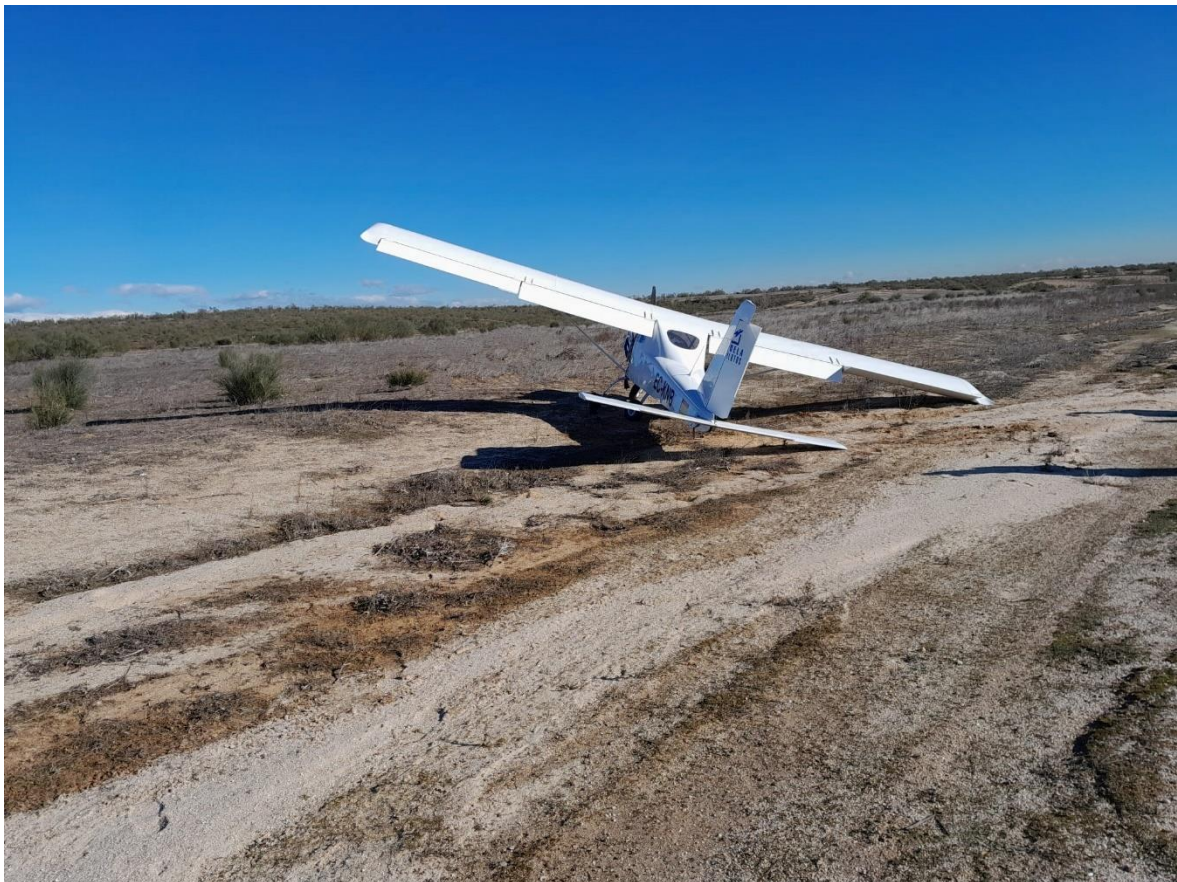
Fig. no. 1 - Final condition and position of the aircraft.

The aircraft sustained significant damage to the anchor point of the right main landing gear leaf spring, the underside of the left wing, and the attachment and underside of the right horizontal stabiliser.

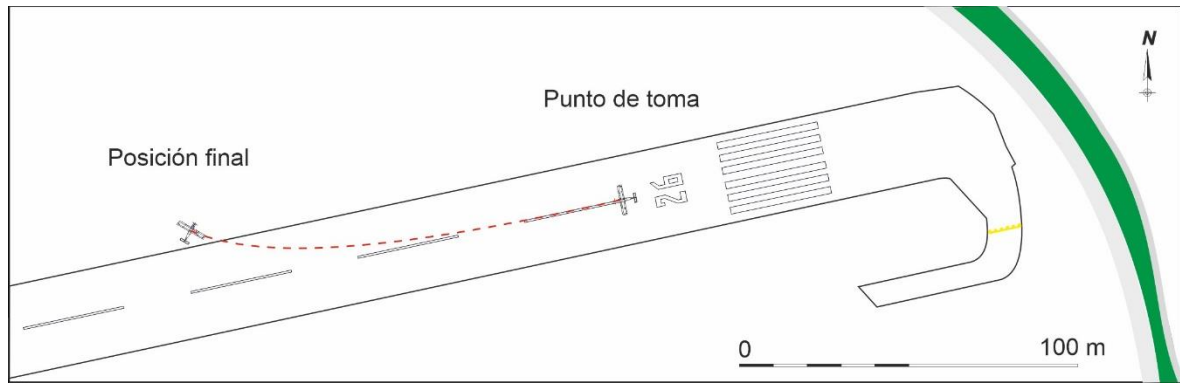
The accident occurred during the rollout after touchdown on runway 26 just after applying full power to take off again. It was then that the aircraft started to veer to the right of the runway and eventually came to a stop at the edge of the runway strip.

Fig. no. 7.- - Diagram showing the path of the aircraft

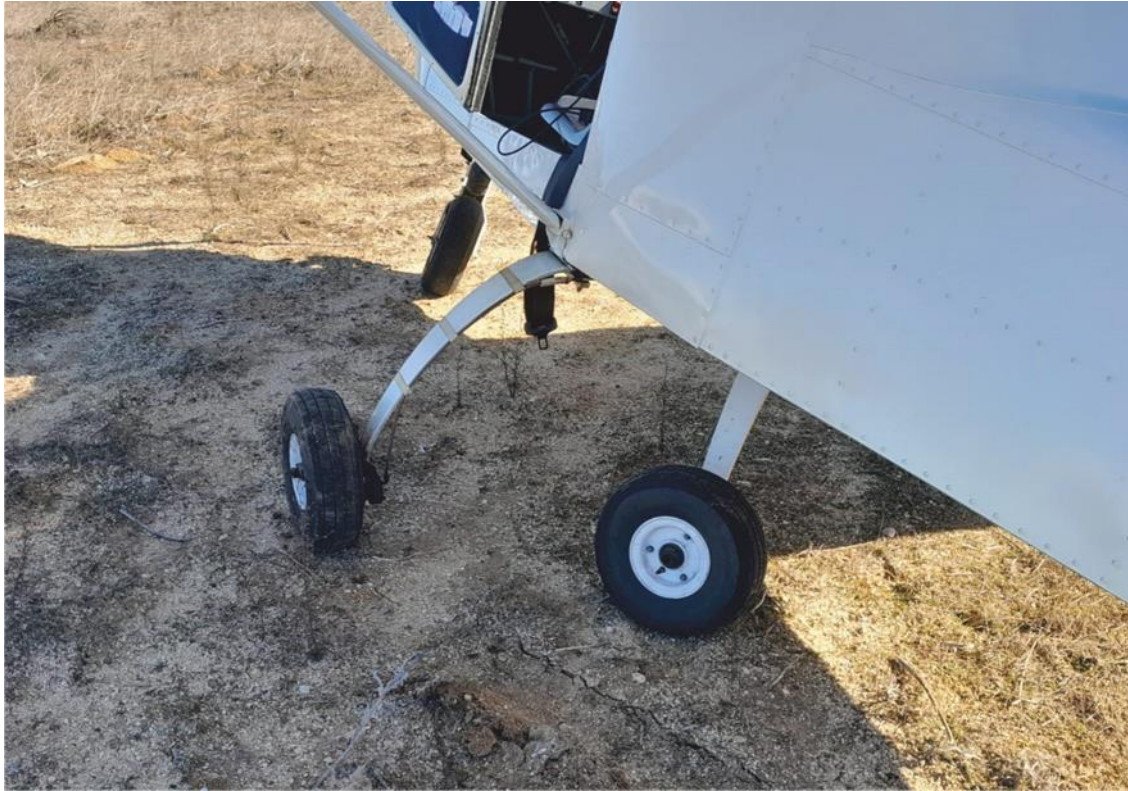
On exiting the aircraft, the pilot could see that the right leaf spring was partially detached and had bent backwards in the direction of travel.

Fig. no. 8.- Final position of the main landing gear legs

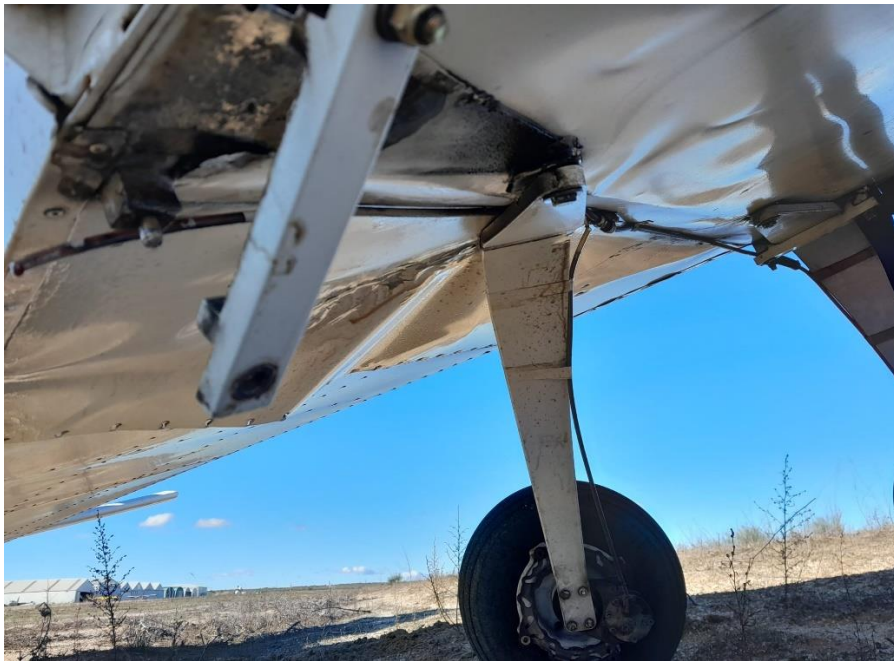
Fig. no. 9 - Close-up of the detachment of the right leaf spring

Consequently, we can deduce that the application of thrust put pressure on the right leaf spring attachment, and it must have been at that moment that the bolt broke, allowing the right leaf spring to bend under the fuselage. Up until that point, the aircraft had been moving forward and deviating toward the edge of the runway.

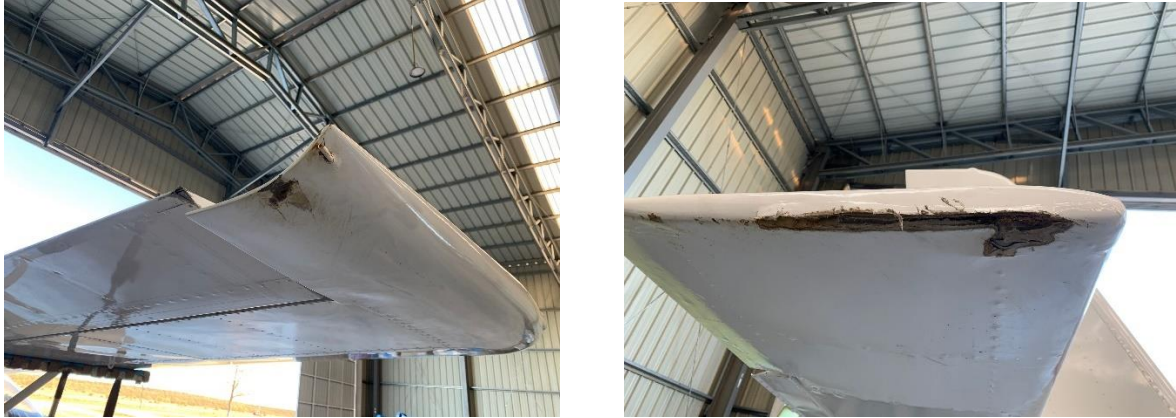
The inspection of the aircraft identified damage to the right main landing gear leg, the right wing, the right stabiliser on the tail empennage and the underside of the fuselage. The tyres and brake system were in good condition with no abnormal wear.

Fig. no. 10.- Damage to the wing and right stabiliser

As the aircraft lost speed, the right wing descended until it hit the ground and then dragged along the runway surface. This dragging caused damage to the intrados and the right horizontal stabiliser.

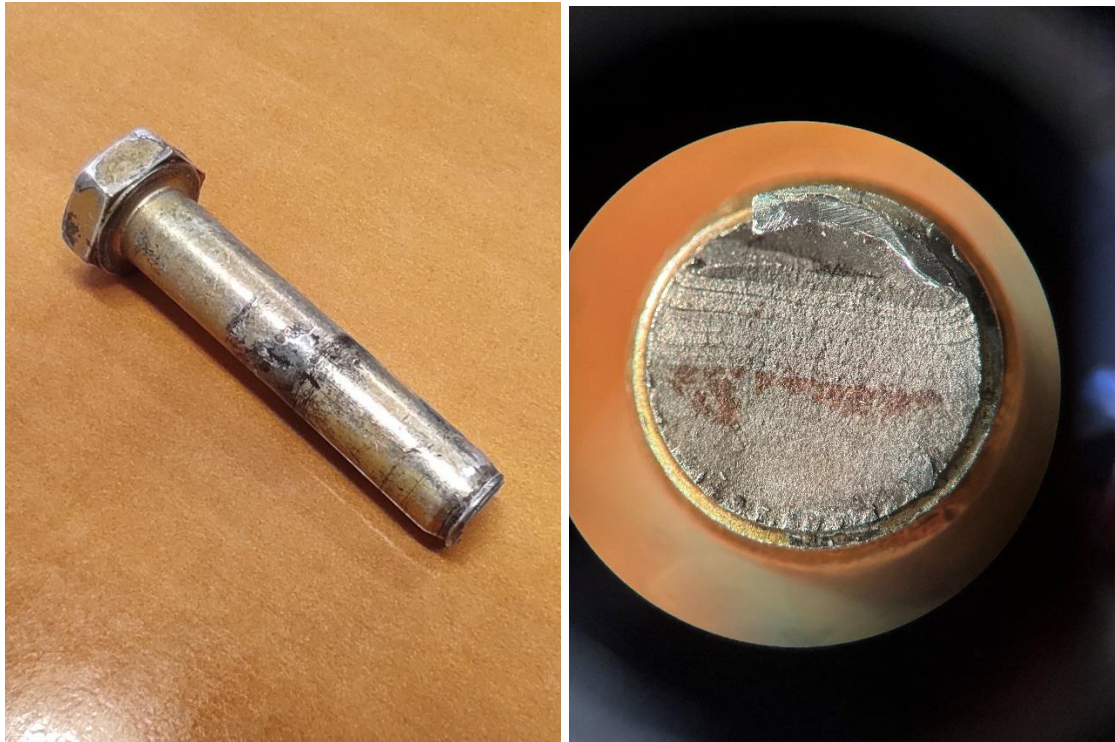
Fig. no. 11 - Close-up of the ruptured bolt

This bolt revealed a fracture at the thread level. A detailed study of the fracture surface revealed features typical of a fatigue fracture.

There were two distinct areas on the fracture surface, one being the part of the fracture where the fatigue mechanism had taken effect and the other being the area subjected to the static load from the remaining section of the part.

The recovered broken bolt revealed characteristics typical of a progressive fatigue fracture.

Given that, on the one hand, the leather parts were clearly missing and, on the other, we were unable to confirm that suitable tools had been used to ensure the correct tightening of the components, we can conclude that good maintenance practice was not followed.

It has been concluded that the cause of the accident was the collapse of the right main landing gear leaf spring and consequent runway excursion, which occurred due to poor maintenance practices that led to the rupture of the rear bolt in the right leaf spring clamp plate.

The bolt failed as a result of progressive fatigue.

It is recommended that Ignagua Center, S.L. guarantees the use of the appropriate tools to carry out maintenance tasks that require a tightening torque specified by the aircraft manufacturer and also ensures that the technical specifications of the components involved meet the aircraft manufacturer's requirements.
