Technical report

ULM A-006/2023

Accident involving an EVEKTOR EV97 EUROSTAR aircraft, registration EC-EQ7, on 23 March 2023 at San Torcuato Aerodrome (La Rioja).

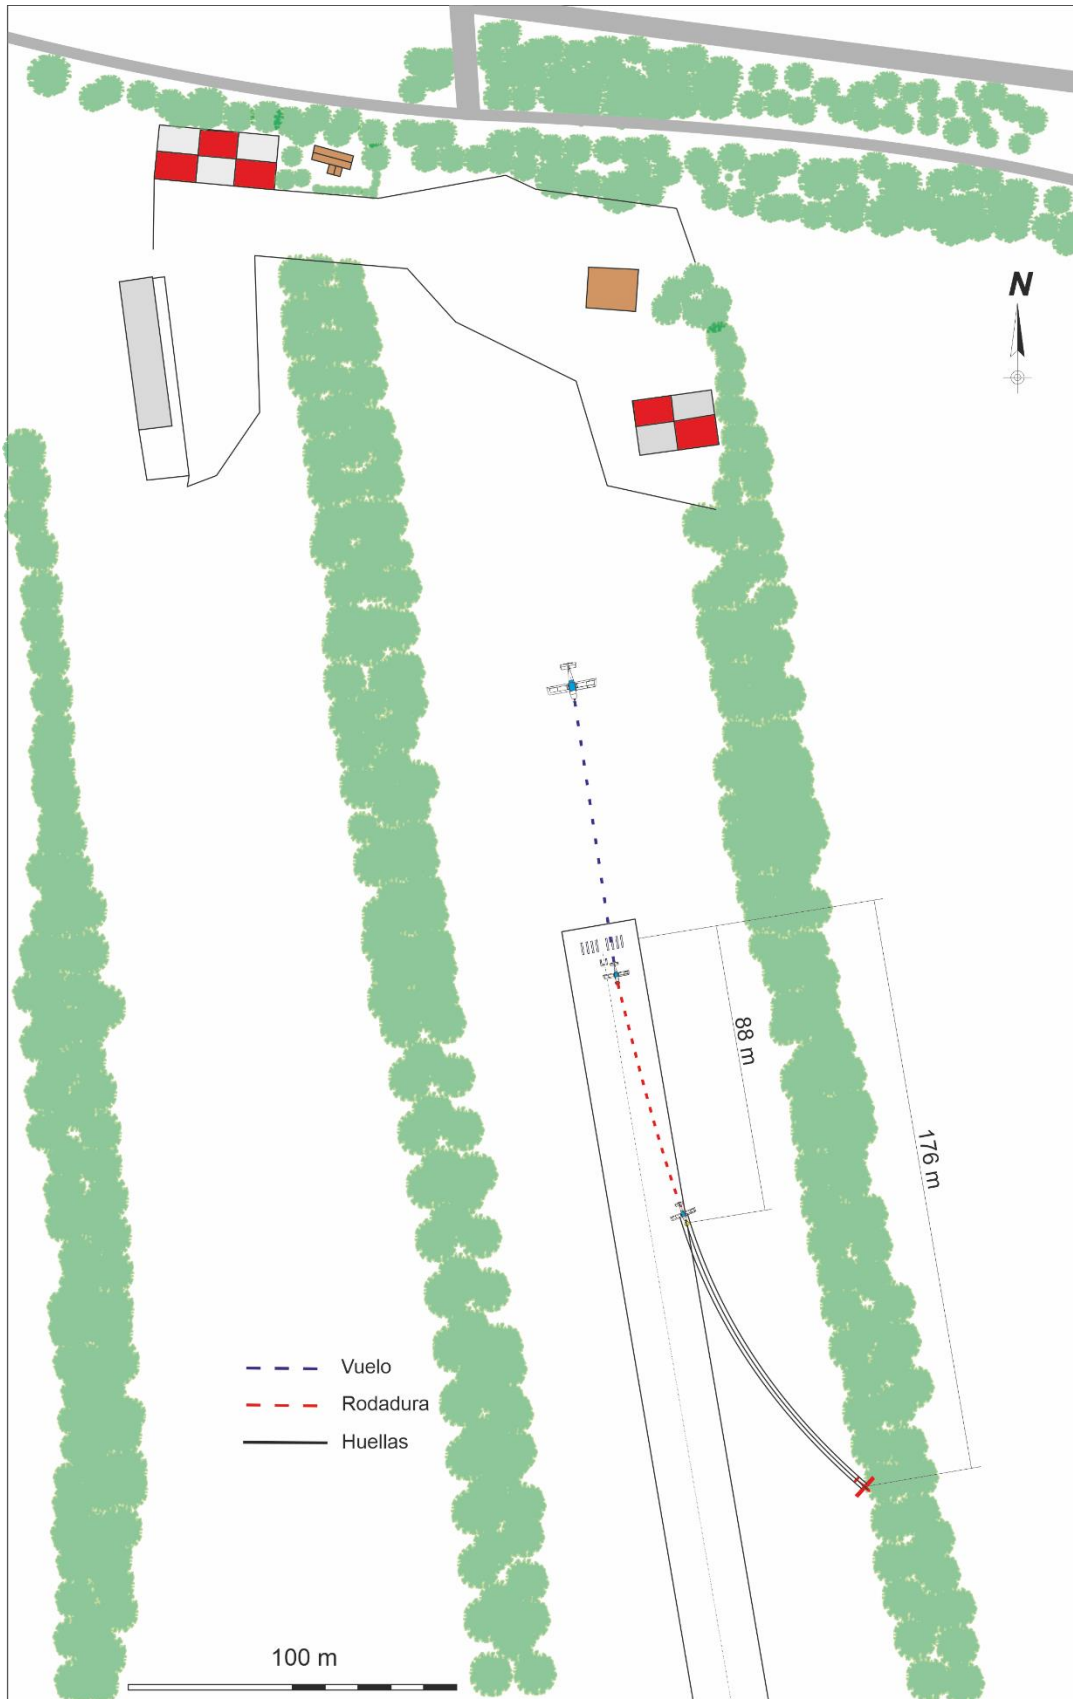
Fig. no. 1 - Diagram of the aircraft's trajectory and final position

According to several witnesses and the pilot himself, the aircraft touched down approximately 12 m past the runway markings and 3 m to the left of the centreline, therefore doing so correctly and at the right speed.

As the aircraft was travelling on a slight but continuous curved trajectory to the left, the pilot attempted to correct its path by turning to the right, trying to bring it parallel to the runway centreline. However, he stated that the controls were unresponsive, and the aircraft eventually crashed into the vegetation to the east of the aerodrome.

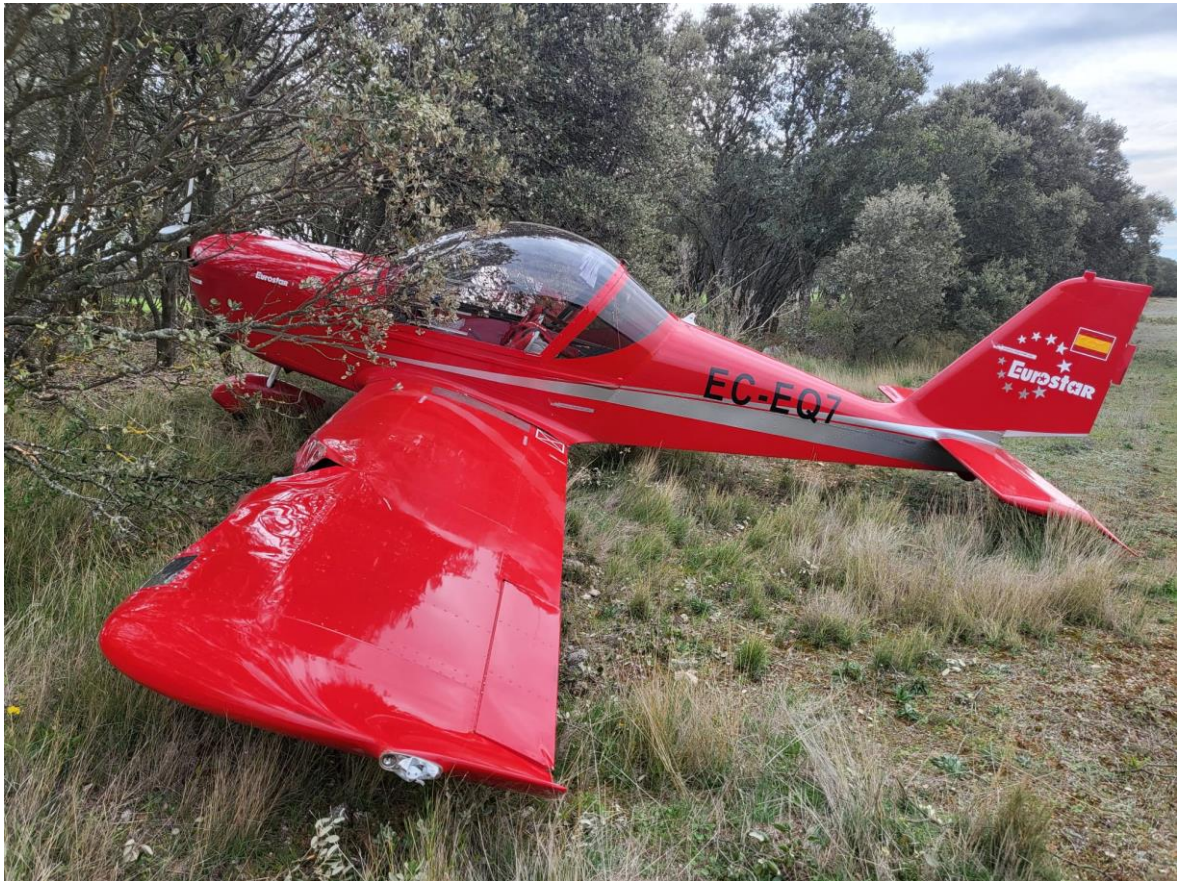
Fig. no. 2 - Aircraft in its final position

The damaged aircraft remained supported on its landing gear.

One of the three propeller blades was broken and there were scratches on the tip of one of the others. In addition, there was damage to the tips of both wings, to the leading edge of the left wing and the horizontal stabiliser on the tail empennage.

The vegetation in the area where the aircraft came to a stop displayed broken and torn branches.

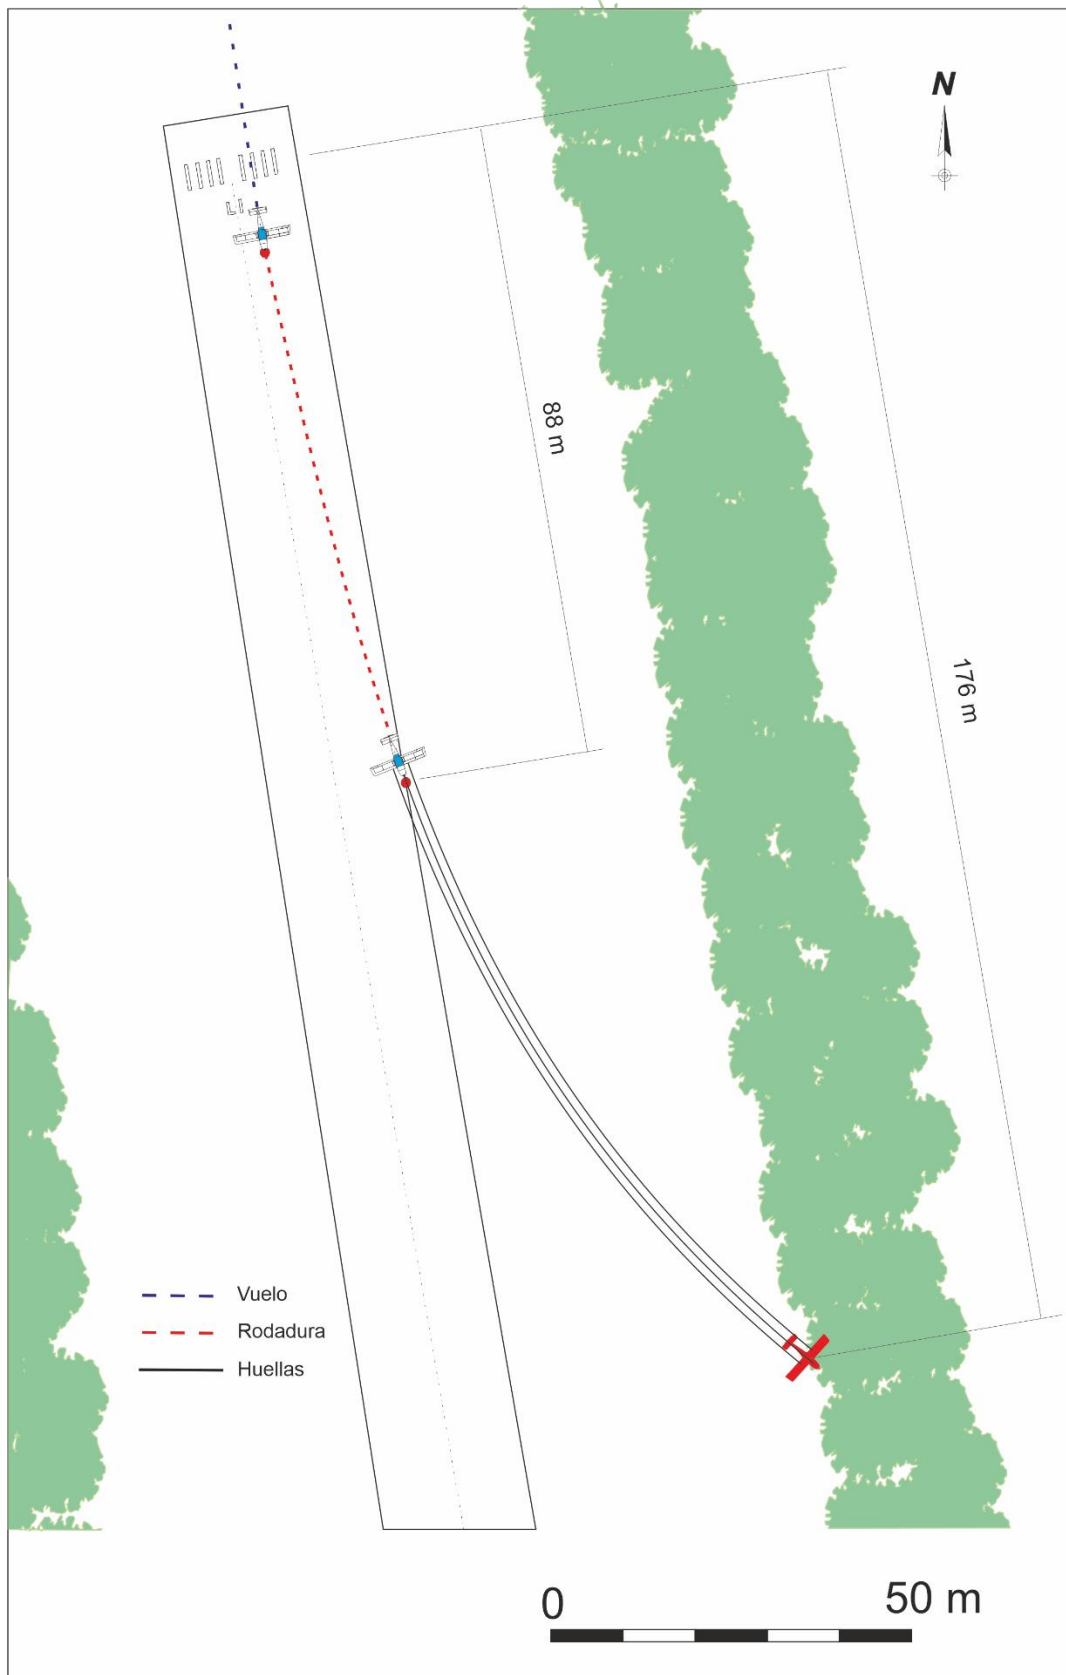
Fig. no. 3 - Detail of the track marks on the ground

The tracks on the ground were distributed, with varying intensity, over a distance of 88 m beyond the runway, between the point where the aircraft crossed over the left edge of the runway and the point where it came to a standstill. They consisted of three parallel lines curving slightly to the left in the direction of travel on the runway.

The tracks on the ground were consistent with the contact made by the landing gear wheels as the aircraft taxied. Furthermore, there was no evidence to suggest the aircraft braked, either on or off the runway, and this was supported by the condition of the tyres, which showed no signs of friction against any surface.

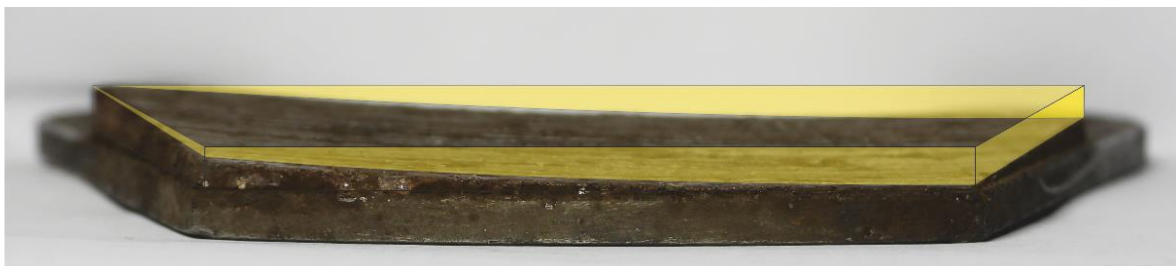
Fig. no. 4 - Wear to the right inner brake pad

As regards the condition of the components inspected, there was considerable and uneven wear to the friction material that rubs against the disc on the inner pad of the right wheel brake.

Visually, it was apparent that the thickness of this layer varied across the different areas of the pad to the point where it was practically non-existent at one end.

The brake system inspection revealed a high level of uneven wear to the friction material that rubs against the disc on the inner pad of the right main gear leg. As a consequence of the uneven wear, the thickness of the friction layer varied from a similar magnitude to the rest of the pads at one end to almost non-existent at the opposite end.

Given the way in which the friction layer has worn away, it is reasonable to conclude that at no time has the entire surface of the friction layer been in contact with the disc surface, which leads us to believe that, comparatively speaking, this brake could never have worked as effectively as the brake on the left wheel, the difference being more noticeable the faster the brakes were applied.

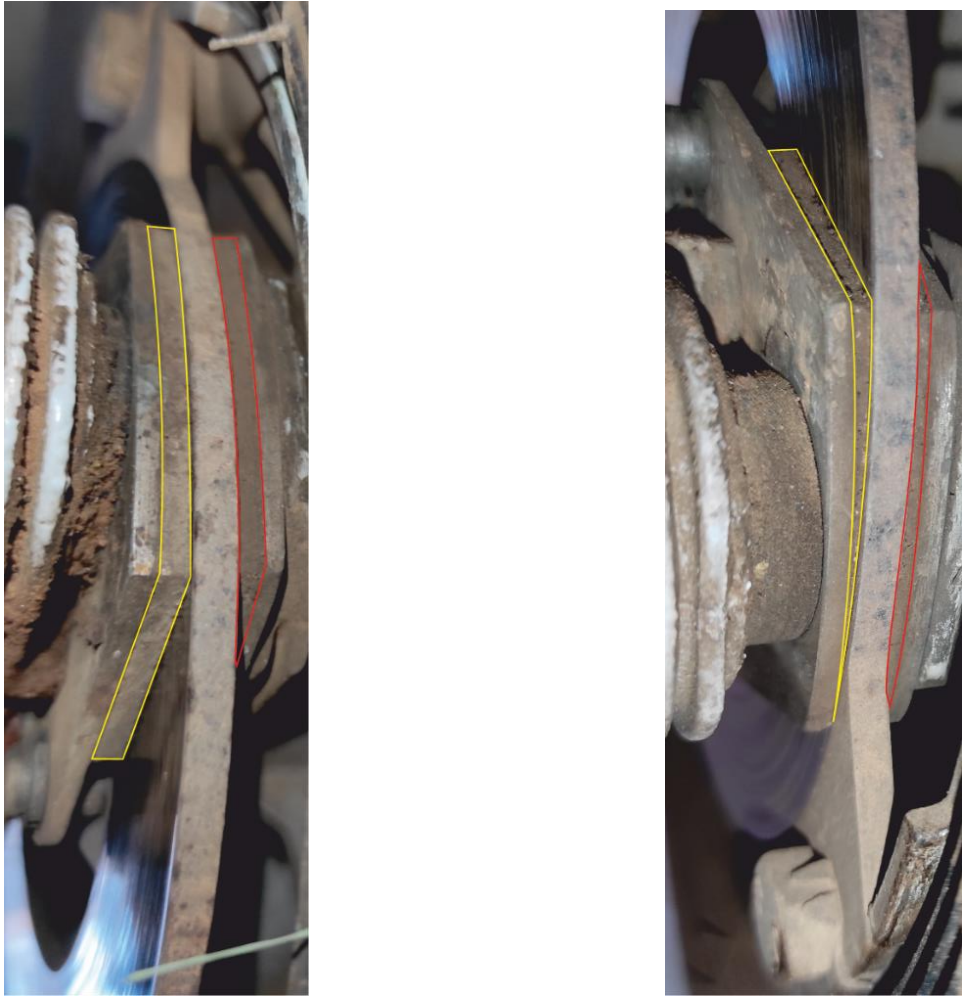
Fig. no. 5.- Condition of the brake pads

The other pads had minimal, evenly distributed wear.

Nevertheless, the abnormal condition of one of the right brake pads does not imply a total malfunction of the brake system as a whole and certainly not of the left brake.

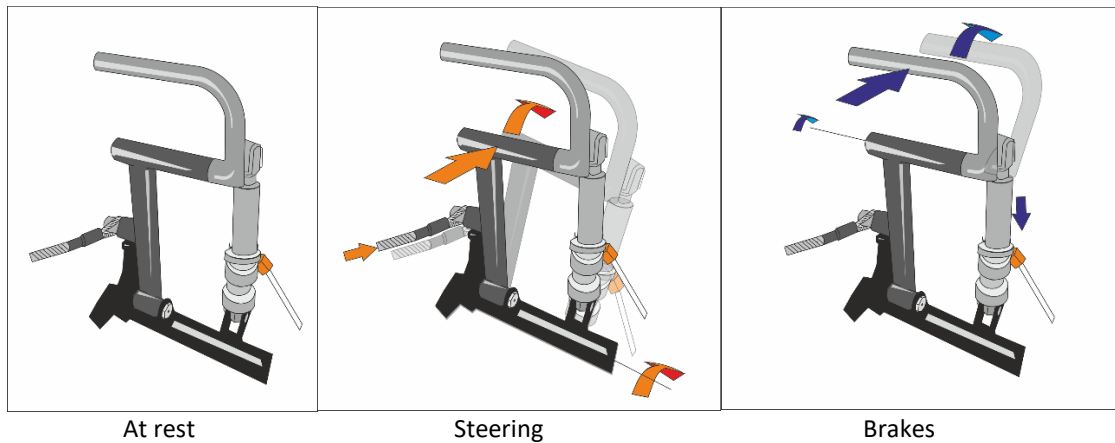
Fig. no. 6.- Steering and braking system

- The rotation of the pedals achieved by applying pressure to the lower bar of the pedal causes a change of direction towards the pedal pressed (they are connected, so when one moves forwards, the other moves back).
- Applying pressure to cause a slight rotation of the pedal's upper bar activates the hydraulic pressure that operates the brakes.

For example, at some point during the rollout pressure may have been inadvertently applied to the lower rather than the upper pedal bar, activating the steering rather than the brakes. Moreover, even if only slightly more pressure were applied to the left pedal than the right, the aircraft would respond by deviating from its trajectory to the left.
