Technical report

ULM-A-007/2021

Accident on 5 May 2021 involving a ZENAIR CH-701 aircraft, registration number EC-XSP, in the municipality of Robledillo de Mohernando (Guadalajara).

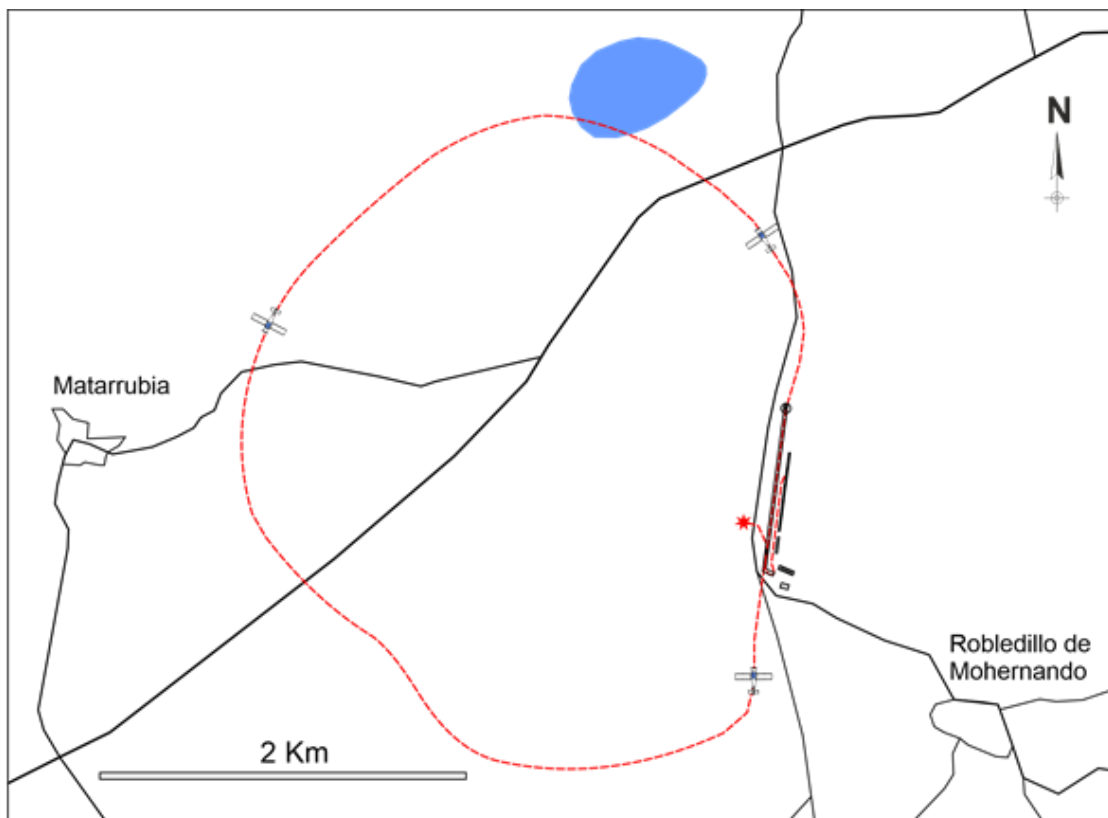
Fig. 1 - Diagram of the aircraft's trajectory

As indicated by the pilot, the diagram shows the initial taxi to runway 01, the subsequent takeoff and the flight around the western side of the aerodrome. The aircraft then returned to the start of the runway, touching down and then taking off again, before spinning off to the left and impacting with the ground.

From takeoff to impact, the total duration of the flight was 5 minutes and 15 seconds. During the first 3 minutes, the aircraft ascended 1411 ft above the ground, moving at speeds² ranging from 105 km/h at takeoff to 133 km/h while heading back towards the runway. During the remaining 2 minutes and 15 seconds, the aircraft descended at speeds not exceeding 126 km/h, reaching 100 km/h when touching down on the runway and slowing to 96 km/h immediately afterwards. Subsequently, the aircraft rose for barely a few metres before suddenly losing speed, turning sharply to the left and impacting with the ground. (Although three additional readings were recorded after takeoff, they are considered spurious, because even though they offer an idea as to what happened, they do not provide a precise record of the aircraft's altitude or speed during the moments immediately prior to the impact.)

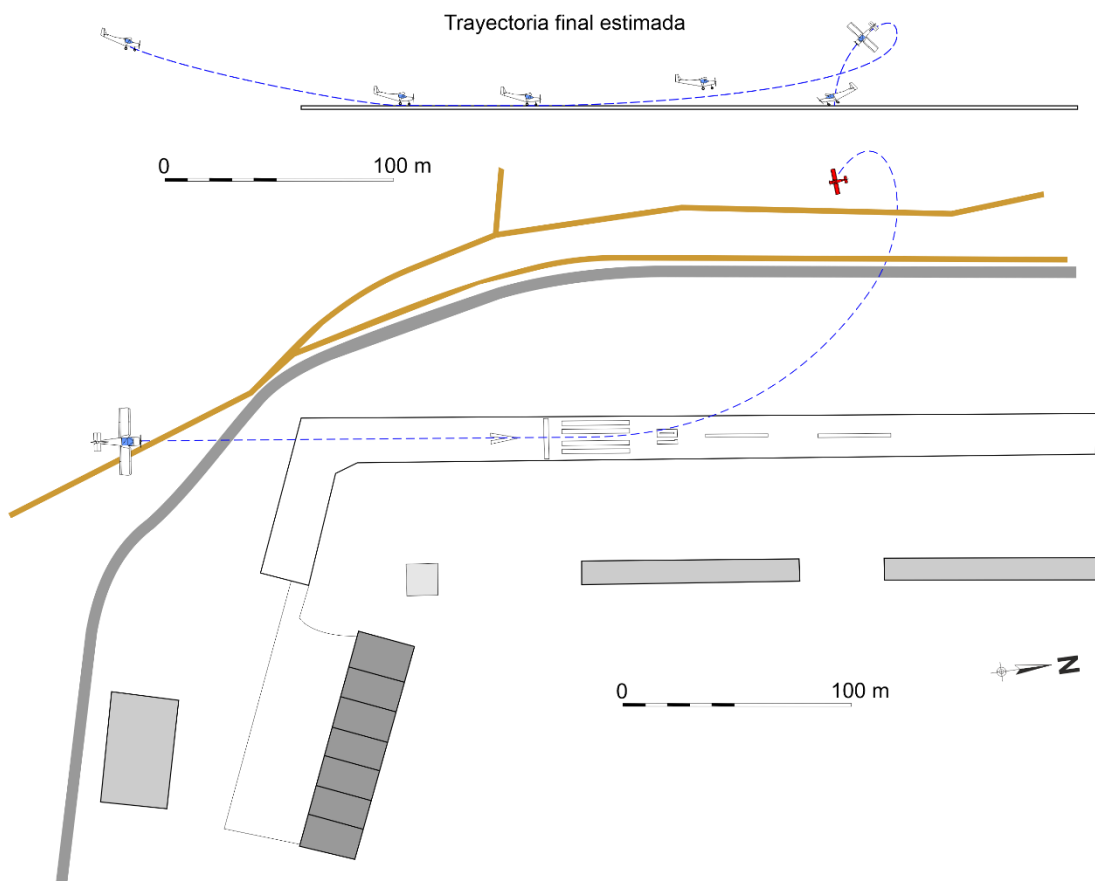
Fig. 2 - Diagram of the estimated final trajectory (ground plan and elevation)

In view of the location of the wreckage, and according to the data recorded by the GPS, the aircraft touched down at the start of the runway and after taxiing for a short distance, it took off again, before descending in a curved trajectory towards the left and impacting with the ground 130 m from the threshold and 110 m from the runway centreline.

This situation is consistent with the aircraft entering a stall immediately after taking off, which may have occurred due to low speed during the ascent, a steep angle of climb, or a combination of the two factors.

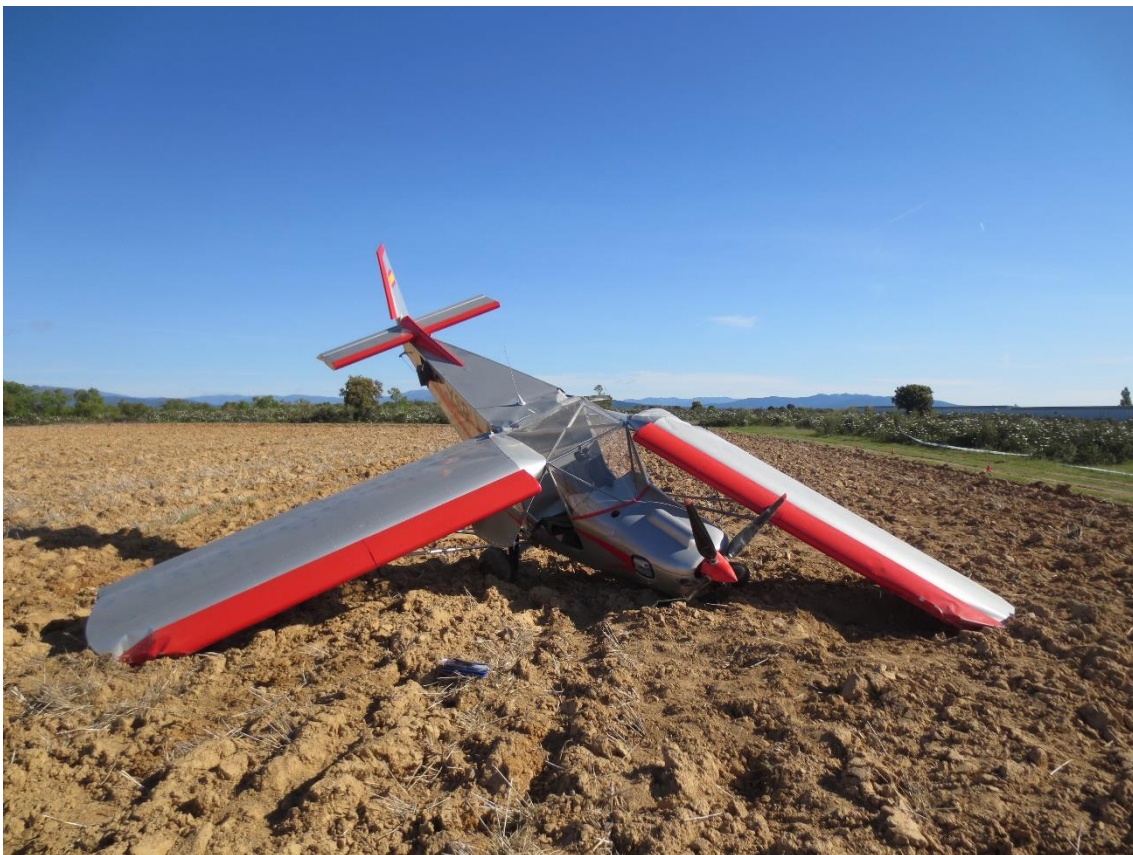
Fig. 3 - Final position of the aircraft

The aircraft followed a downward trajectory (it is not possible to specify the precise height from which it descended) curving off to the left, eventually hitting the ground 130 m from the crosswise threshold bar in the direction of the runway centreline, 110 m from the latter.

The wreckage was concentrated around the point of impact. There was no sign of travel across the ground.

There were no signs that the aircraft had travelled across the ground, which indicates that it was carrying a significant amount of vertical speed when it made contact with the ground.

From direct observation of the aircraft's position on the ground, it can be concluded that the aircraft struck the ground with its propeller, the lower right section of its nose, and its landing gear (first with the nose landing gear, followed by the main landing gear), in such a way that its position was angled slightly downwards and its trajectory slightly oriented towards the right.

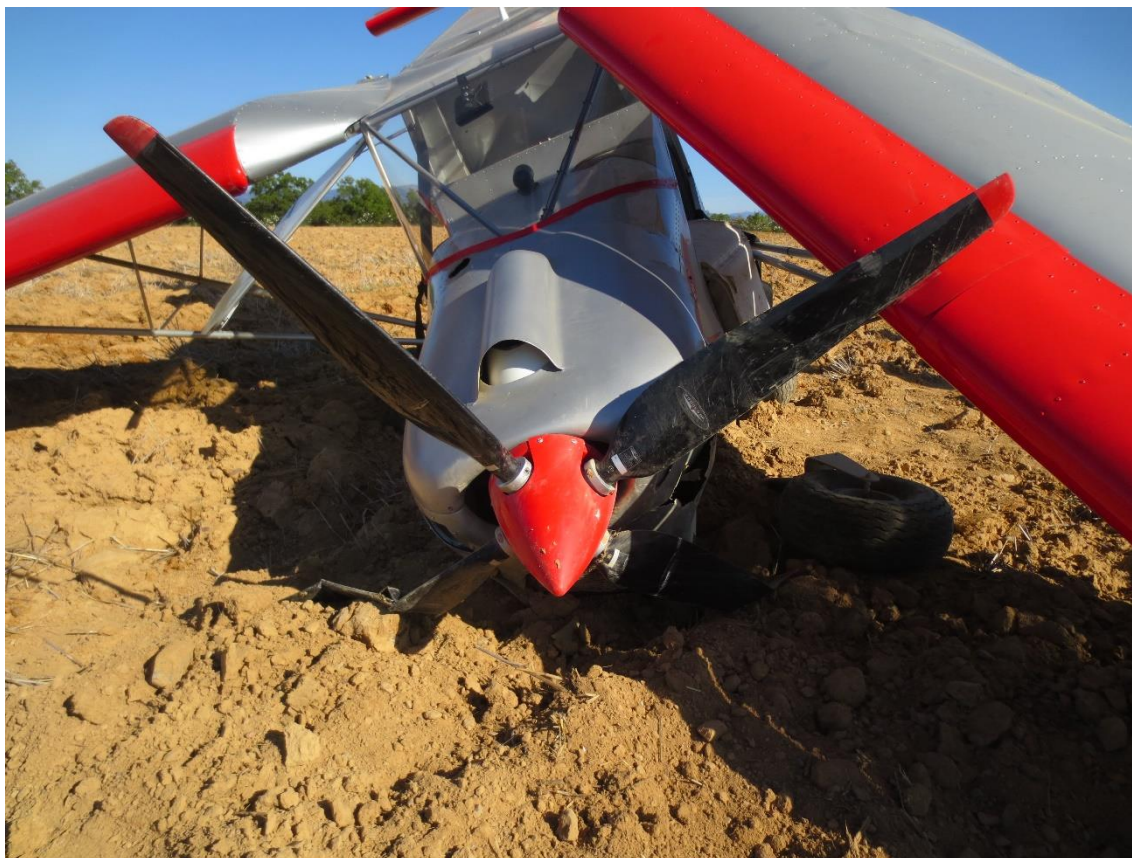
Fig. 4 - Position of the aircraft wreckage

In general, the aircraft retained its original shape, with the following exceptions: the left wing, which was broken and pushed forward; and the nose landing gear, which was broken

and detached from the aircraft, having been pushed to the left and slightly back from its original position.

The rest of the aircraft’s components remained in place, although they suffered significant damage: the right wingtip was crumpled and deformed; the main landing gear was deformed and the left anchor had become loose; the nose, cabin and middle part of the fuselage had suffered breakages and deformation.

The deformation observed on both the nose landing gear and main landing gear is congruent with the above, insofar as the landing gear was bent backwards and to the left. The left wing had also become detached and was bent forwards.

Two of the propeller's four blades remained unbroken and in their original shape. The other two blades had impacted the ground and broken off as a result of backwards flexion. It can therefore be concluded that the aircraft was not under power at the moment it impacted with the ground.
