ULM A-009/2020

TECHNICAL REPORT

Accident involving an ULM ELA-07 R-115 autogyro, registration EC-GF2, on 9 July 2020 at Villanueva de Gállego Aerodrome, in the municipality of Villanueva de Gállego (Zaragoza – Spain).

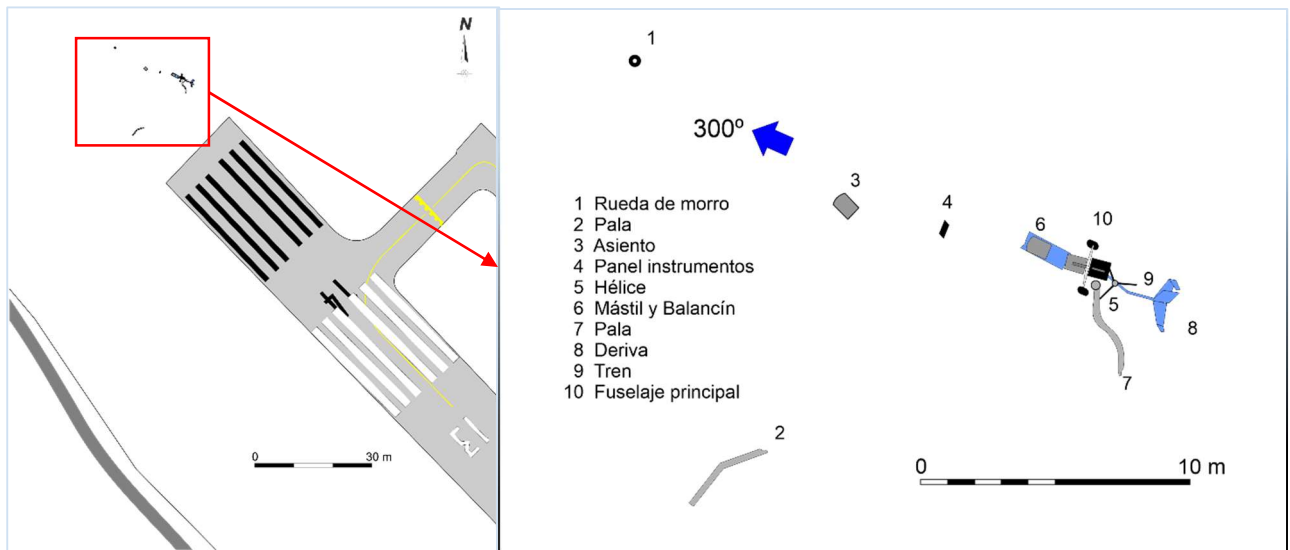
At the impact zone, the aircraft was embedded in the ground in a nose-down attitude consistent with the steep downward attitude reported by the people who witnessed the take-off. The aircraft's airframe was severely deformed.

The main wreckage of the aircraft was highly concentrated, with no evidence of horizontal displacement in the impact zone. The frame remained embedded in the terrain and the components that had detached during the impact were found in the immediate vicinity.

Figure 1 - Final position and distribution of the aircraft wreckage.

As described in 1.12, the damage and deformities sustained by the aircraft and the distribution of the wreckage suggest that the autogyro hit the ground with considerable force, as a consequence of following a steep descent path while maintaining a nose-down attitude.

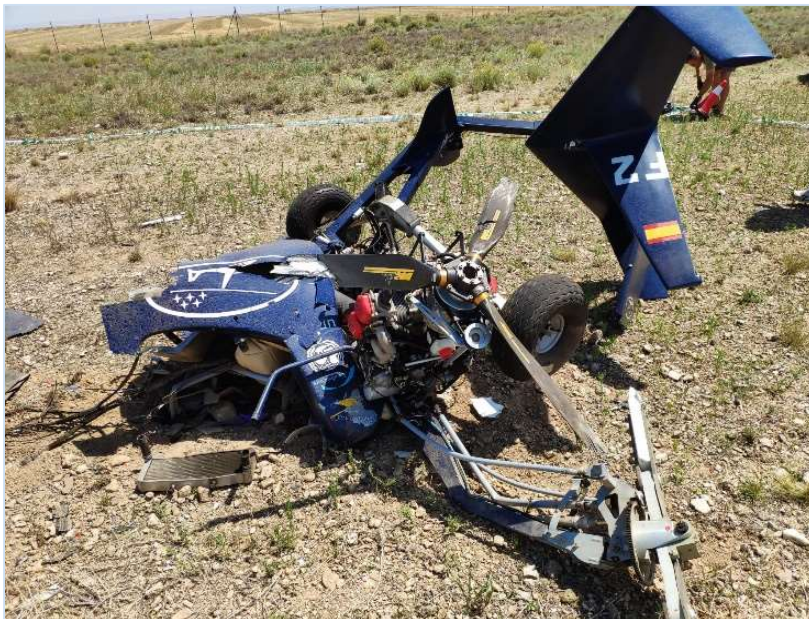
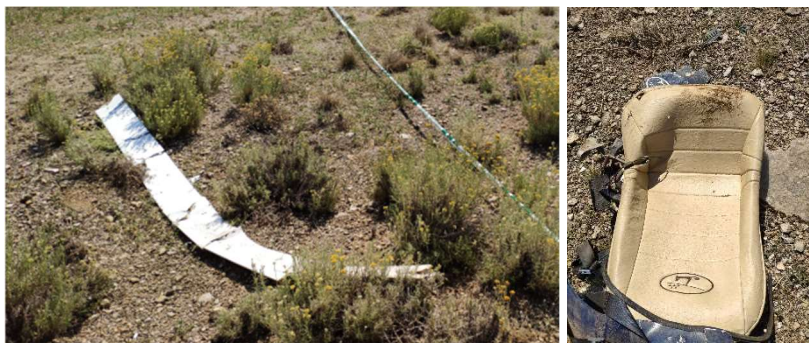
The rotor blades were damaged as a result of the impact with the ground. One had broken into multiple fragments, while the other was deformed but remained intact.

crash. There was no evidence of any failure of the aircraft's structure or flight controls prior to its impact with the ground.

Figure 2 - Pictures of the aircraft wreckage.

- Main wreckage
- Detached blade
- Rear seat, detached

Both rotor blades were damaged during the crash; however, while one broke into several fragments due to the violence of the impact, the other was deformed but not fragmented due to the lower speed at which it impacted. This suggests lower rotor revolutions at the moment of impact with the ground.
