# **TECHNICAL REPORT**

## **ULM-A-009/2023**

### **Accident on 11 June 2023 involving a VOL-9 SKY RANGER aircraft, registration EC-FR3, in the municipality of Majadahonda (Madrid, Spain)**

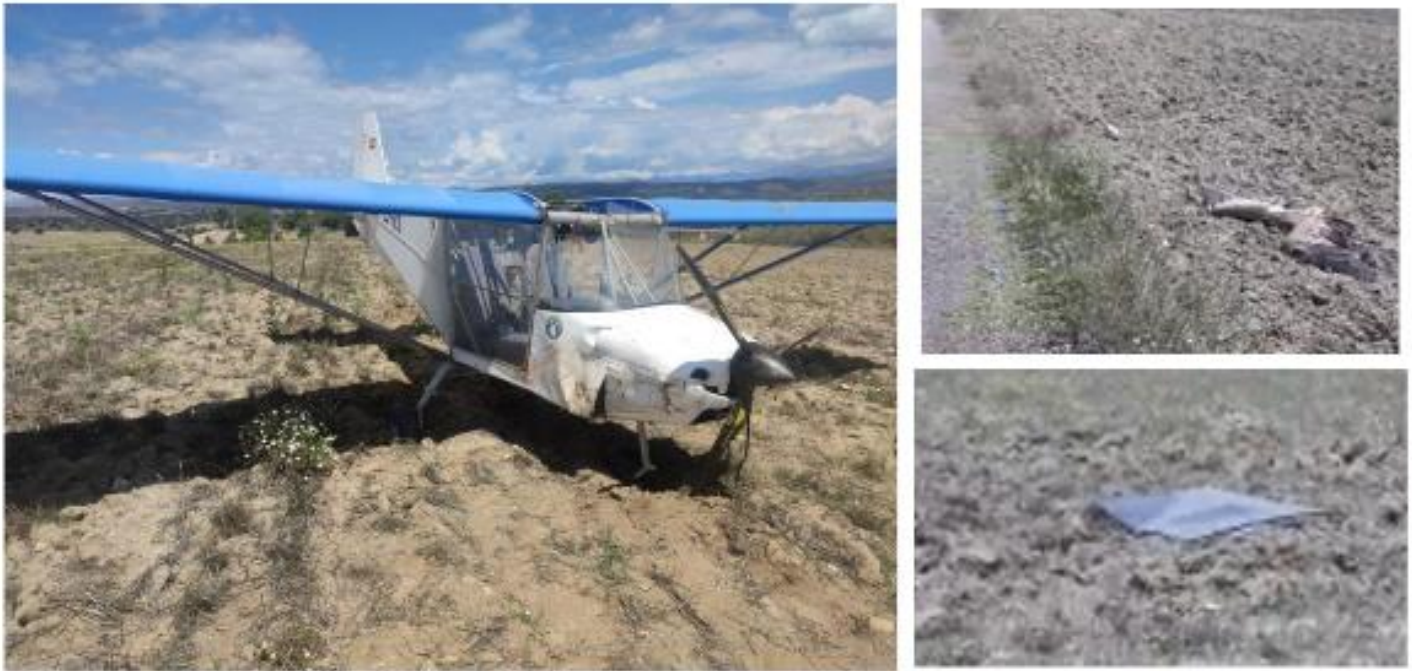
**Figure 3 Final position of the aircraft, the vulture and the**

The aircraft was found at 40° 29' 45.7" N - 3° 55' 47.0" W in a ploughed fallow field 5,200 m west of the Villanueva del Pardillo Aerodrome.

One of the propeller blades was in a downward position, resting on the ground, with a partial break one-third of the way down. The second blade had been severed two-thirds of the way down, the longest piece having broken off in flight and disappeared after the impact with the vulture. The third blade was undamaged.

The nose wheel fork was bent backwards, and the wheel was slightly embedded in the ground.

The aircraft had been hit on the right side of the engine housing, where traces of the vulture's blood were present. The impact deformed the fairing and, as a result, partially broke the plastic windscreen, although it remained in its frame.

The upper part of the cockpit had detached and was found next to a road, very close to the vulture, at 40° 30' 09.2" N - 3° 55' 37.0" W
