Technical report

ULM A-010/2020

Accident on 13 July 2020 involving a
DYNALI H3 'EASY FLYER' aircraft with
registration EC- GS5, in Ontígola (Toledo)

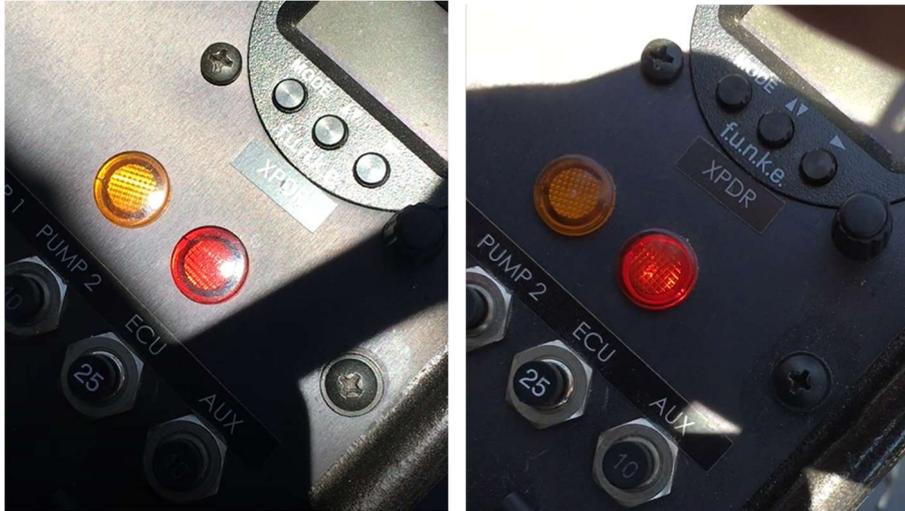
Illustration 4: impact of the sun on low battery warning light (and others)

In this area, it's easier for direct sunlight to affect the light (see Illustration 4). In current versions of the helicopter, however, this warning light is located on the main digital display (EFIS).

- The inspection of the aircraft found that direct sunlight makes it hard to see the activated warning light and that it is positioned in a place where direct sunlight can easily fall on it (see Illustration 4).
- The warning light is at the bottom of the control panel, out of the pilot's line of sight. In addition, the cyclic control can obscure the pilot's view of it.
- The time of the alarm activation coincided with the take-off of the aircraft, so the pilot was probably focused on other tasks.

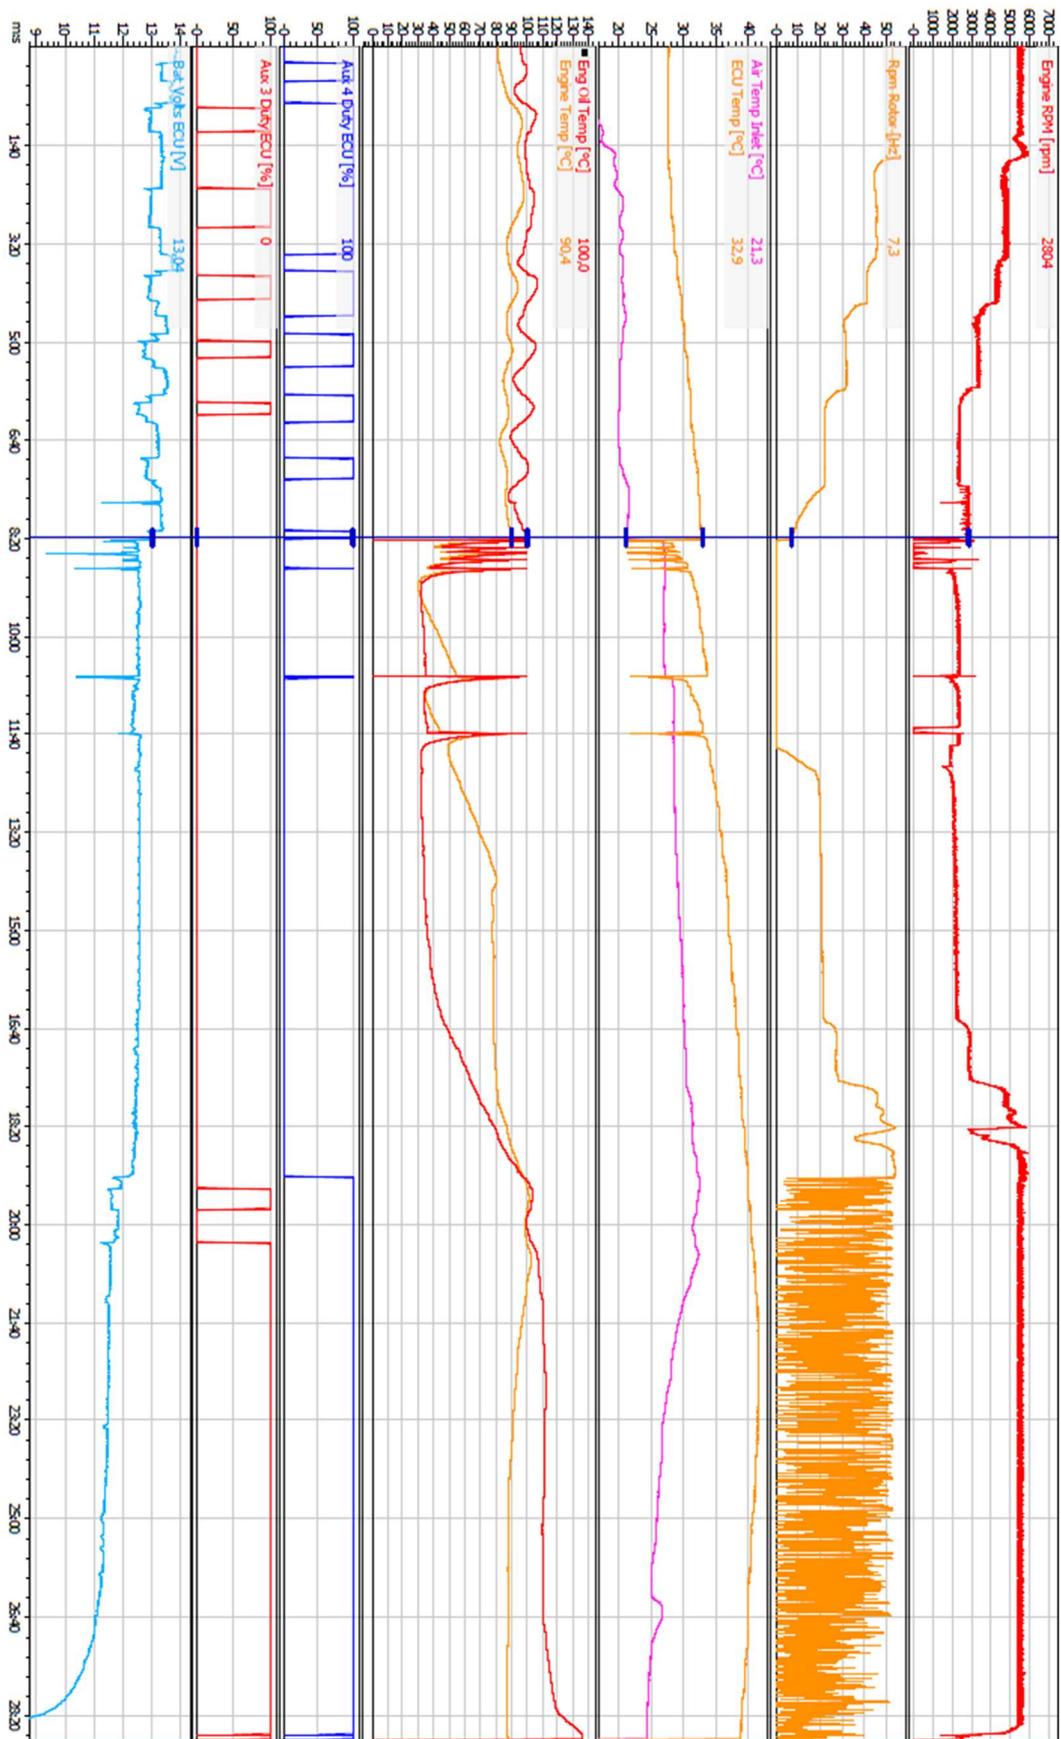
Illustration 5: Graphic showing the most relevant data recorded by the ECU for the accident flight

- The main rotor RPM measurement starts to give meaningless values.
 - One of the 2 fans activates (10 s later, the second fan activates). Both of them ran without interruption until the battery failure.

According to the manufacturer's statement, insufficient voltage can cause some measurements to display meaningless values (such as the main rotor revolutions). In addition, the fans started to run at lower power, reducing their efficiency.

- Every time either of the two fans activated, there was a drop in voltage of about 0.3 V.
 - During the accident flight, and the other flights recorded, the battery was slowly losing charge, even at cruising power. Regardless of abrupt drops at the start, the battery voltage declines steadily, little by little, dropping 0.3 V in 16 minutes on the first flight (0.018 V/min) and 0.43 V in 16 minutes on the second flight (0.025 V/min). During the accident flight, comparing the area where the voltage drops linearly (before the final non-linear deterioration), the drop is 0.1 V in 221 seconds (0.027 V/min).

- For much of the flight, the T of the engine oil and coolant remained stable (around 110 and 90°C, respectively). However, when the battery voltage dropped below 11 V (at sec 1,600 - 26:39), the engine oil T began to increase, initially linearly and then parabolically until the engine failure.

- At second 1,709 (28:28), a decrease in engine RPM begins, with the engine finally stalling at second 1,724 (28:44)

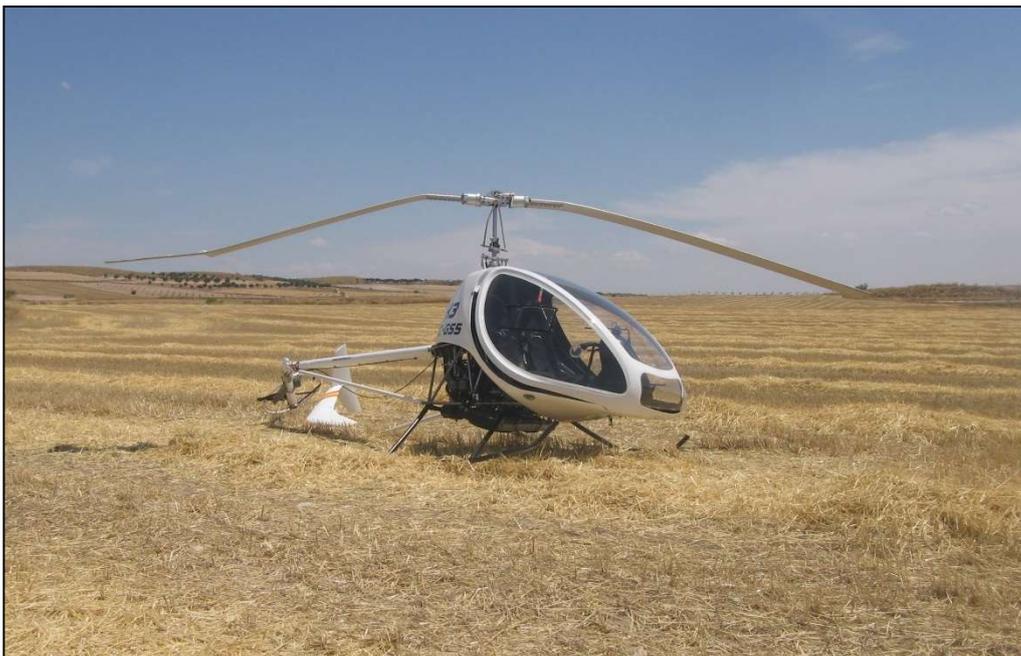
Illustration 6: Final position of the aircraft after the accident

The impact site was located about 9 km to the north of Olocau Aerodrome. Its coordinates are 40° 01' 11" N, 3° 30' 15" W. The aircraft came to rest facing south, 10 m east of a road. The terrain where it crash-landed was a stubble field. The ground was hard and covered with the remains of a harvested cereal crop, making it difficult to detect any possible markings left by the aircraft.

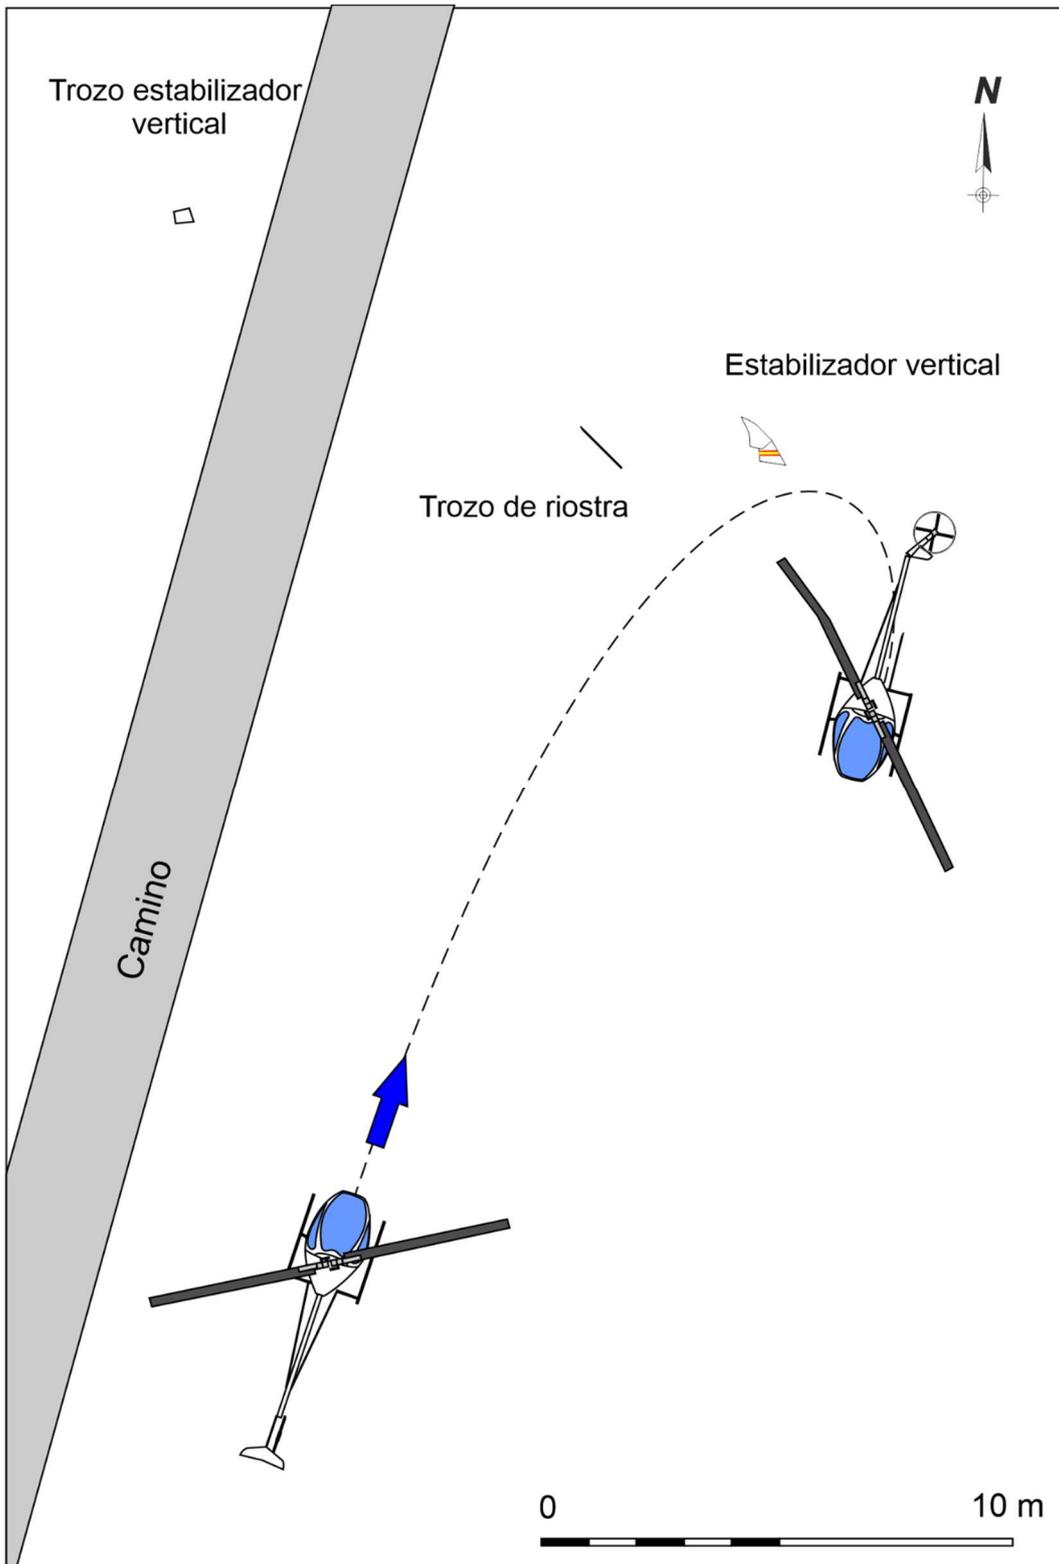
Illustration 7: Sketch of the positions of the aircraft wreckage

Illustration 7 shows the relative positions in which the helicopter and the parts that came off in the accident were found. No impact or drag marks were found except for those where the aircraft was already located.

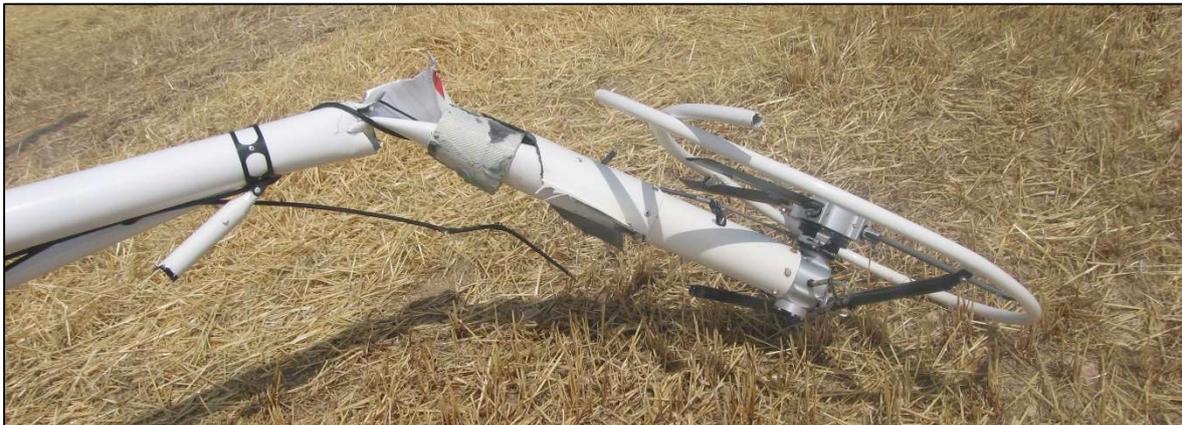
The mast had a large crack in its final third, where it had been bent and torn to the point of almost detaching. This gash was about 30 cm long. There were marks and scratches covering an area of the same length on the tip of one of the main rotor blades.

Image 9: Damage to the tail mast and anti-torque rotor

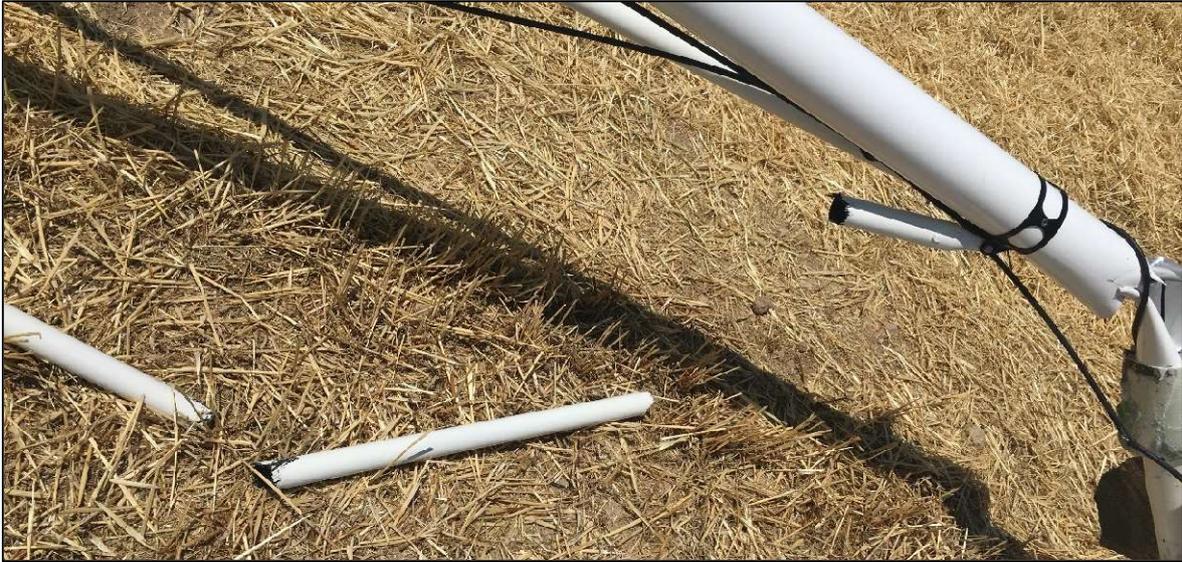
The left tail mast bracing strut (carbon fibre) was broken at two different points.

Image 10: Damaged left strut

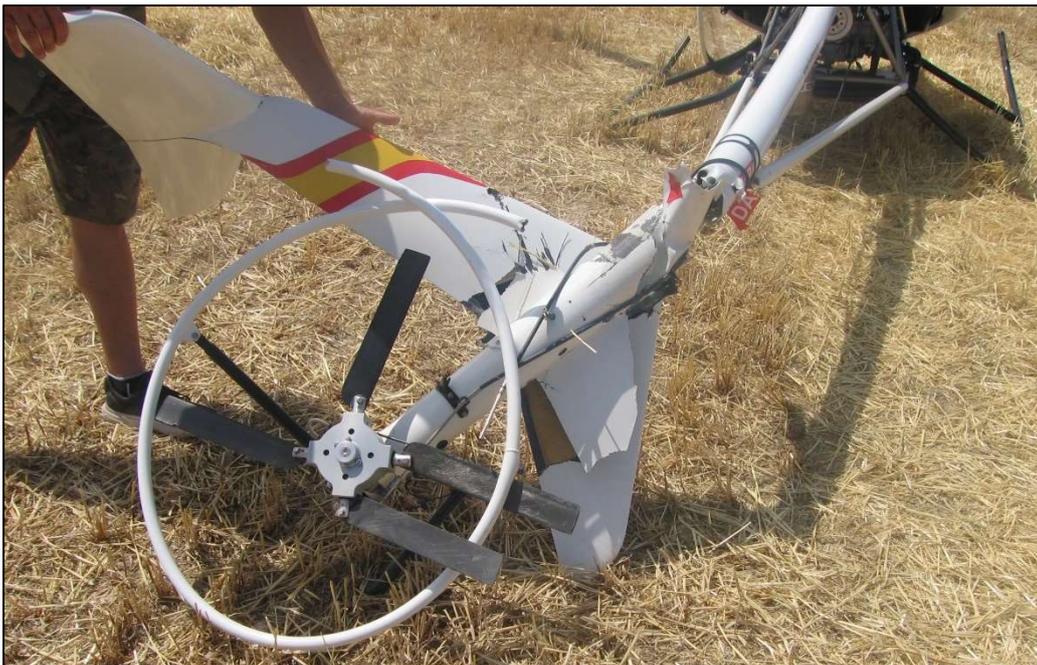
Illustration 11: Damage to the 'Shark Fin' and the anti-torque rotor

The bulk of the 'Shark Fin' (horizontal and vertical stabilisers) had detached, leaving only the bit closest to the tail mast attached. There was a small notch in the lower third of the leading edge of the vertical stabiliser (about 2x2 cm).

The protective ring around the anti-torque rotor was broken and bore marks from striking the ground (traces of dirt). One of the two metal rods supporting it was bent and separated at the joint. There were marks and scratches on the anti-torque rotor blades (carbon fibre), but they remained intact (see Illustration 11).

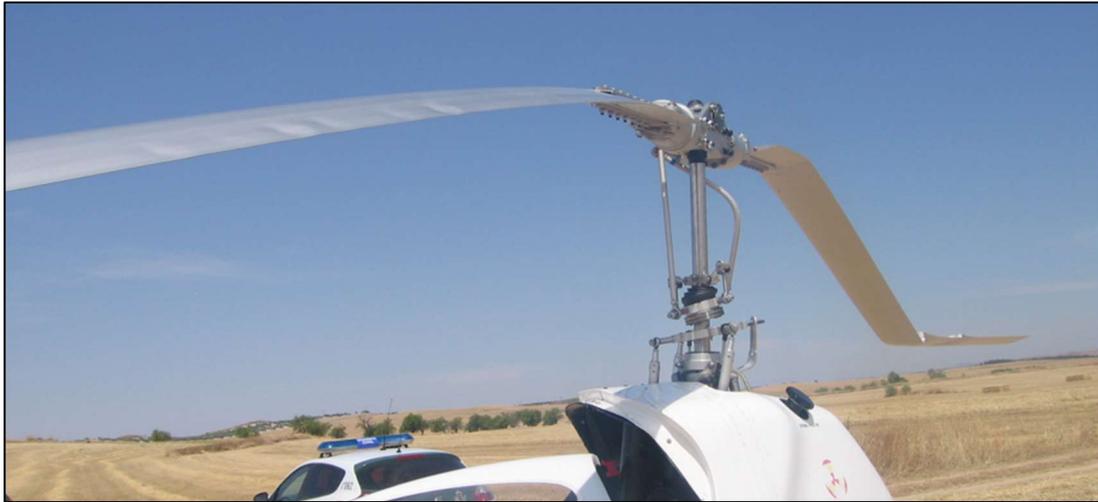
Illustration 12: Main rotor blades and shaft

The aluminium main rotor blades were scratched and had traces of white and red paint on the leading edge. Both were also bent downwards at their attachment point. In addition, the blue blade was bent sharply backwards from the middle and had rotated 180° on its longitudinal axis, bending the pitch change rod in the process (see Illustration 12). The main rotor shaft displayed marks where it had come into contact with the blade attachment sockets. The lower ring of the swashplate was severed in one place.

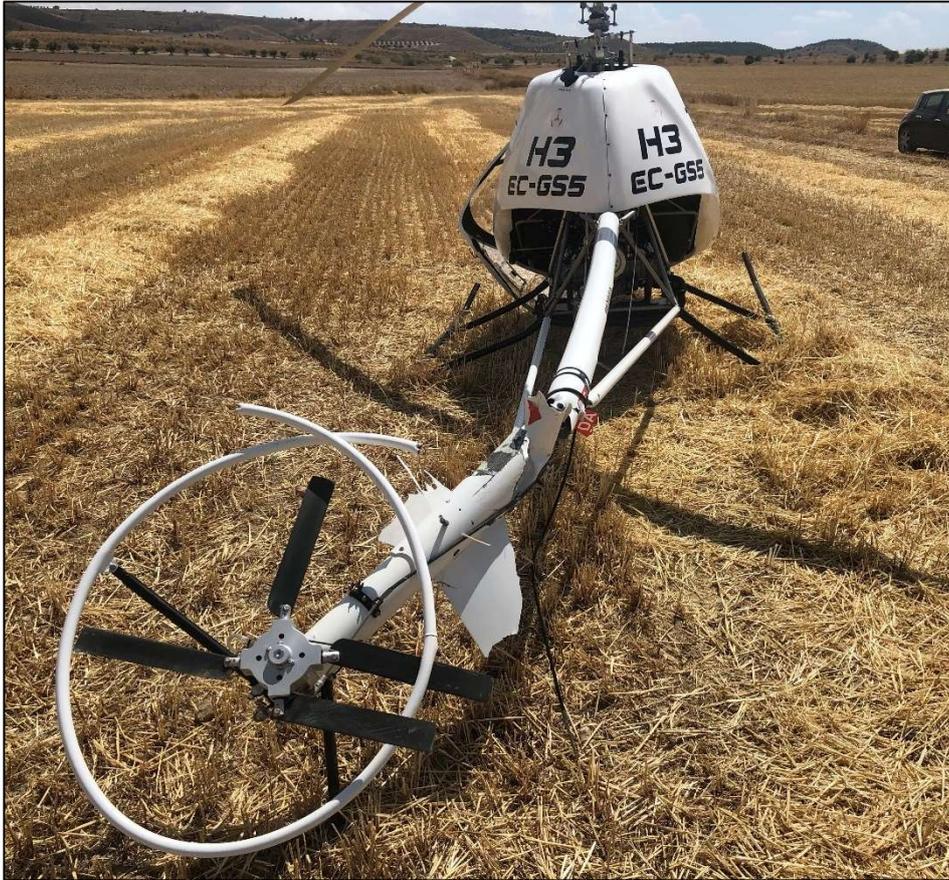
The carbon fibre canopy was partially cracked from the left lower mounting to the window. The upper couplings to the aircraft cabin were completely detached. However, a safety restraint strap (made of fabric) at the top prevented the canopy from moving by more than a few centimetres, the displacement being forward and to the left.

The skids had been deformed by crushing, pulling away from the fuselage. The left skid was notably more deformed than the right.

Image 13: Damage to the tail, mast struts and skids.

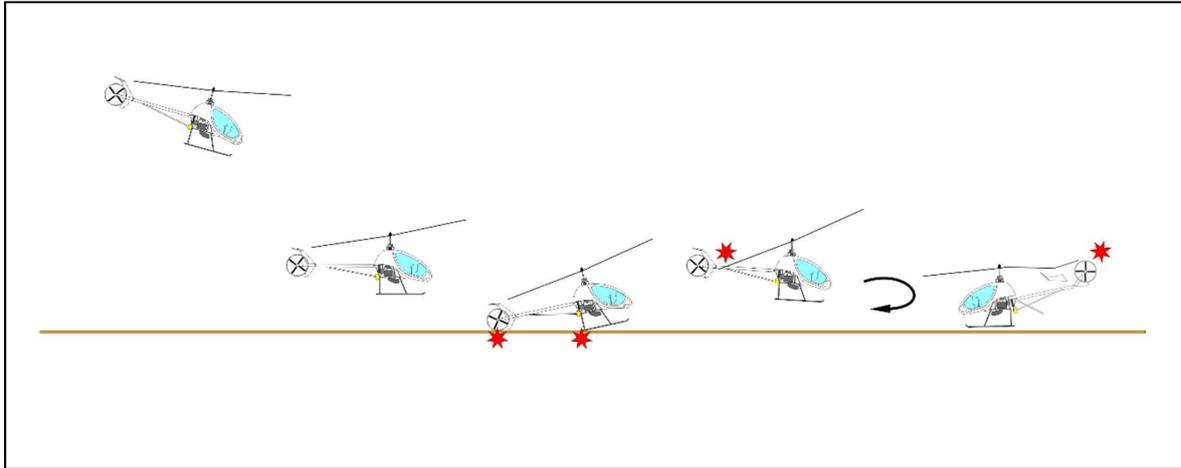
Image 14: Probable sequence of events in the final part of the autorotation

Given that the pilot performed such an abrupt flare (raising the nose and lowering the tail) at such a short distance from the ground, it seems perfectly feasible that its tail, the back of its skids or both might have hit the ground. This scenario would explain the dirt marks on the tail rotor protection ring and its bent bracing strut and would also have made the helicopter's subsequent commanded pitching movement faster while the main rotor blades continued to rotate backwards due to inertia, causing them to hit the 'Shark Fin' and the mast. The type of terrain, which was hardpacked and covered with cut cereal crop remnants, would explain the absence of marks on the ground despite the helicopter hitting it. In addition, if performed abruptly, this manoeuvre could cause negative load factors, which are expressly prohibited by the flight manual.

The blade strike resulted in the break and near separation of the last third of the tail mast and the compression fracture of the left mast brace. One of the blades flipped over on its longitudinal axis when it struck the mast. The impact and consequent transfer of kinetic momentum from the rotor to the fuselage also caused the helicopter to yaw to the right, causing the aircraft to turn 180° to the right and eventually hit the ground. Once the structural strength of the tail was compromised, the 'Shark Fin' eventually detached.
