Technical report

ULM A-014/2022

Accident on 5 June 2022 involving a TECNAM model P96-G aircraft, registration EC-FO7, in the municipality of Pilar de la Horadada (Alicante /Alacant, Spain)

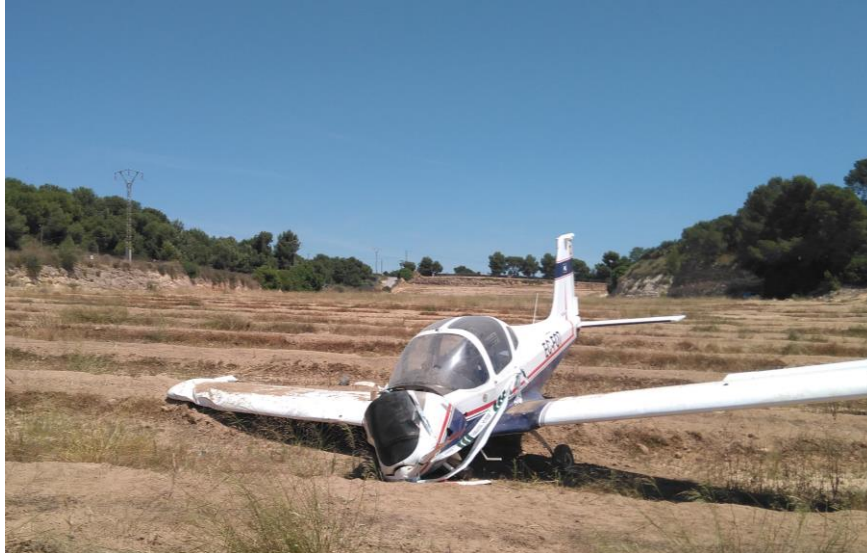
As a result of the accident, the aircraft sustained significant damage to its landing gear, propeller, forward fuselage and engine.

Figure 5: Aircraft after the accident.

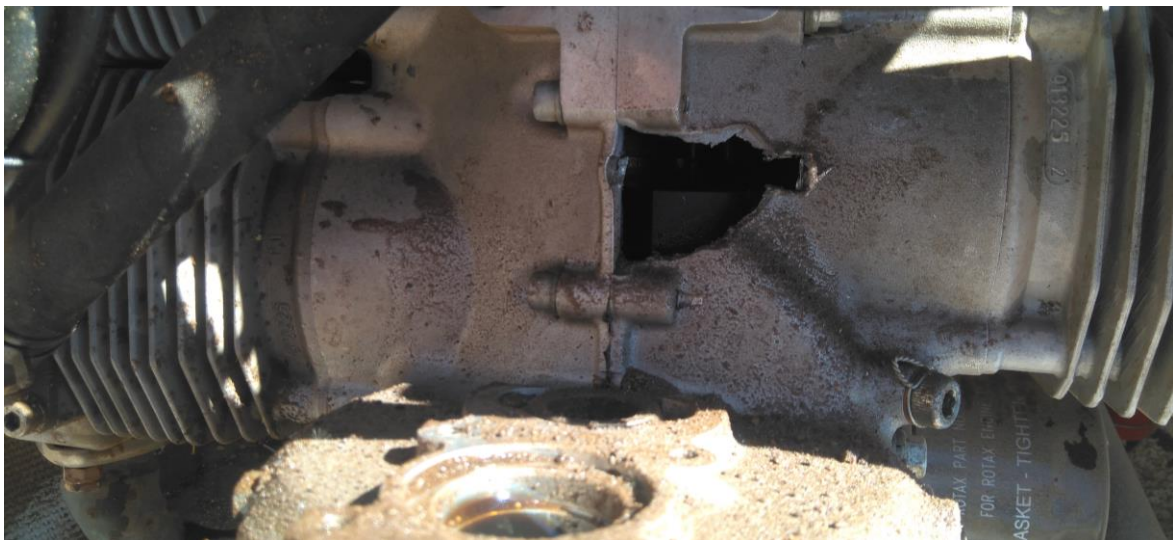
- The oil tank was empty.
- The lubrication lines were in good condition, with no leaks, and securely fixed in position. On cutting one of the pipes to free the engine, oil came out of it.
- The engine was covered with oil.

- The coolant tank was full, as was the radiator. The coolant fluid appeared as expected.
- The aircraft's tanks contained fuel.
- There was fuel in the carburettor float chambers.
- There was a hole in the crankcase.
- Cracks were observed in the nose leg and right landing gear leg, the propeller, the forward part of the fuselage, the engine mount and various engine components.

Figure 6: Damage observed at the accident site.

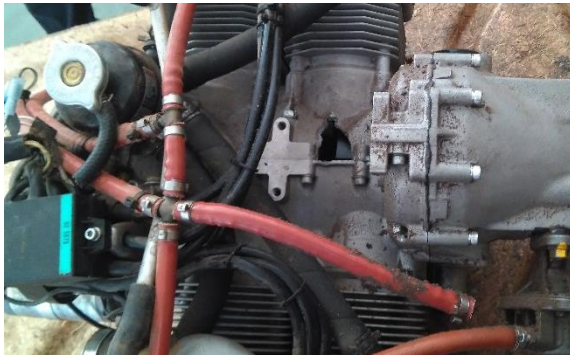
Figure 7: Close-up of crankcase rupture (1).

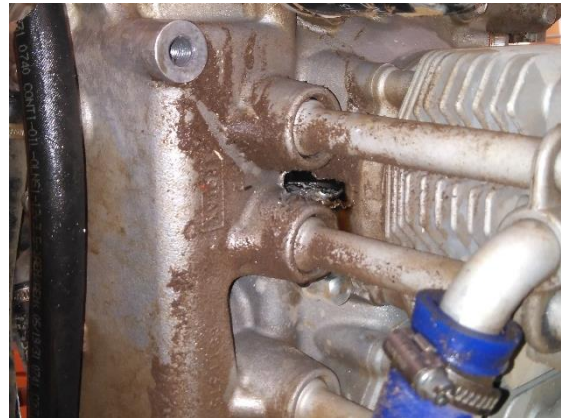
Figure 8: Close-up of crankcase rupture (2).

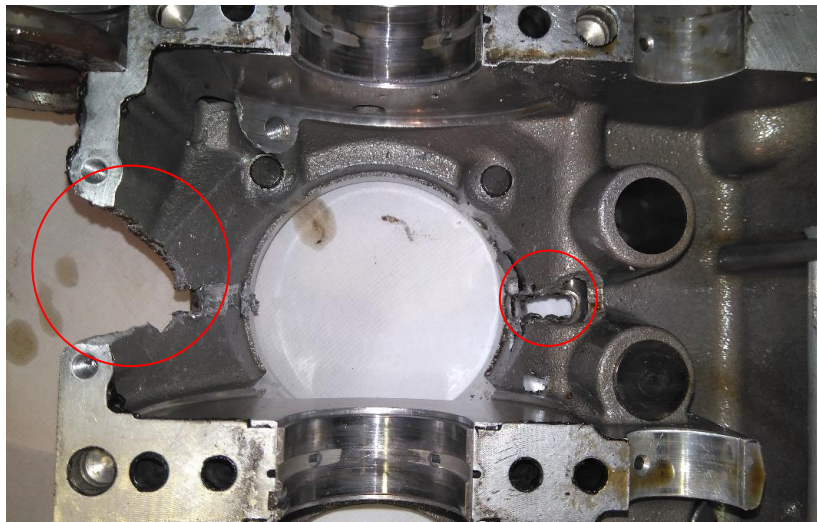
Figure 9: Close-up of crankcase rupture (3).

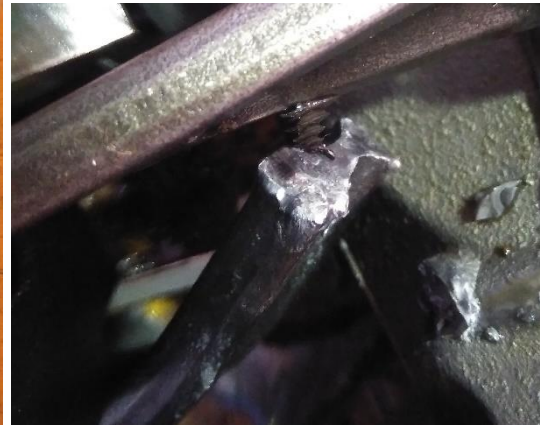
- On opening the crankcase, it was noted that the connecting rod of cylinder #2 was broken off at the small end. In addition, it was twisted and interfering with the crankshaft. The connecting rod of cylinder #1 was also twisted around its axis.

Figure 11: Close-up of connecting rod rupture (body end).

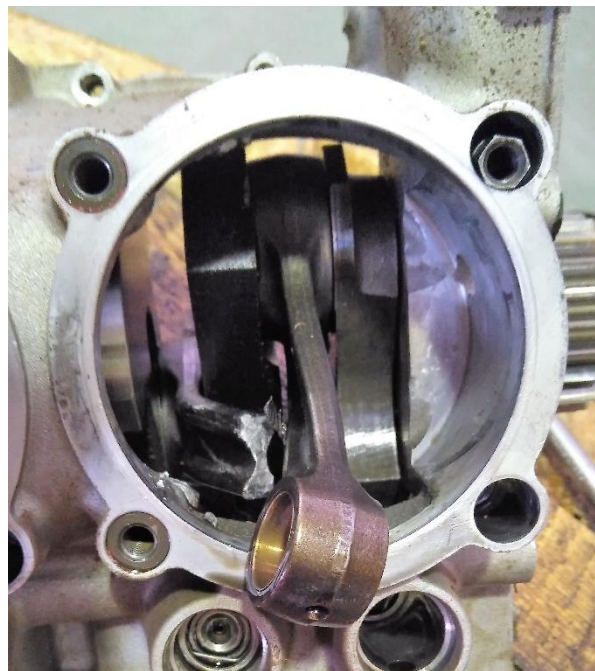
Figure 12: Close-up of connecting rod #1 and the interference of connecting rod #2 with the crankshaft.

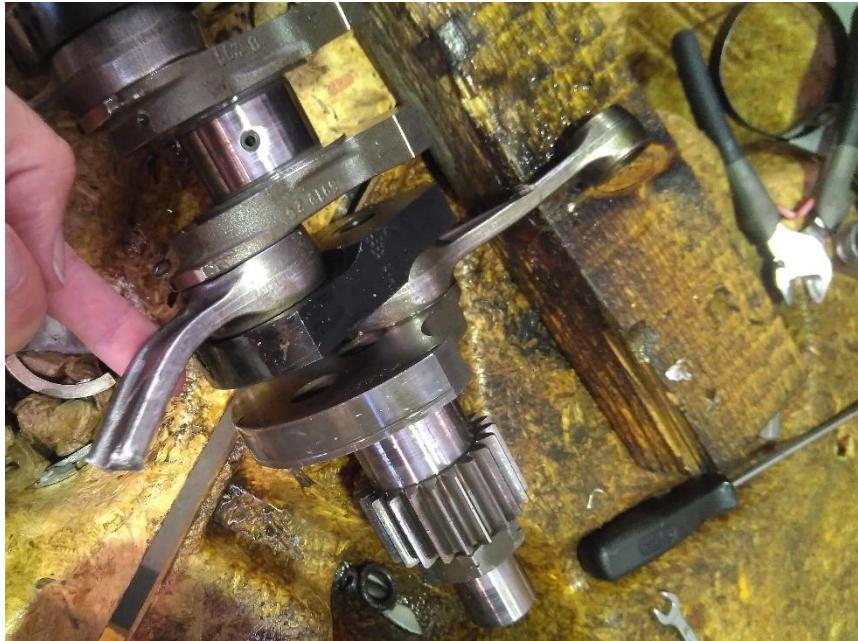
Figure 13: Connecting rod rupture (overview).

After 25 hours of flight following this general overhaul, connecting rod #2 of the connecting rod-crankshaft assembly with S/N 22133 failed. This then led to a further chain of internal failures and deformations which caused the connecting rod-crankshaft assembly to jam and, therefore, the engine to cut out.

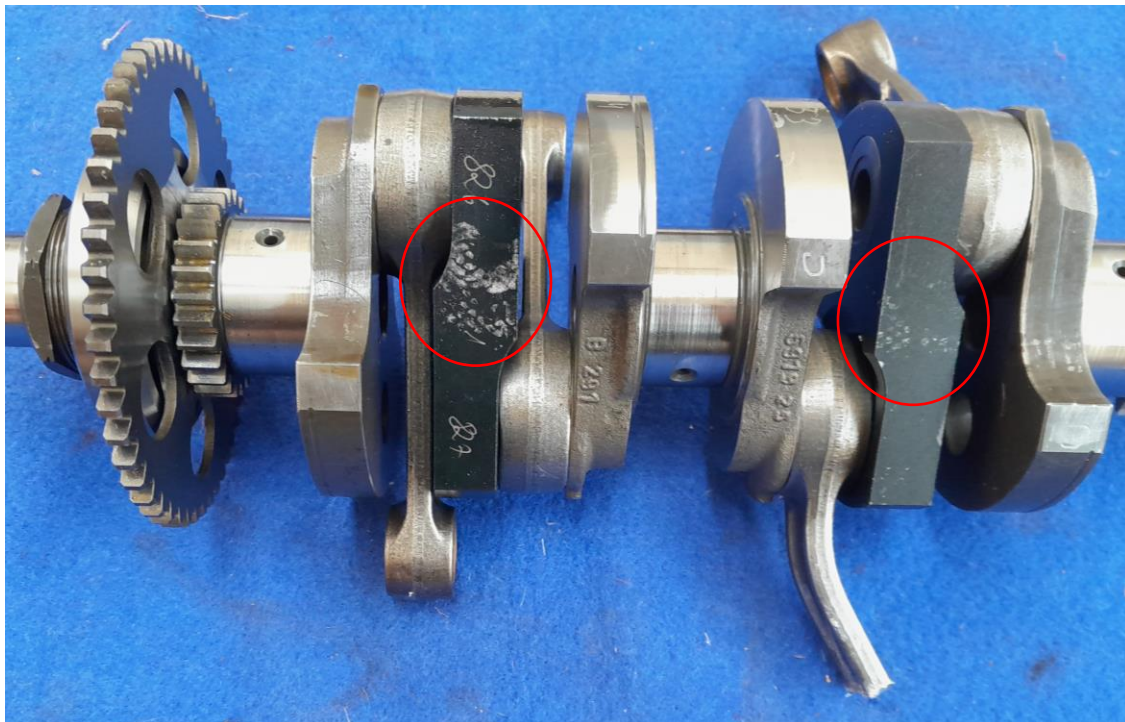
- There were clamp imprints on the crankshaft:

Figure 14: Close-up of the crankshaft.

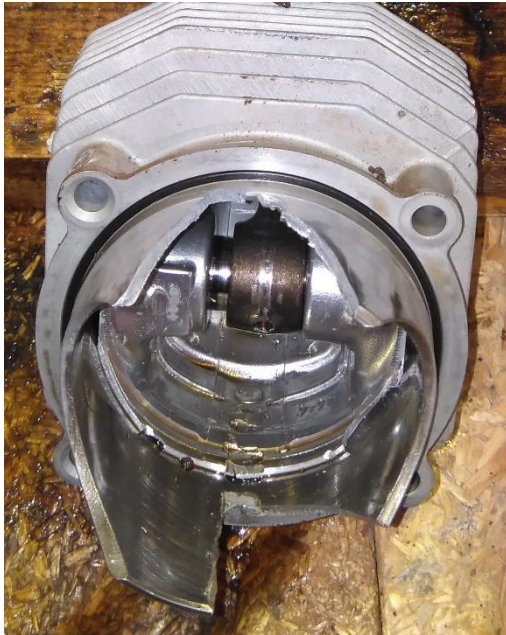
- Several breakages were noted on the lower part of the cylinder on cylinders #1 and #2 and the skirt on pistons #1 and #2:

Figure 15: Close-up of breakages on cylinder sleeve and piston #2.

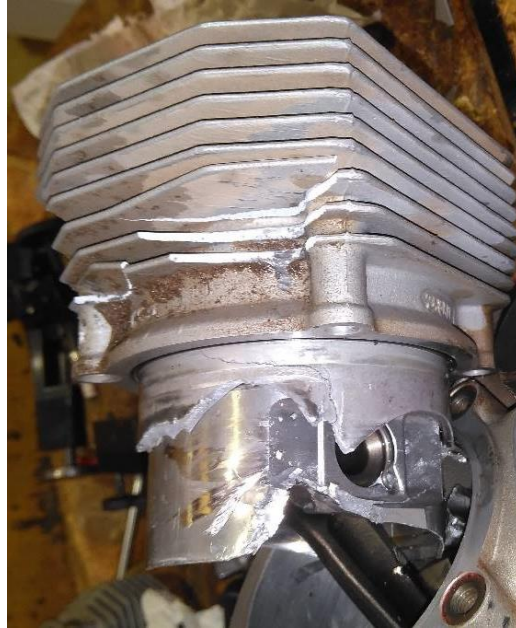
Figure 16: Close-up of breakages on cylinder sleeve and piston #1.
