ULM A-016/2022

TECHNICAL REPORT

Accident involving an ICP SAVANNAH VG 912 homebuilt ULM aircraft, registration EC- XTX, on 11 June 2022 at Villanueva de la Cañada Aerodrome, in the municipality of Villanueva de la Cañada (Madrid – Spain).

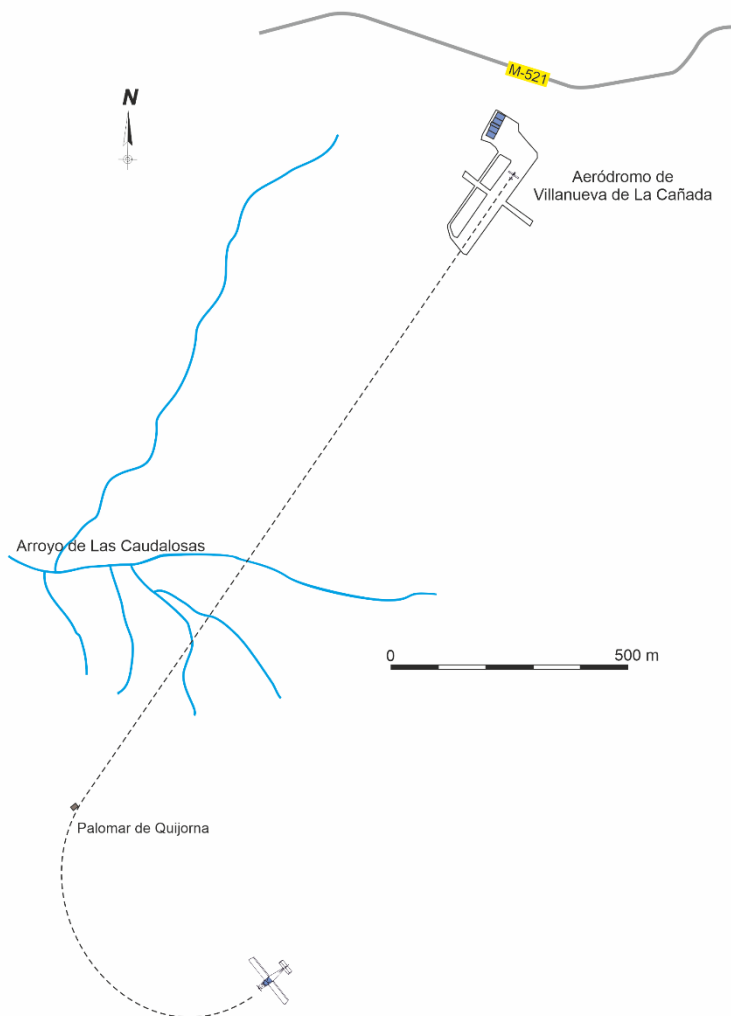
Figure 1.- The aircraft's trajectory.

Figure 1 shows the path of the aircraft, based on the information provided by the pilot and the final position of the aircraft.

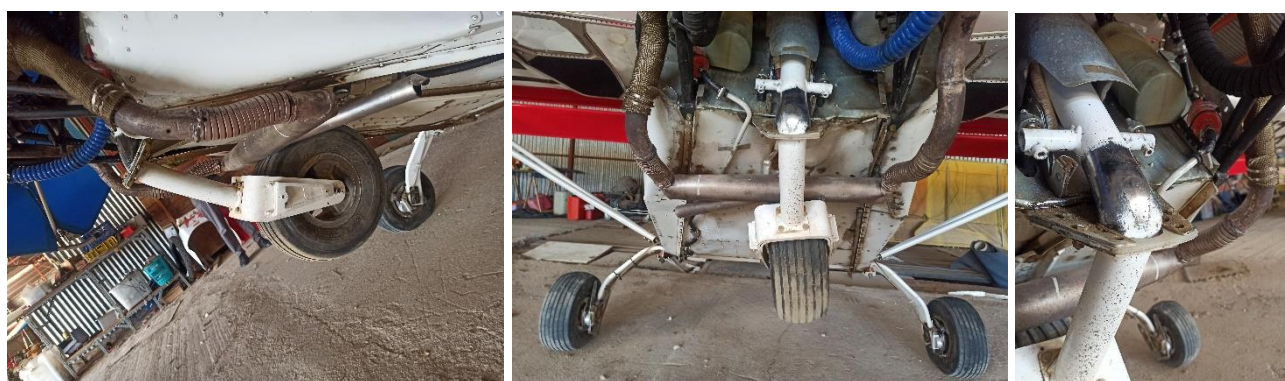
- Rearward collapse of the nose landing gear, with the wheel resting on the underside of the fuselage.
- Breakages and deformations in the lower engine cowling due to impact and dragging.

Figure 4.- Close-up of the buckled forward undercarriage

Once it was airborne again, the pilot could not regain adequate control of the aircraft, and it fell back to the ground in a nose-down attitude, initially contacting its nose gear, which collapsed.
