Technical report

ULM A-019/2022

Accident on 12 July 2022, involving a TECNAM P-92-ECHO-S, registration EC-DG4, at Bétera (Valencia, Spain)

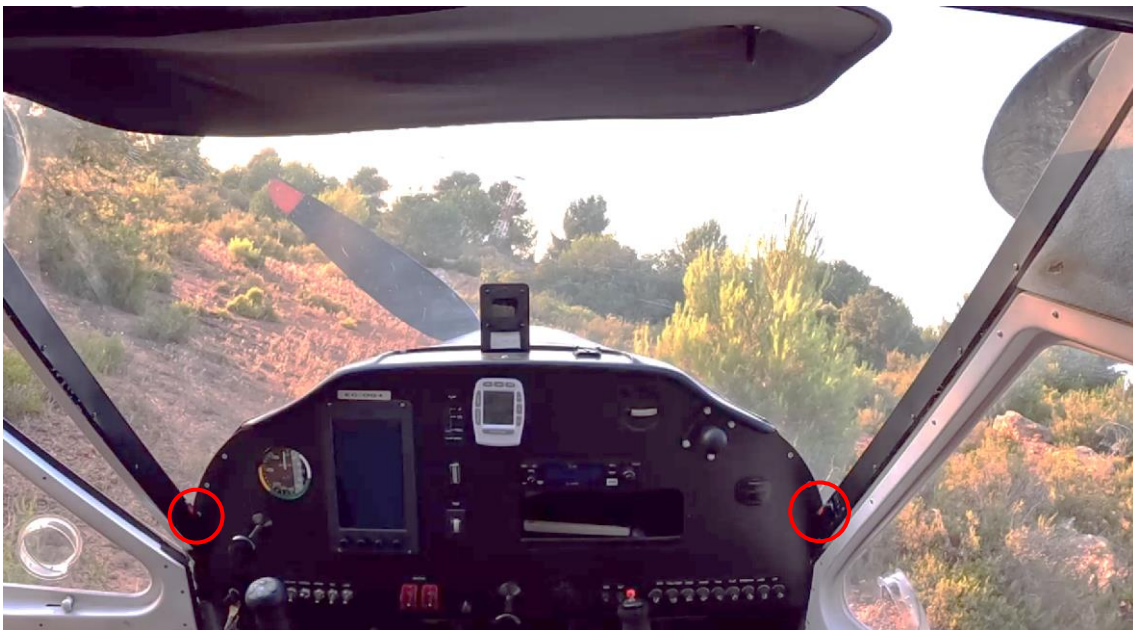
FIG. 1 POSITION OF FUEL VALVES AFTER THE ACCIDENT

Each tank has an independent valve on the side of the cabin frame that cuts off the fuel flow to the rest of the system. The following figure shows the position of the valves (both in the open position) after the accident.

On Tuesday, 12 July 2022, when aircraft EC-DG4 was flying eastbound towards the coast while conducting tank compensation with the right tank fuel valve open and the left tank fuel valve closed, the pilot closed the right tank valve, preventing fuel from reaching the engine and failing to check to see how this action affected the fuel pressure.

REC 03/24. It is recommended that the owner revert the modification to the fuel valve to return it to its initial certified configuration.

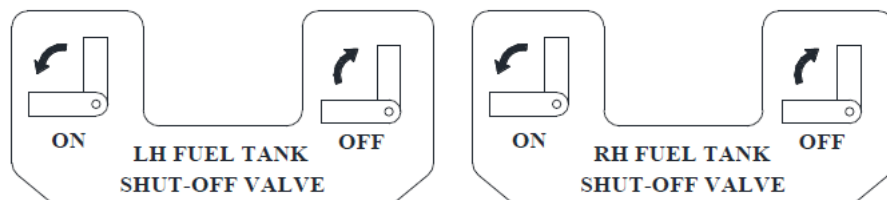
FIG. 2 VALVE POSITION INDICATION MARKING

The fuel valves had ON/OFF markings to indicate their position for the left valve (LH) and for the right valve (RH):

When the valve lever is aligned with the frame of the cabin structure, the valve is open. If the lever is rotated 90° with respect to the frame, the valve is closed.

Both bulletins indicate to replace the placard showing the position of the fuel valve with a new one. These placards must be installed on the next 50 FH⁹ of the aircraft or at the next inspection.

REC 04/24. AESA is recommended to consider the issuance of an airworthiness directive to make mandatory the service bulletin SB 090 - UL dated June 8, 2022 issued by TECNAM.

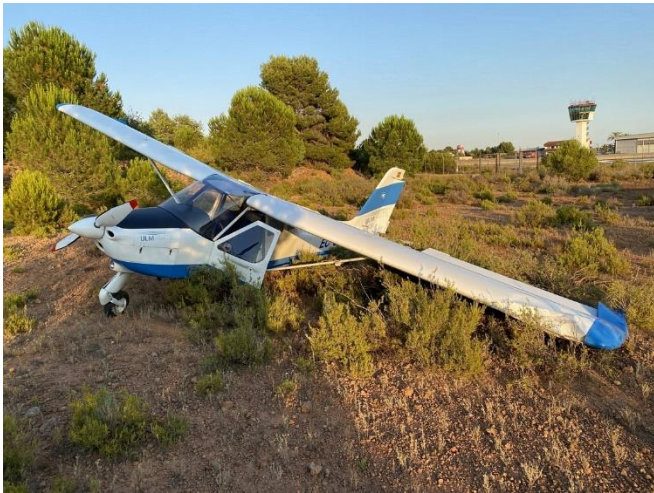
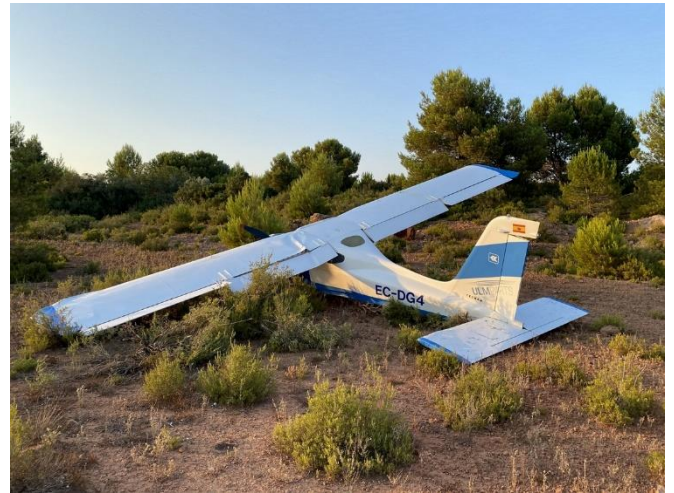
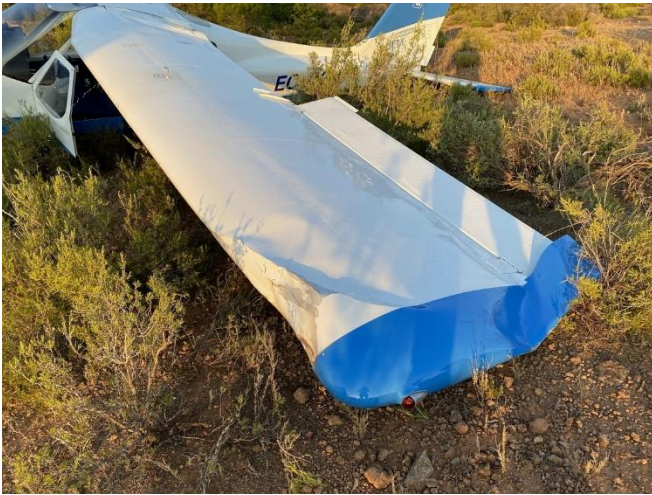
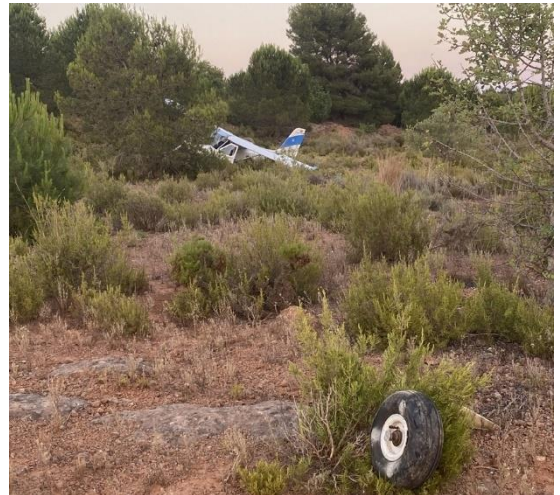
FIG. 3 CONDITION OF THE AIRCRAFT AFTER THE ACCIDENT

The aircraft sustained significant damage to its landing gear, left wing, elevator and fuselage.

The following images were provided to the investigation. They show the aircraft with its left wing resting on the ground. The nose of the aircraft was facing north, perpendicular to the runway centreline.

The detached left main gear leg can be seen. There was drag damage to the tip of the left wing and the lower part of the fuselage. The elevator was detached from its mounting point to the fuselage.

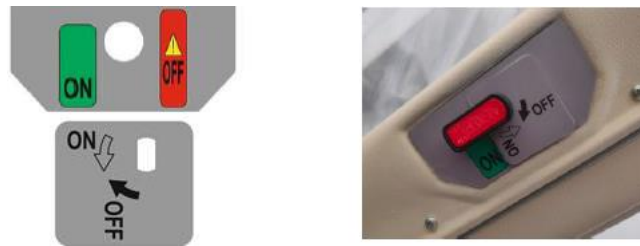
FIG. 5 NEW FUEL VALVE PLACARD

The aircraft flight manual in its edition 3, revision 2 of August 11, 2022 incorporated the new rotary placard to show the valve position:
