Report ULM-A-010/2018

Accident involving a PIPISTREL VIRUS
SW 100 aircraft, registration 55SE, at
the airport of La Seu d'Urgell (Lleida -
Spain) on 16 May 2018

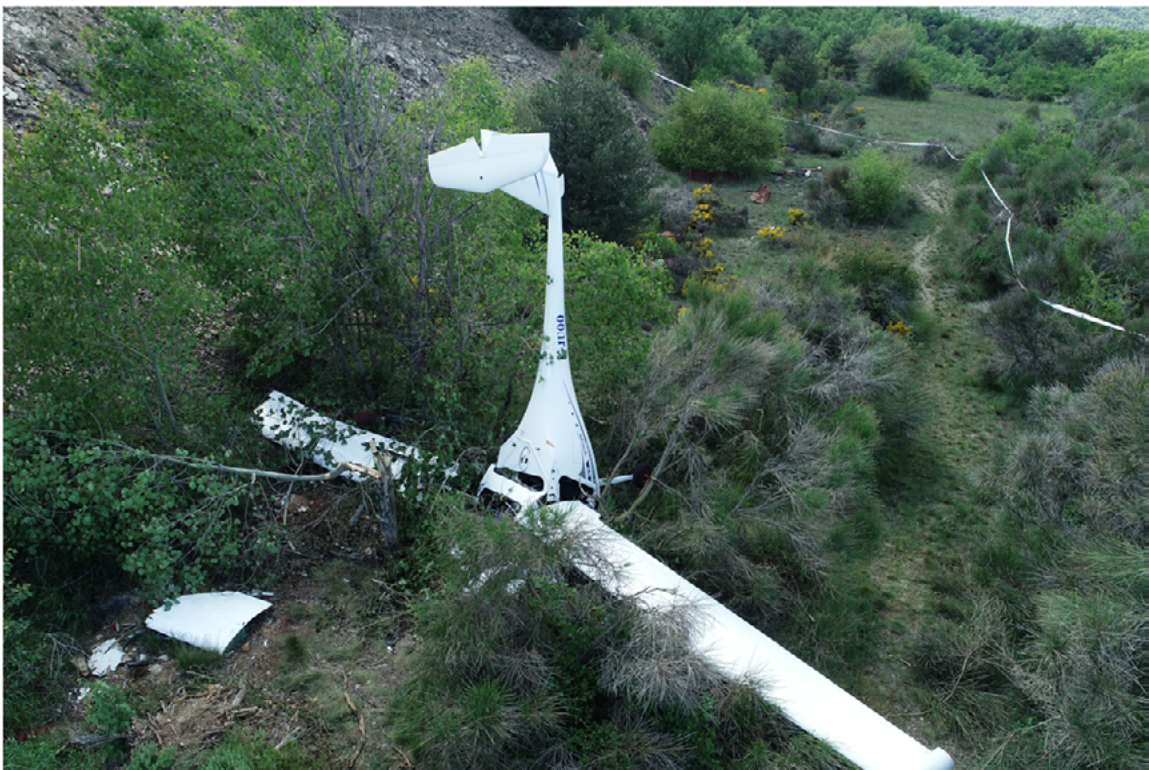
Figure 1. Photograph of the aircraft

The aircraft was destroyed, ending up in a vertical position. The front end, cockpit and right wing were severely damaged.

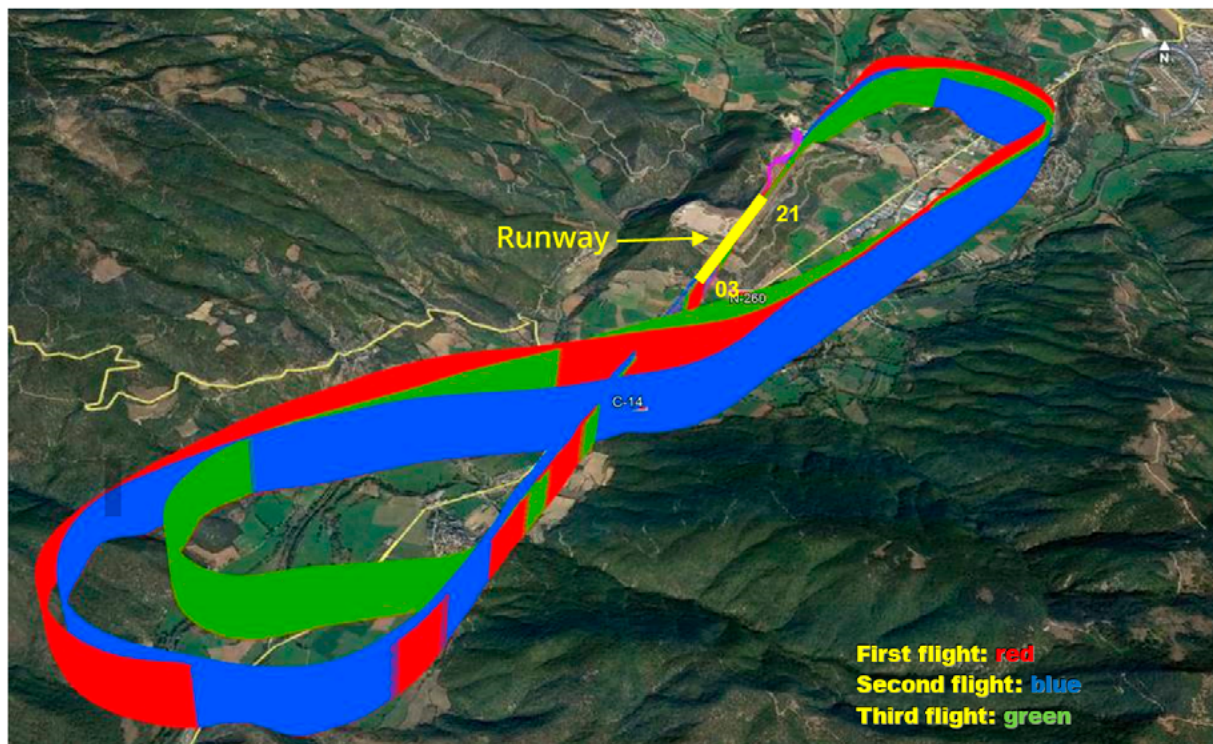
Figure 6. Flights around the aerodrome

In all three cases, after taking off, he turned right (to the east of the runway) and entered the downwind leg, as if flying the standard aerodrome pattern; however, instead of flying the base and final legs of the pattern, which would have required making two consecutive 90°-right turns, he crossed the extended centerline of runway 21 and flew outbound to the southwest before making a very wide 180° left turn and completing the flight by making a long final approach to runway 03 (see Figure 6).

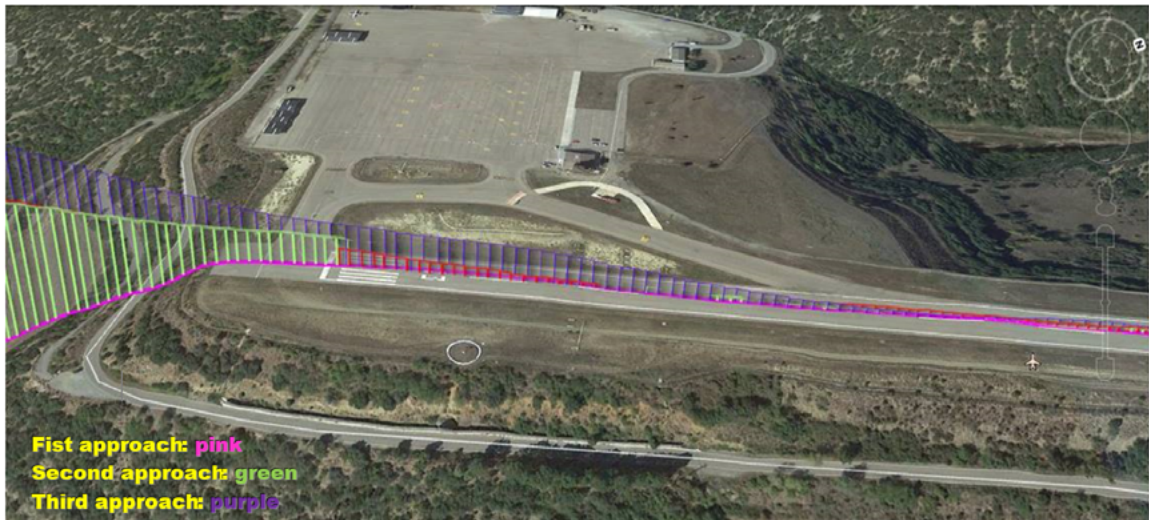
Figure 7. Side view of the three approaches to runway 03

The gradient on the third approach was steeper. Figure 7 shows the first approach in pink, the second approach in green and the third in purple, with each one being steeper than the last.

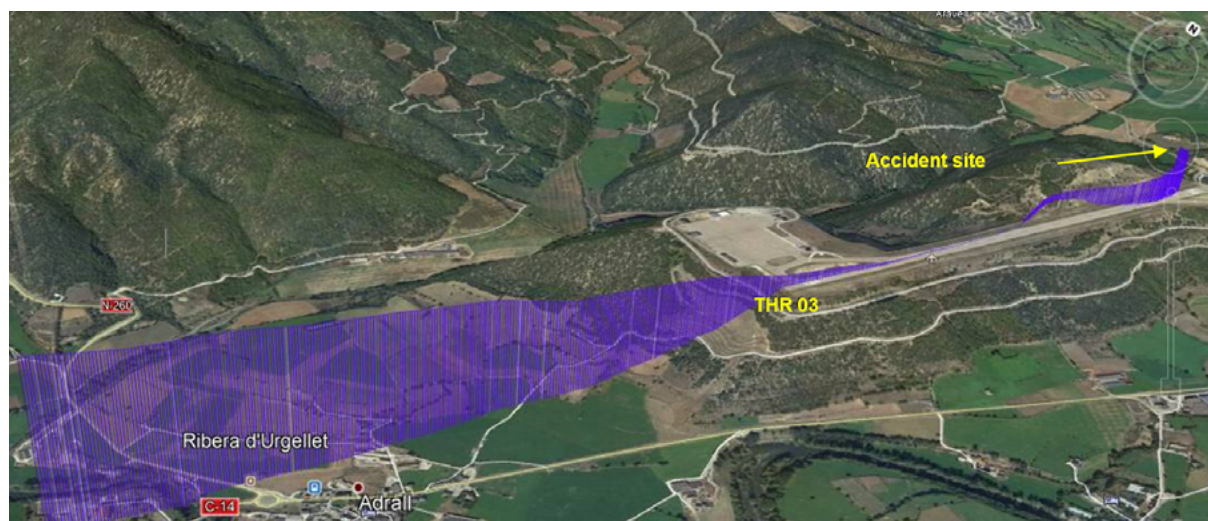
Figure 8. Third approach and fourth takeoff

After the third approach, on the same run the pilot started the fourth takeoff, during which the aircraft veered 20° to the left for 6 s, banking left and heading for a hill that is on the left side about halfway down the runway, inside the aerodrome complex. It then banked right for 13 s, flying back over the runway and then veering 20° to the right. It finally turned left again for 8 s before crashing to the ground.

In the final seconds of the flight, the pitch angle recorded was around 24° (24.9° at 10:43:38). Also recorded were high left and right bank angles and, in the final 3 s, a high dive angle (up to 61°).

The final coordinates place the aircraft practically over the impact point. The data recording stopped at 10:43:44. The last data set showed a balance angle of 15° and an IAS of 42 kt.

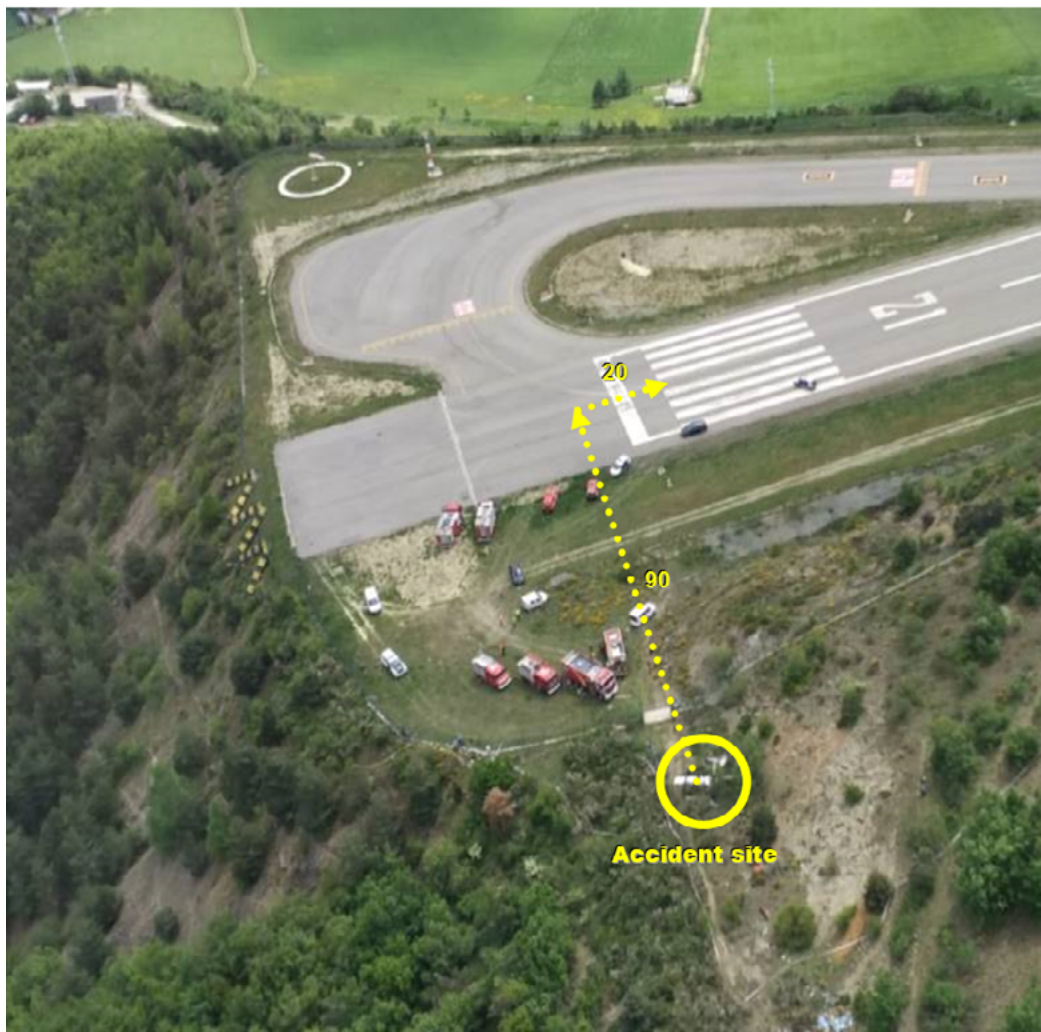
Figure 9. Aerial view of accident site

The aircraft ended up west of the runway, outside the aerodrome, 15 m away from the perimeter fence, with its longitudinal axis facing 125° true. It was 90 m away from the runway centerline as measured perpendicularly, and 20 m ahead of the runway 21 threshold, measured along the centerline; specifically, the wreckage was at coordinates 42° 21' 47" N – 3° 36' 49" W.

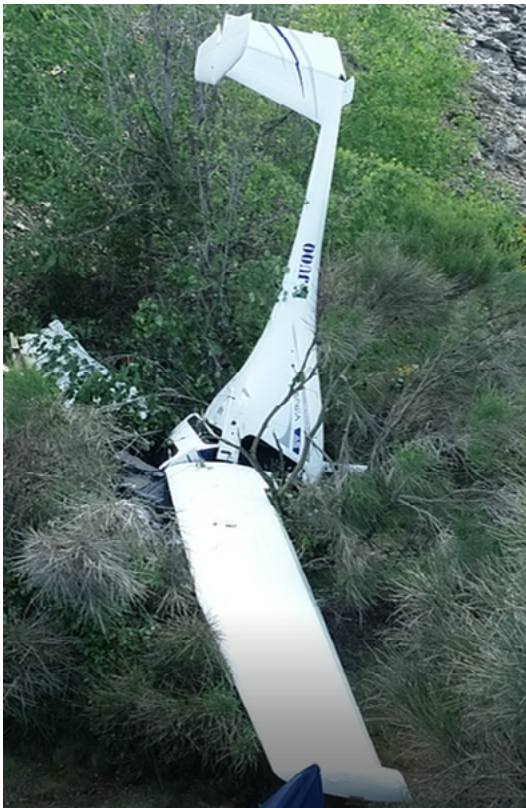
Figure 10. Condition of aircraft

The front of the aircraft had impacted the ground, and specifically, against the base of a tree, remaining in a vertical position.

The engine and cockpit compartments were the areas most affected by the crash and sustained heavy damage.

The front landing gear wheel was lodged underneath the engine.

The throttle lever was identifiable in the cockpit, though its exact position could not be determined due to the post-impact deformation. There was no continuity between the lever itself and the control cable that ran to the motor.

The propeller blade pitch control was in the forward position and the throttle control for cold start was activated.

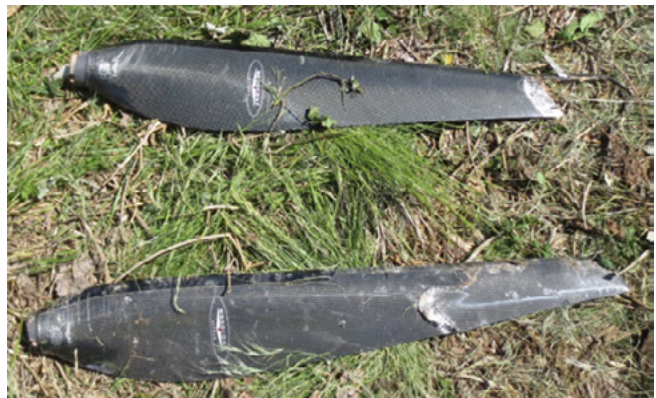
Figure 11. Propeller blades

The two propeller blades had detached from the hub, but were practically in one piece (see Figure 11).

- It impacted the base of a tree, falling from a low altitude in a vertical position.
- There was no fire.
- The occupants were killed on impact.
- An analysis of both the engine and the condition of the propeller blades showed that the engine had stopped by the time the aircraft reached the ground, and that it had been at idle in the final moments of the flight.
