Report ULM A-016/2018

Accident involving an ELA-07-R-115
powered ultralight, registration
EC-EZ1, in Camarenilla (Toledo, Spain)
on 8 August 2018

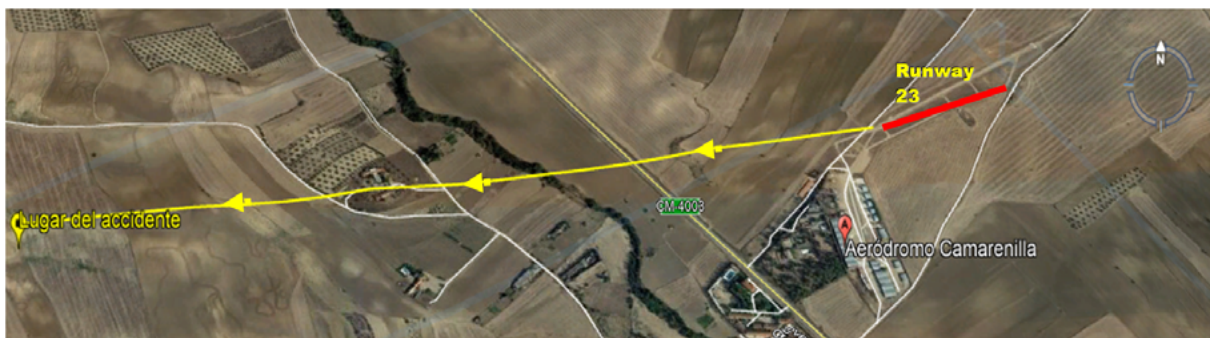
Figure 1. Aircraft path

The aircraft crashed approximately 1.6 km away from the aerodrome, along the extension of the runway centerline, and caught fire after impacting the terrain.

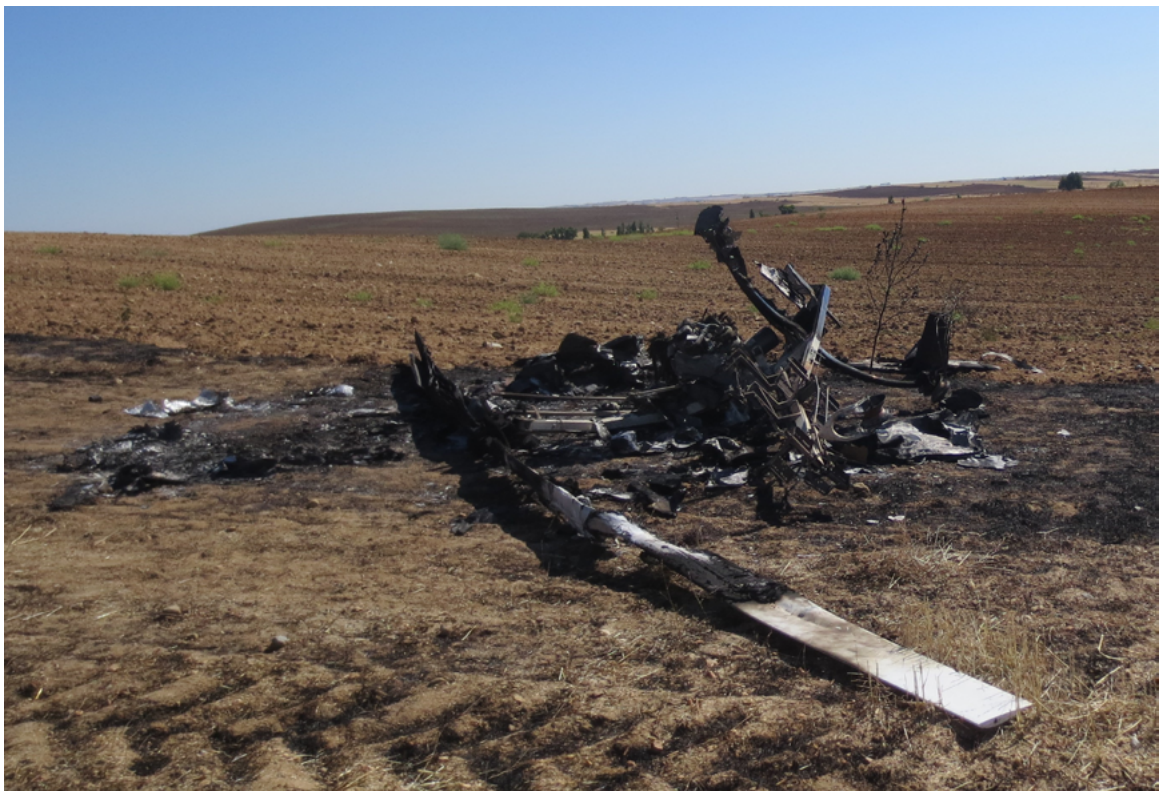
Figure 5. Status of the autogyro at the accident site

The wreckage was in a crop field divided into two slopes by a strip of land.

The autogyro was on its right side, with its longitudinal axis facing 200°. The main rotor was facing the high part of the field.

Behind the tail of the autogyro was the strip that separated the two slopes of the field.

The main wreckage had been moved down the slope, perpendicular to its longitudinal axis, some 2 m by emergency services in order to recover the pilot's body.

The marks left by the propeller indicate that the aircraft also moved simultaneously along its longitudinal axis.

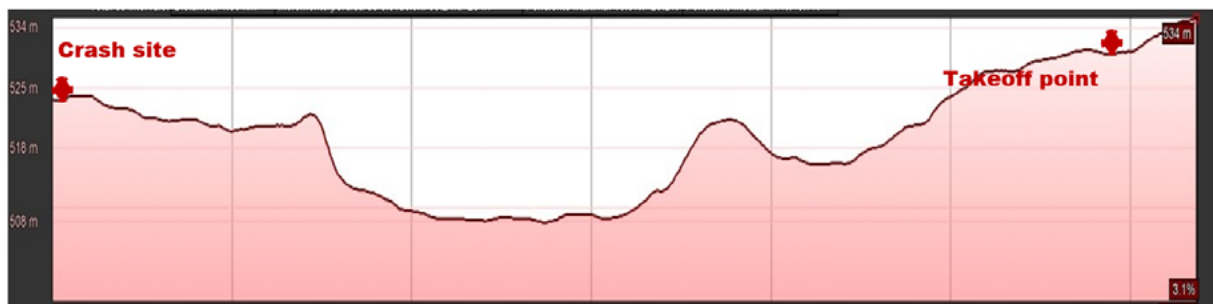
Figure 6. Profile of the terrain throughout the flight

The aircraft traveled a distance of 1,590 m along a ground elevation profile that was descending from the aerodrome to the accident site at an average gradient of 3.7%, with the aircraft impacting a point that was 14 m below the elevation of runway 23.
