**COMISIÓN DE  
INVESTIGACIÓN  
DE ACCIDENTES  
E INCIDENTES DE  
AVIACIÓN CIVIL**

## **Report ULM A-001/2019**

Accident on the 18th of January 2019, involving an ALPI PIONEER 300 aircraft, registration I-9318, in the municipality of Usagre (Badajoz)

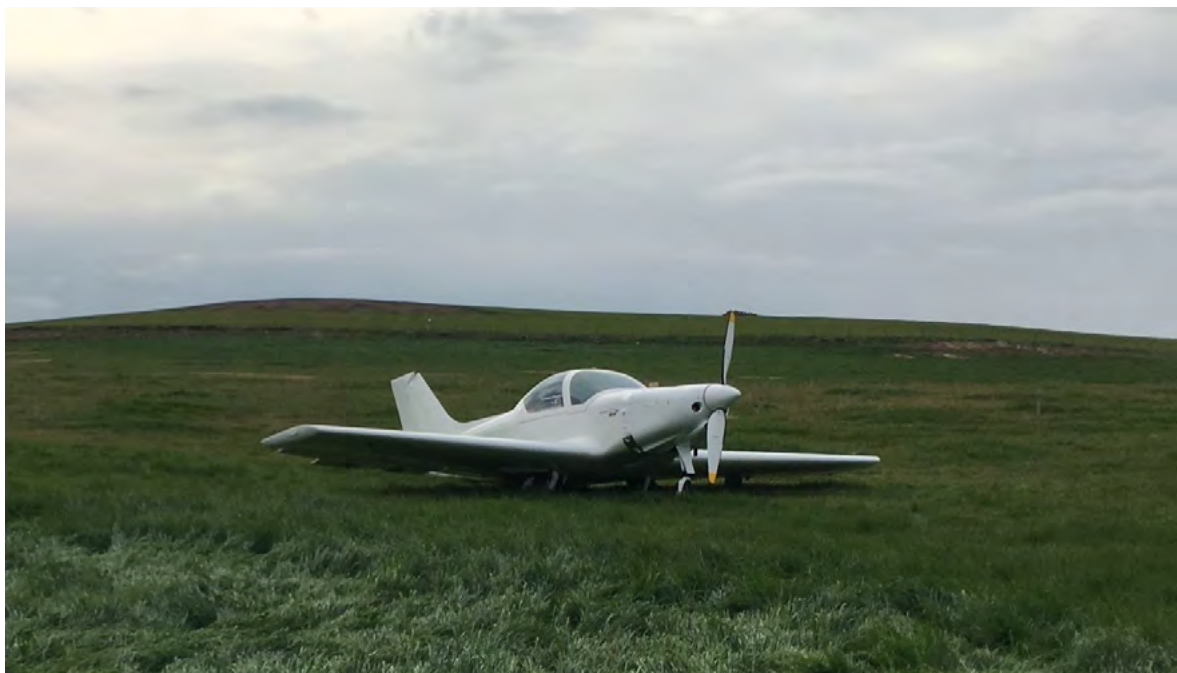
Photograph 1. Aircraft at the accident site

The analysis of the aircraft's position at the accident site shows the touchdown was controlled, with level flight until ground contact, and delaying the nose landing gear's final ground contact, as evidenced by its undamaged condition after the accident. The main landing gear may have been deformed as a result of miscalculating the aircraft's height above the grass, as it would have been difficult to judge its length and any unevenness in the terrain accurately.

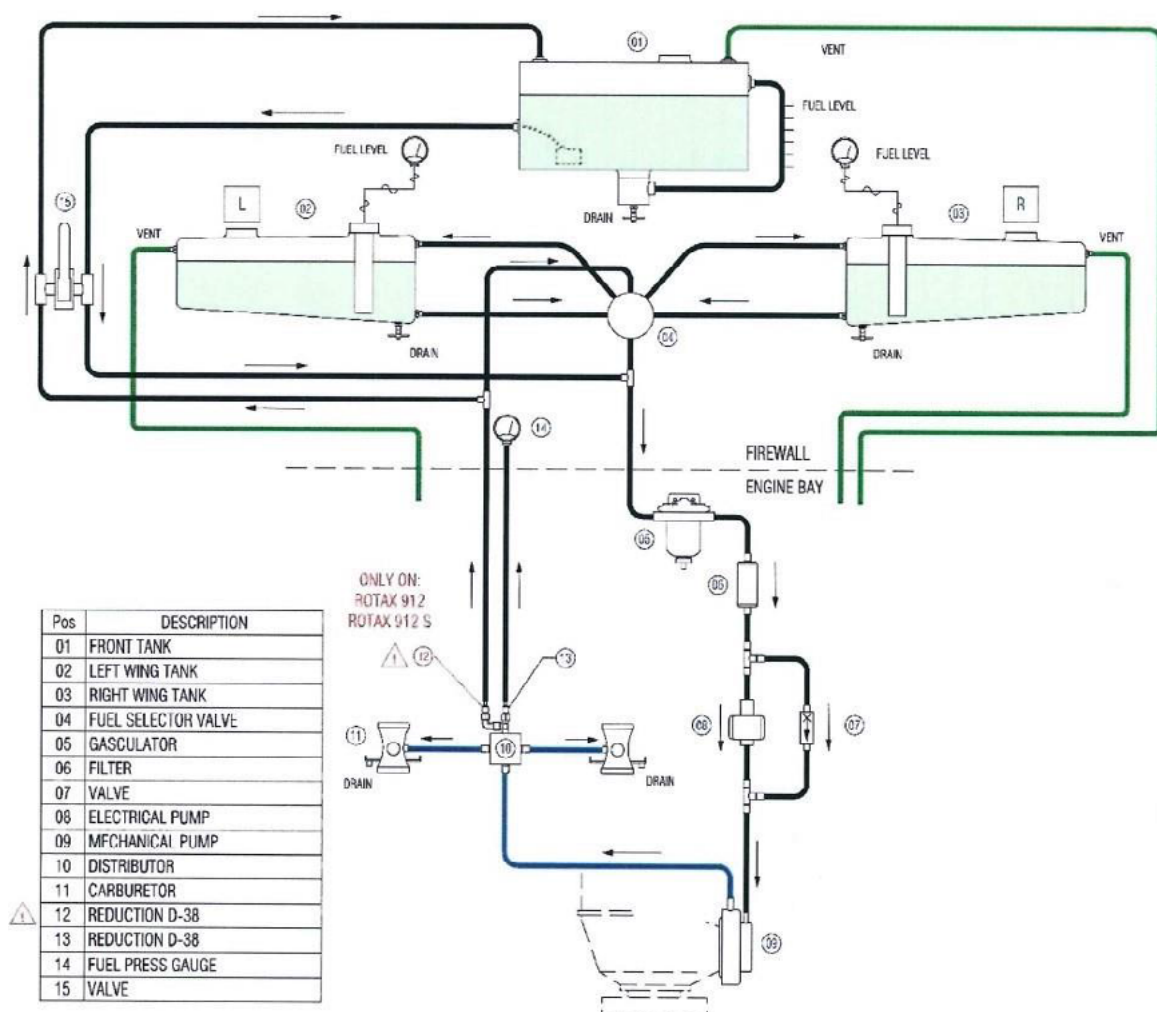
Figura 1. Esquema del sistema de combustible

A selector valve allows the fuel supply from one of the selected wing tanks, and another valve from the central tank (see Figure 1).

The selection of one of the tanks implies the exclusion of the non-selected one.

If the selected tank is emptied, the engine will stop. Restarting it in flight requires selecting one of the other available tanks, switching on the secondary electric pump, and closing the empty tank selector.

The aircraft was found in the place of the accident with the central and left tanks empty, and about 25 liters of fuel were found in the right tank. The central tank fuel valve was found closed, and the fuel selector of the wing tanks was selected on the right one.

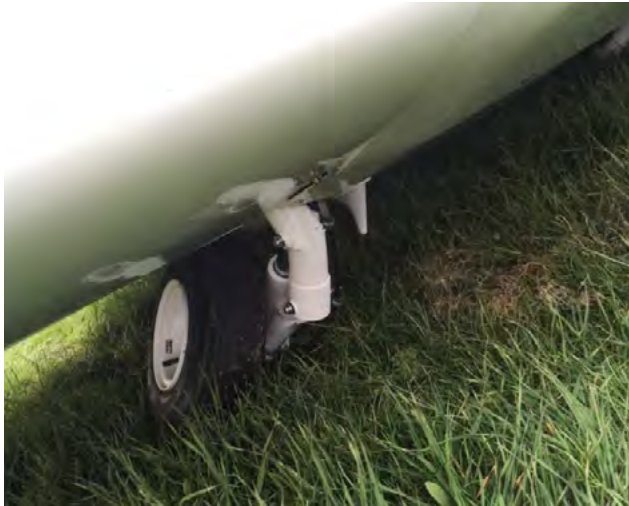
Photograph 3. Damage to the main landing gear

The only damage identified after the emergency landing was to the main landing gear, which was deformed and inoperative.

- The unevenness of the terrain and the thickness of the grass which made landing precision difficult and damaged the main landing gear.
- The possible lack of fuel produced by insufficient fuel tank management that may have caused the engine to stall.
