ULM A-005/2019

REPORT

Accident involving an ULM EVEKTOR EV-97 EUROSTAR SL aircraft, registration EC-LSP, on 24 February 2019 at La Nava-Corral de Ayllón Aerodrome, in the municipality of Corral de Ayllón (Segovia – Spain).

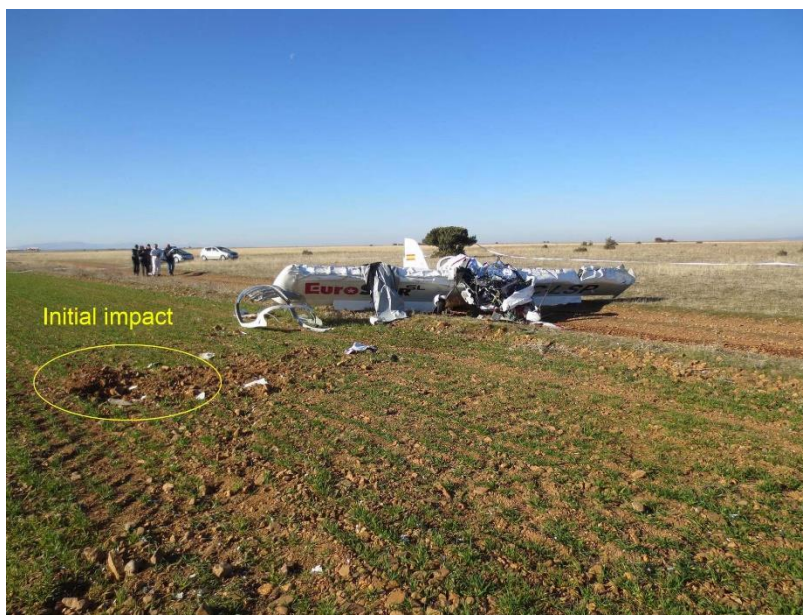
The aircraft wreckage was found on a road located inside La Nava Aerodrome, approximately 220 metres to the southeast of runway header 18 of runway 18/36, with an orientation of 032°.

Figure 3.- Views of the aircraft in its final position.

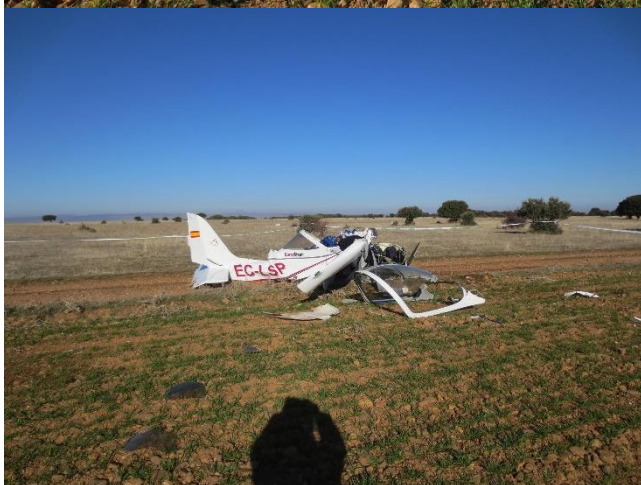
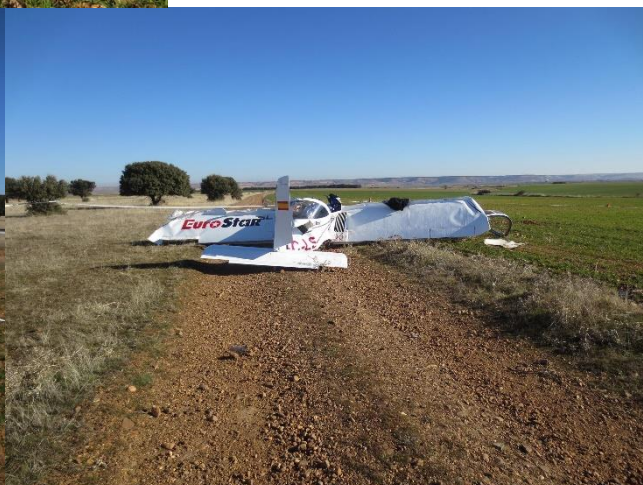
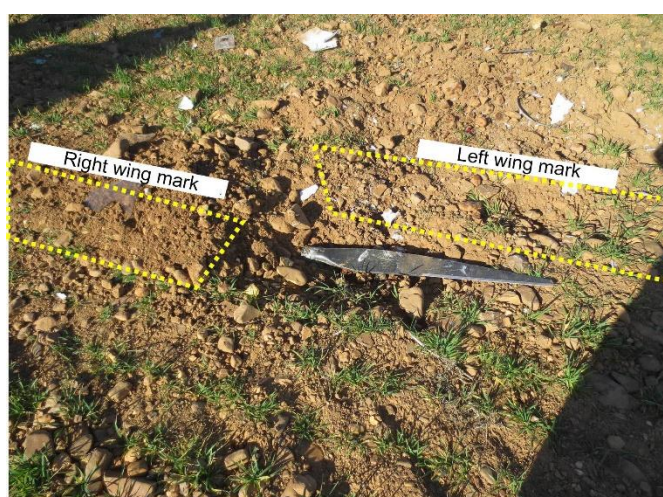
Figure 4.- Nose impact zone, with the remains of the propeller and the wing marks.

Off the road, 7.40 metres in front and to the right of the wreckage ⁽²⁾ and propeller hub, was a hole made by the nose of the aircraft when it first hit the ground. One of the three propeller blades was still in the hole (see figure 4).

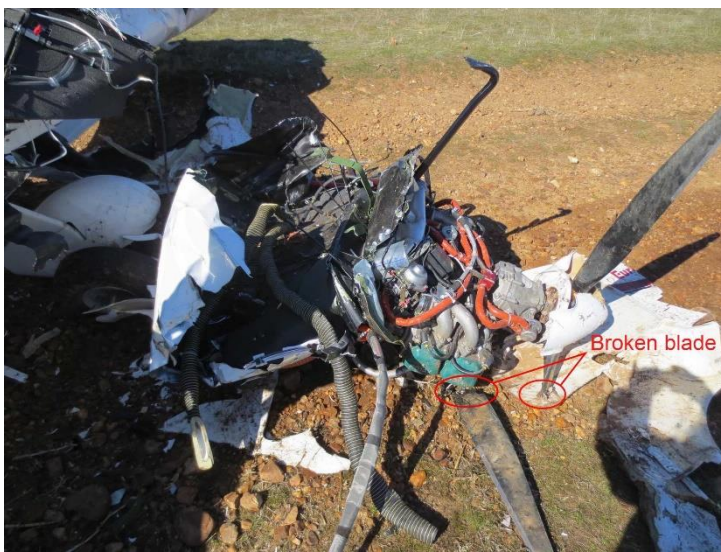
Figure 5.- Front of the aircraft. Propeller blades in the main wreckage.

In its final position, the propeller cone had suffered a significant impact on one side and was barely damaged on the other. Of the three propeller blades, one had separated from the propeller hub and remained in the hole made by the aircraft's nose during the initial impact. The other two were with the main wreckage, with one snapped close to its root and the other still in position. None of the propeller blades showed signs of damage caused by rotating against the ground.

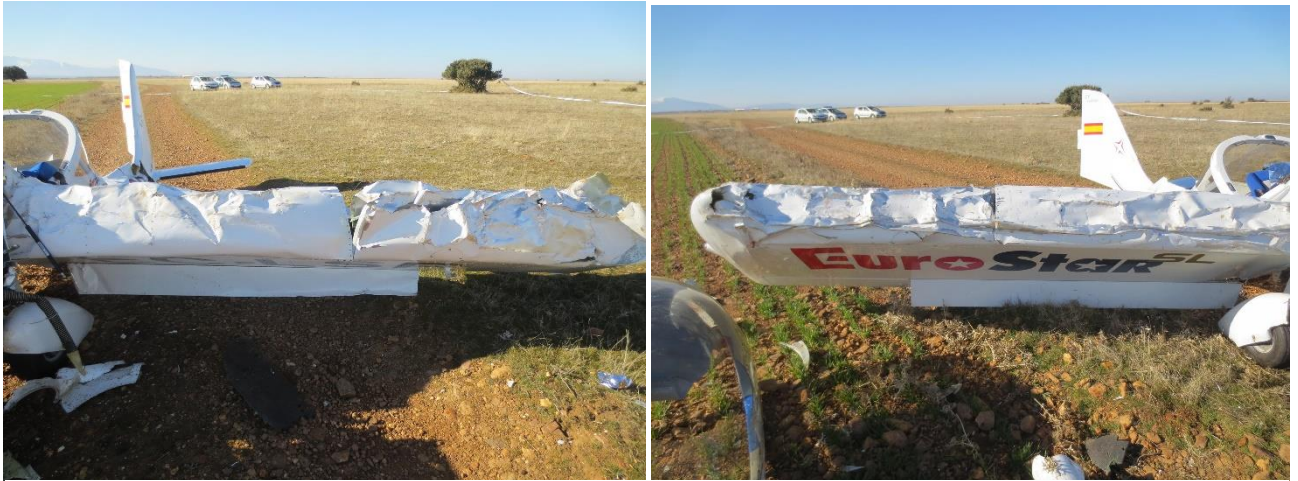
The left wing's leading edge was completely crushed and broken in several places, the most significant damage being near its tip. The right wing's leading edge was also crushed, with deformations typical of a frontal impact with the furrows on the cultivated land and had practically no cracks.

Figure 6.- Photographs of the leading edges of the two wings.

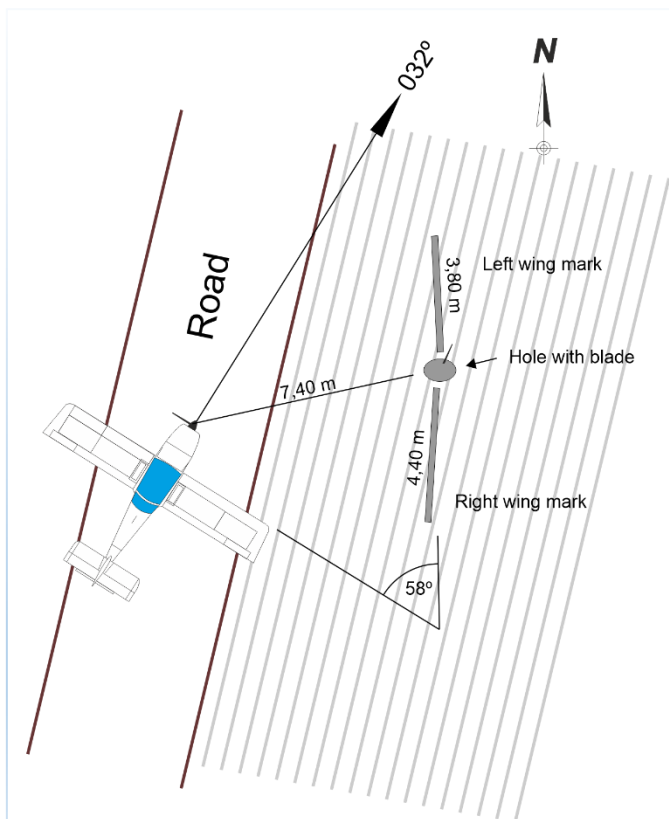
Figure 7 .- Sketch of the marks on the ground and the final position of the aircraft.

In summary, the wreckage showed breakages and deformations characteristic of having suffered a frontal impact with the ground, following an almost vertical trajectory, with slight yaw and roll attitudes to the left, and a small component of rotation to the left around the aircraft's longitudinal axis.

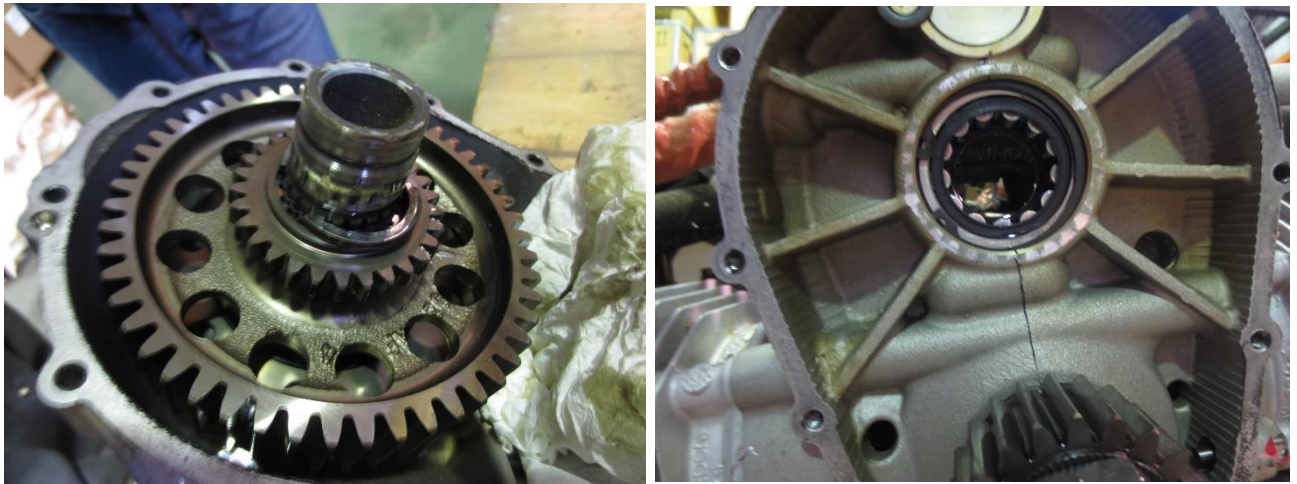
The gearbox had suffered a significant frontal impact, the propeller hub had been displaced (backwards) into the engine's crankcase, the four bolts that secure the hub bearing to the front gearbox case were broken, and the rear part of the case was cracked.

Figure 8(a).- Displaced propeller hub and cracked rear case.

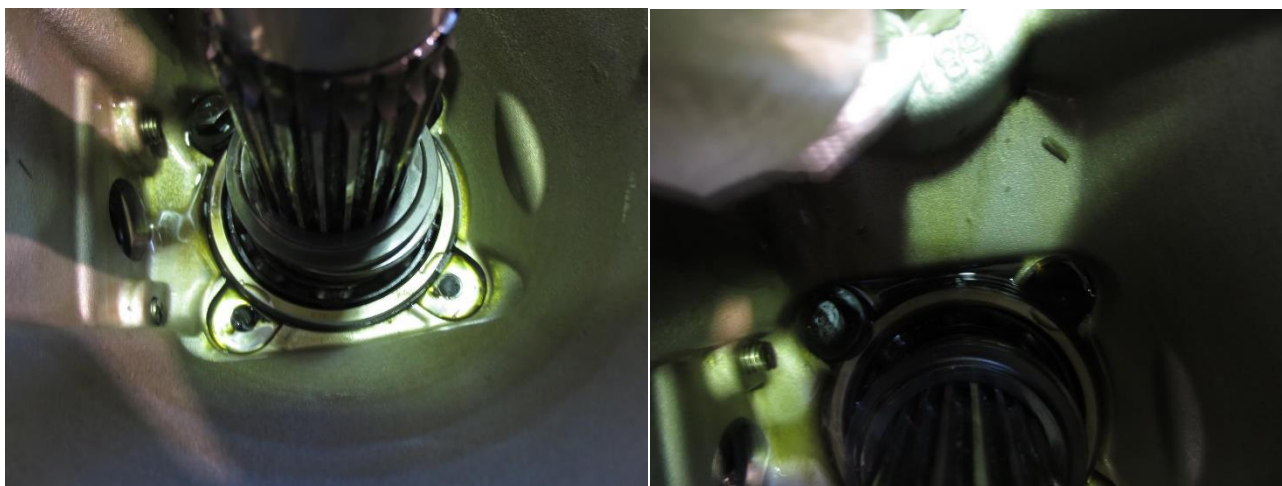
Figure 8(b).- Propeller hub. Broken bearing to case bolts.

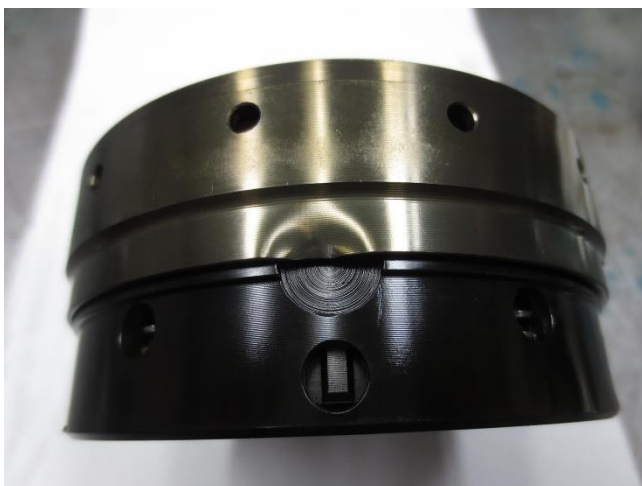
The overload clutch housing was displaced (rotated) away from its original position, as seen in figure 8(c). This would suggest the propeller stopped rotating almost instantly, with the engine turning and supplying power at the moment of impact.

Figure 8(c).- Displaced overload clutch housing.

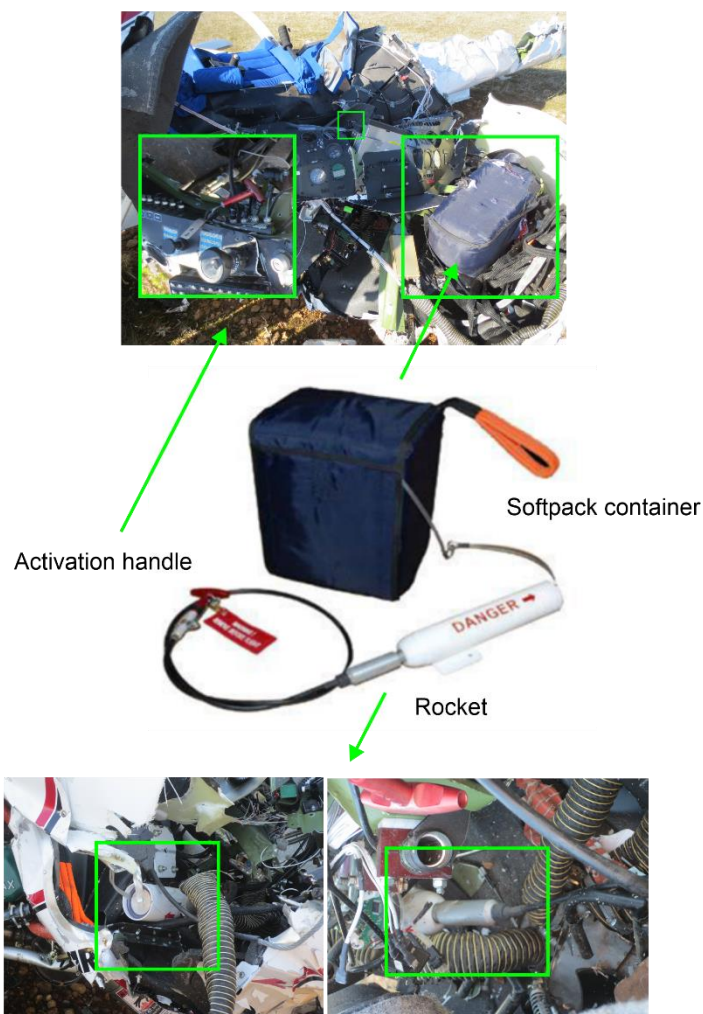
Figure 9 - Ballistic rescue parachute system components in the aircraft wreckage.

In regard to the components of the ballistic rescue parachute system, it was installed in the forward part of the aircraft and, as indicated in 1.16.1 and seen in figure 9, the parachute container was found on top of the engine wreckage, the pyrotechnic device had separated from its anchorage to the aircraft structure but had not been activated, and the system activation handle support was severed and hanging from the activation cable, making it impossible to secure the system with the locking pin.

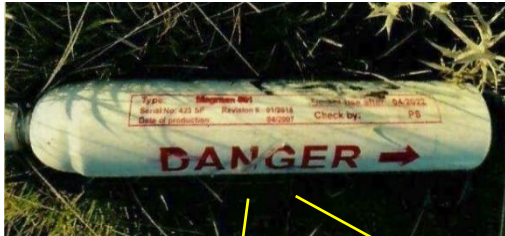
As the force of the aircraft's impact on the ground caused the parachute to detach from its support, the internal condition of the pyrotechnic device was unknown. Therefore, in the interest of safety, the decision was taken to destroy it.

Given the risk that the methods necessary to destroy it could set fire to the aircraft's fuel, making further investigations difficult, the specialists decided to remove the pyrotechnic device by safely cutting the steel cables connecting it to the aircraft. It was then transferred to a nearby location that met the necessary safety conditions and destroyed.

Figure 10.- Ballistic parachute rescue system pyrotechnic device, before and after disposal
