CIAIAC

Report ULM A-007/2020

Accident on the 21 June 2020,
involving a Tecnam P2002 SIERRA
aircraft, registration EC-FM8,
in the municipality of Aibar
(Navarra)

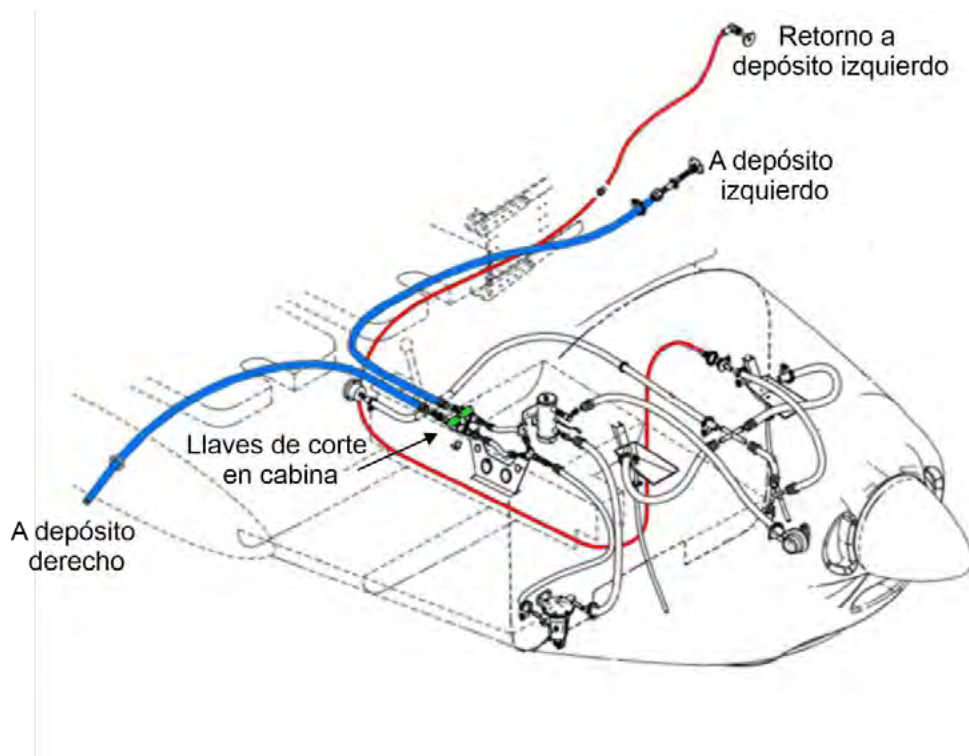
Fig. No. 1.- Diagram of the fuel system.

The fuel system diagram shows the supply pipes running from the two fuel tanks to the engine and a shut-off switch in the cabin, which is used to manage the differential fuel consumption of the two tanks.

It also shows the excess fuel return pipe, which carries excess fuel to the left tank.

Furthermore, the system's design returns the excess fuel pumped to the engine and not used back to the tank on the left wing only. This means that if the right tank is open, a part of its fuel is transferred to the left tank through the return system. Therefore, if the two tank valves are left open, the fuel is not consumed symmetrically, and the fuel level in the left tank may even increase.

In addition, leaving both fuel tank shut-off valves open without continuously monitoring the comparative levels between one tank and another could lead to a situation in which all the usable fuel in the right tank is consumed, and despite there still being fuel in the left tank due to the return system, the engine could absorb air from the right tank, thus impoverishing the mixture and causing it to cut out.

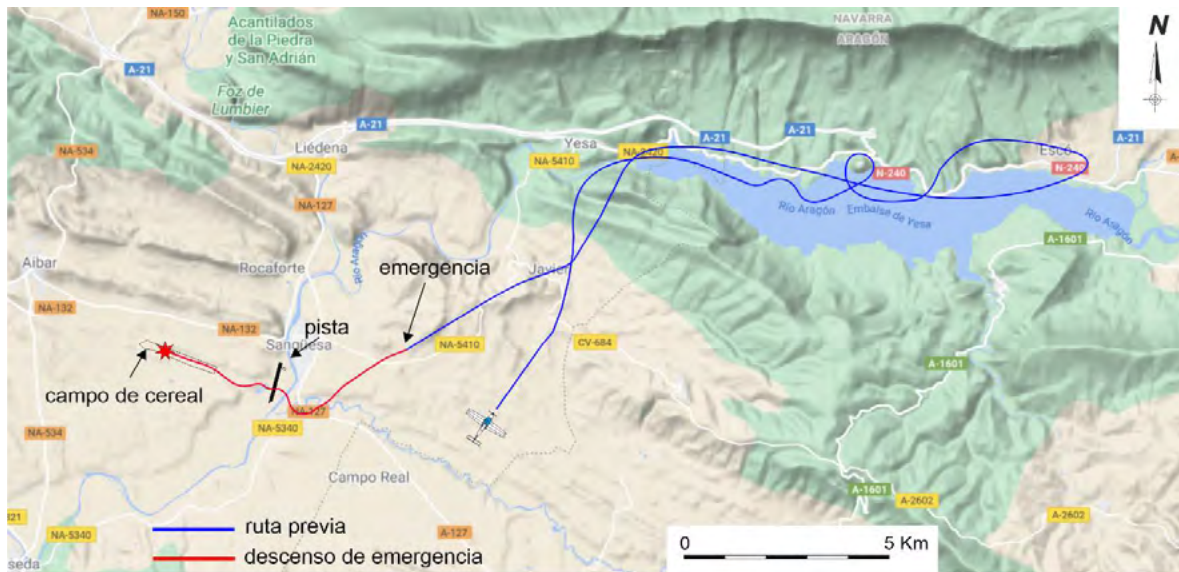
Fig. No. 2.- GPS trajectory.

The flight is first registered at the Tudela Aerodrome apron and then proceeds to ascend gradually during the first 70 km of the route. It then makes a steep descent toward the Yesa reservoir to fly over it and then begin the return to the Tudela airfield.

According to the data, when the aircraft was on the return leg, 108 km into the journey and at an altitude of 1115 m (3658.13 ft), it begins a continuous descent to the accident site and then remains there, at an elevation of 427 m (1401 ft). Thus, it travelled 114 km in total.

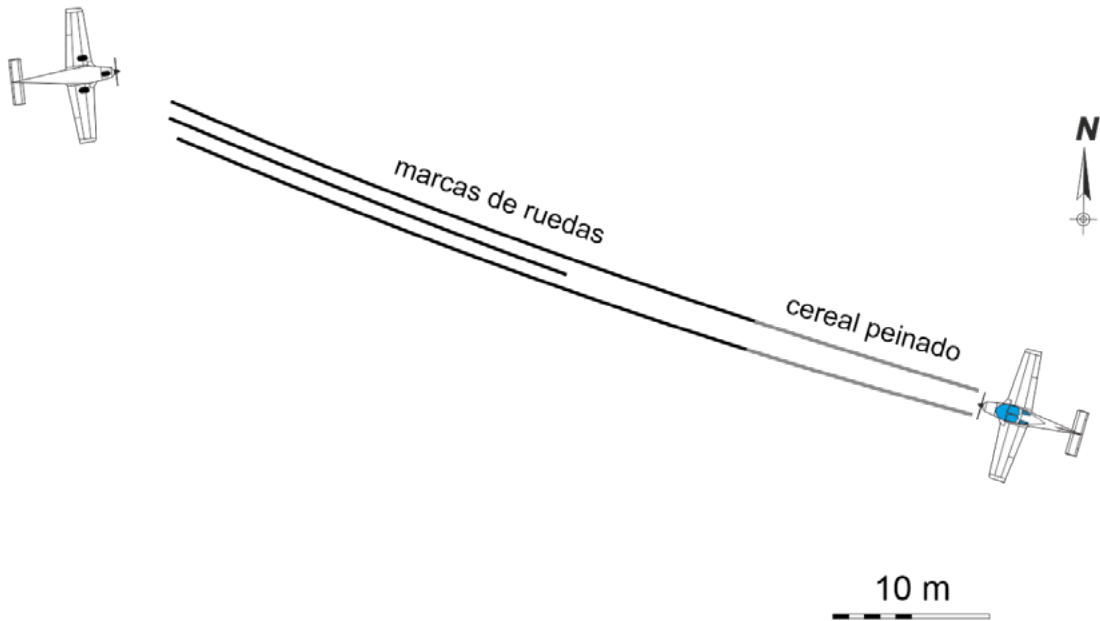
Fig. No. 4.- Track marks sketch.

On the ground, 55 m before the location of the wreckage, a 15 m section of crop 'combing' was visible, followed by two parallel 40 m-long tracks made by the main landing gear wheels as they rolled over the ground. Twelve metres after the start of the two parallel tracks, a third 28 m-long track appears, equidistant from the previous ones. This third track was made by the nose wheel as it travelled along the ground.

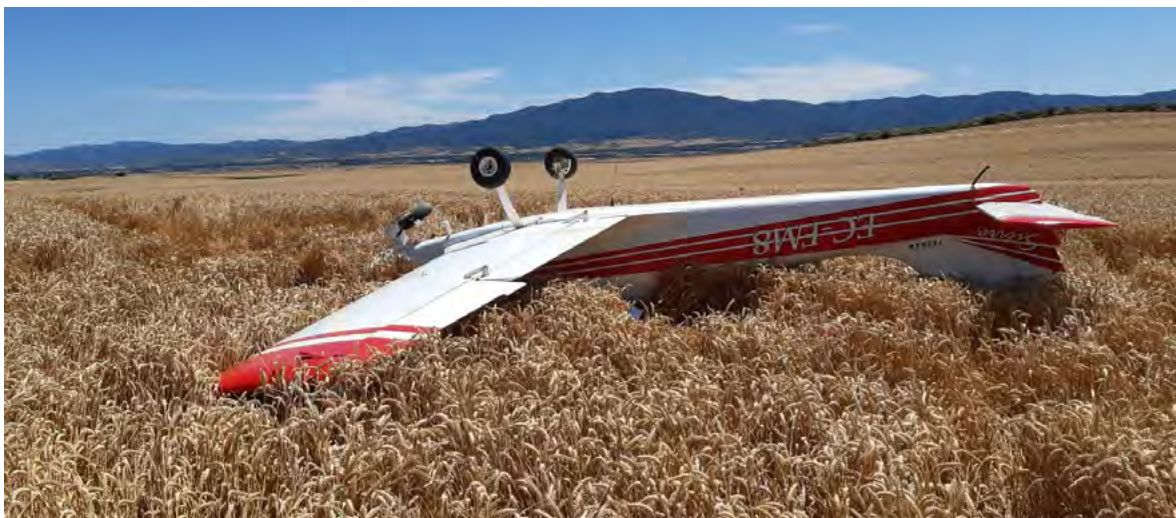
Fig. No. 5 - Aircraft in its final position.

The aircraft was found in an inverted position with an east-west orientation, in a 1898 m long by 170 m wide unharvested cereal field with flat terrain and no appreciable slope.

The aircraft had fractures and deformities on its wingtips and on the rudder and upper part of its vertical stabiliser on the tail assembly. The lower part of the engine fairing and the cabin's methacrylate also sustained damage. The nose leg was bent, and two of the propeller blades were broken.
