**COMISIÓN DE
INVESTIGACIÓN
DE ACCIDENTES
E INCIDENTES DE
AVIACIÓN CIVIL**

Report ULM A-010/2019

Accident involving a TL Ultralight
TL-96 Star aircraft, registration
EC-DS5, at the aerodrome of
Mérida-Royanejos (Badajoz) on 8
June 2019

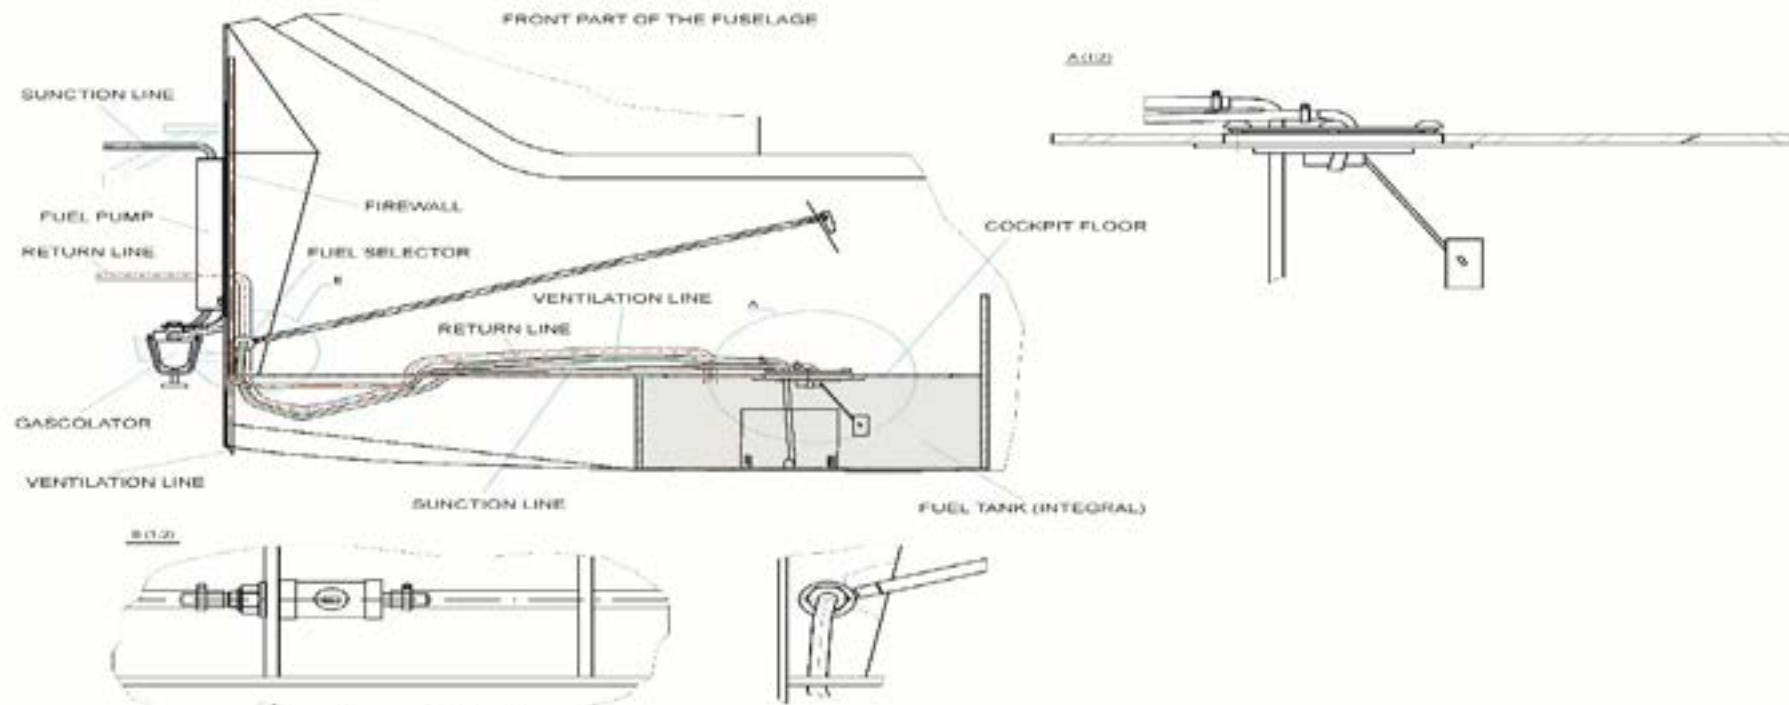
Illustration 1: Diagram of the fuel system installed by the aircraft manufacturer

The aircraft manufacturer stated that there are several couplings and ventilation lines in the floor at the front of the cockpit. The fuel return line is also in this area. These lines are located at the center of the fuselage (widthwise) and covered with a console, the inside of which is made of composite materials. The pilot indicated that the console installed in its aircraft partially covered the lines.

It stated that it was difficult to ascertain where the fuel leak may have originated. It could be that a connector in one of these lines was in bad condition, broken or that the rubber on the lines was old. It added that it could not find any cases in its record similar to this one.

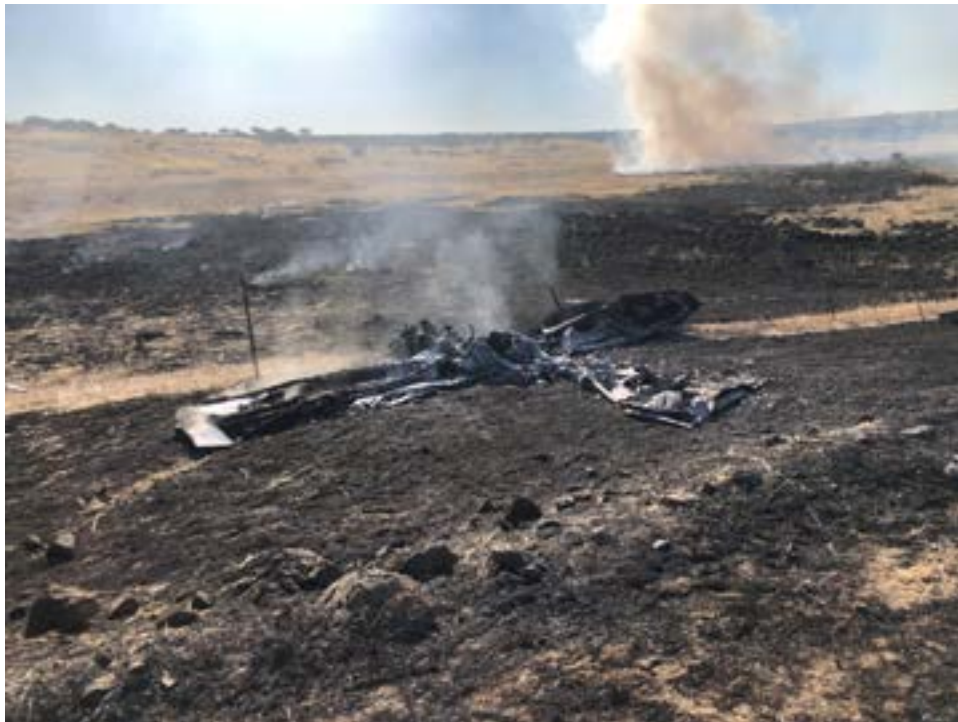
The aircraft was destroyed by the impact and subsequent fire.

The wreckage of the aircraft was found in the vicinity of the fence that surrounds the aerodrome of Mérida-Royanejos, in Badajoz. The aerodrome fence helped stop the aircraft. The impact with the fence and with rocks near the fence caused the aircraft, which was loaded with fuel, to burst into flames.

Illustration 2: Wreckage of aircraft on wheat field
