Report ULM A-013/2020

Accident involving a TECNAM
P96-G aircraft, registration
EC-ZEK, on 27 September 2020,
at the La Juliana Aerodrome
(Seville)

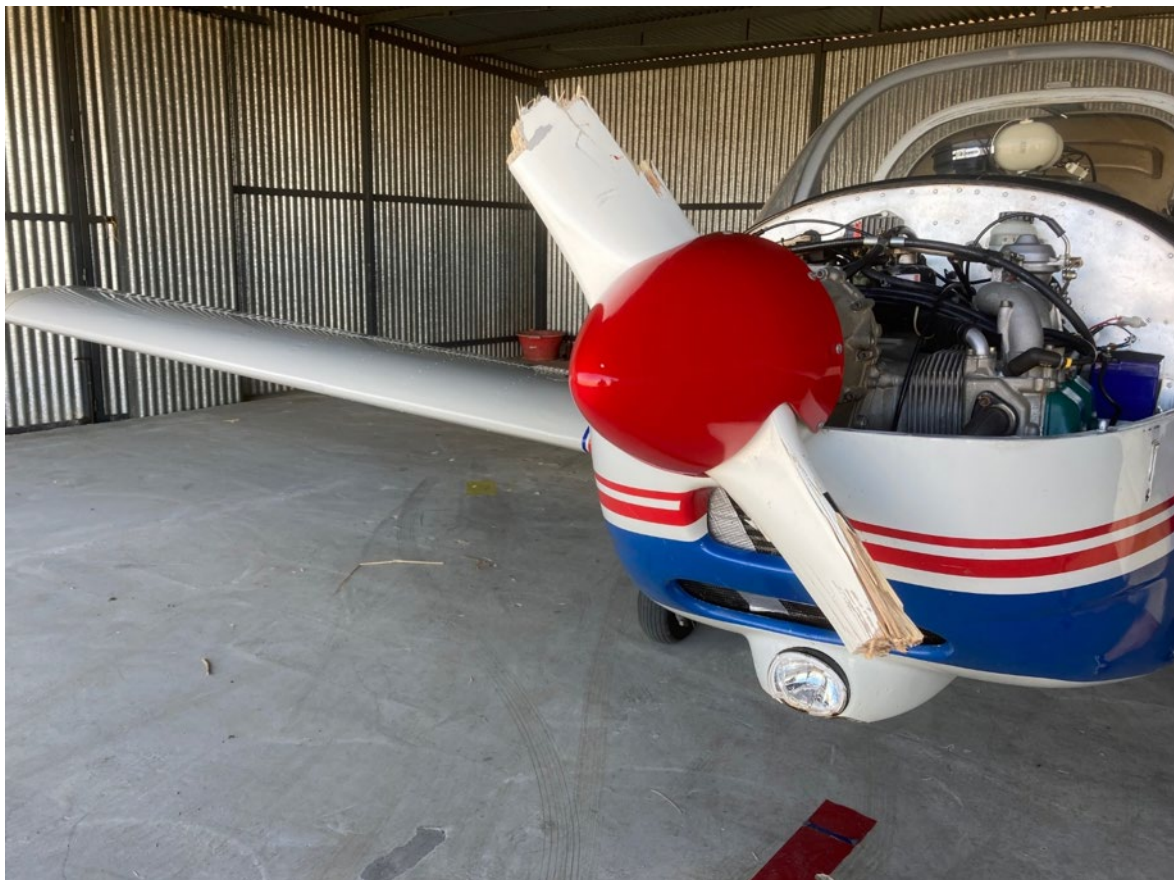
Photograph 1. Accident aircraft in the hangar after the incident

The aircraft suffered significant damage to the engine propeller, the underside of the nose cone and the nose landing gear.

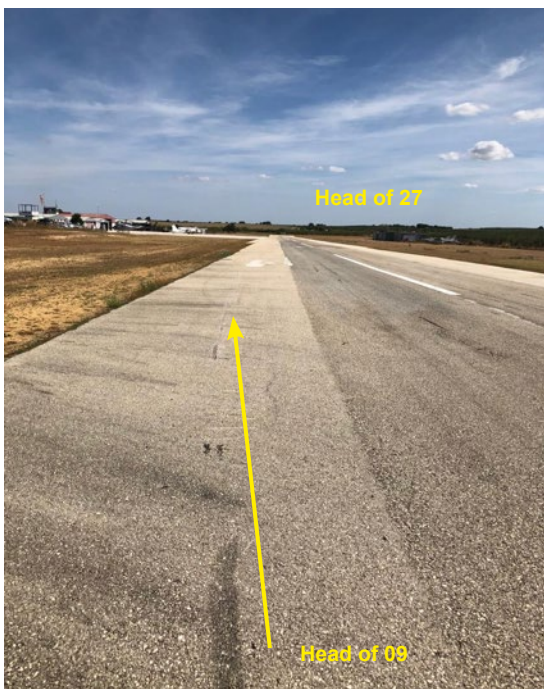
The accident occurred at the end of runway 27 as the aircraft was turning to backtrack towards the parking area, d to the left about 20 m from the end of the runway.

Photograph 4. Path of the aircraft during the event

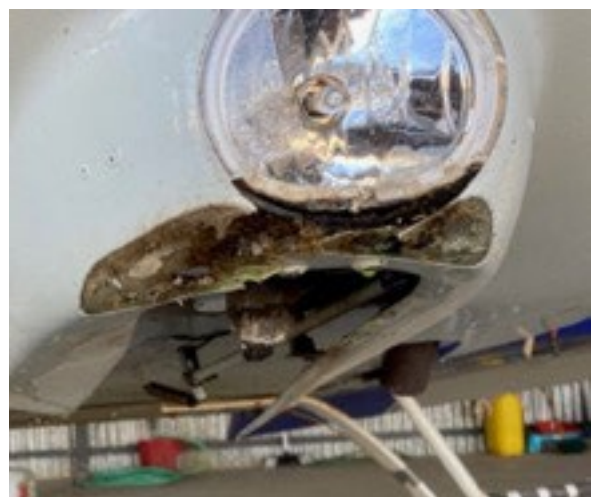
- Underside of the nose cone and the nose landing gear housing: Photograph 5 shows the damage to the underside of the aircraft's nose and landing light.

Photograph 5. Nose landing gear housing damage

The nose landing gear clamping piece to the engine bench can be seen disassembled.

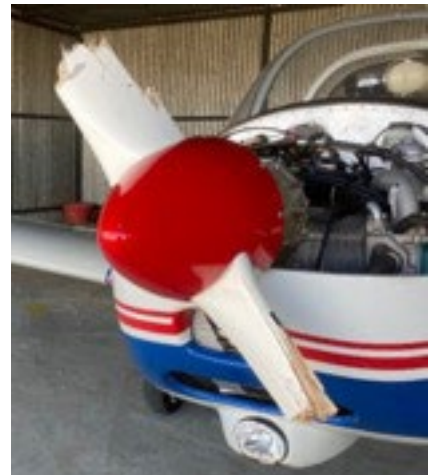
- Propeller: the wooden blades were destroyed, with the breakages occurring close to where the propeller is attached to the nose cone.
- Nose landing gear: the nose landing gear leg broke into four fragments (photo 7).

Photograph 6. Damage to the propeller

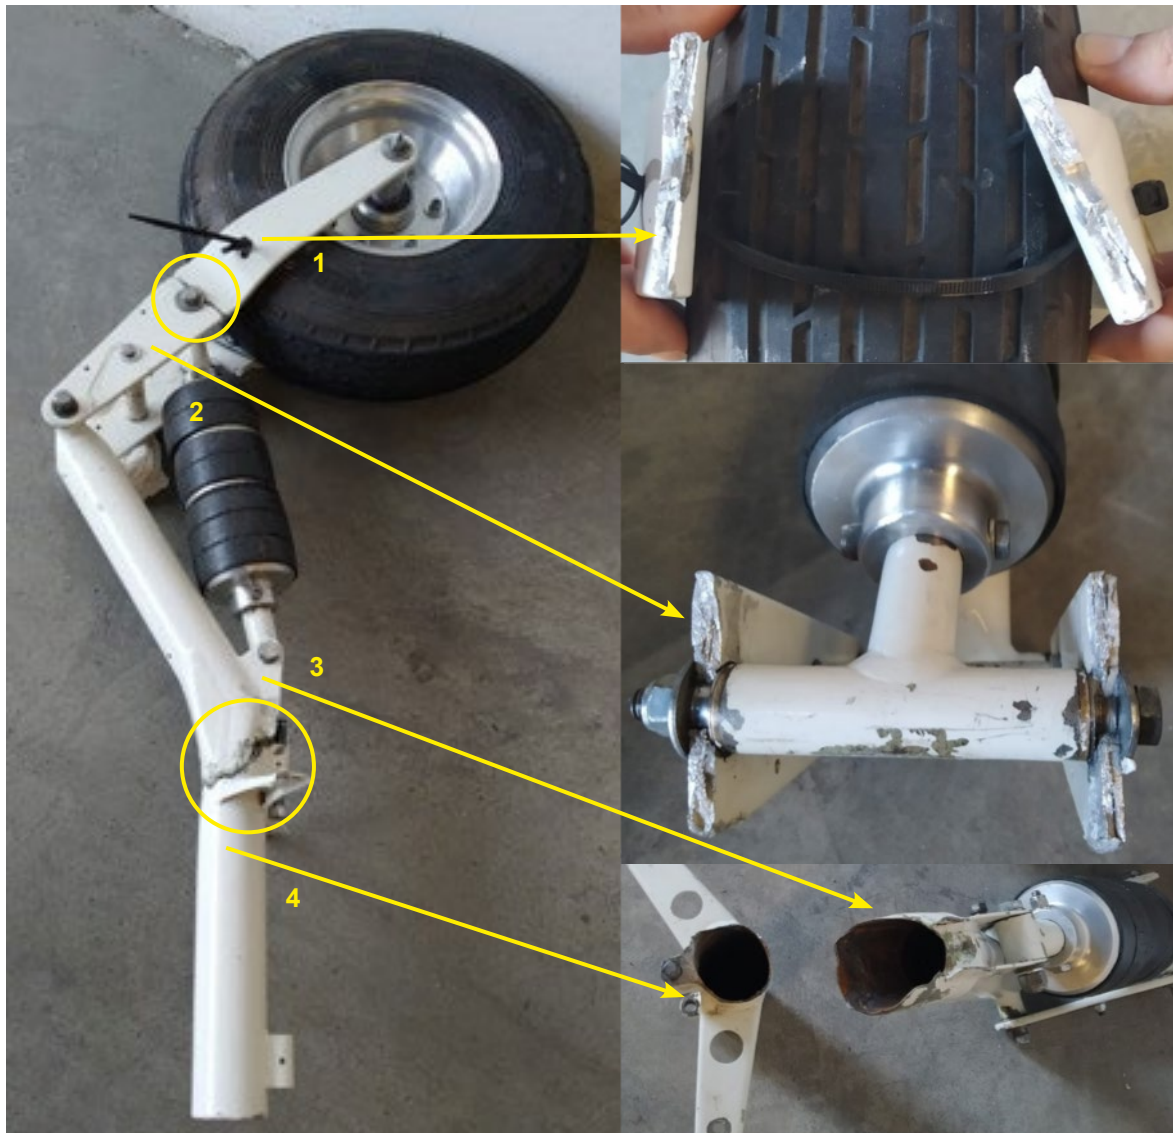
Fragments 1 and 2 are part of the nose wheel fork, which comprises two oscillating arms that connect the wheel axle to the shock absorber and the nose gear leg.

The horizontal break perpendicular to the axis of the oscillating arm occurred in its central part coinciding with the hole of the bolt for fixing the shock absorber.

Photograph 7. Reconstruction of the nose landing gear showing the four fragments and the damage

The fractures seen in fragment 2 (see detail in photograph 7) appear more worn and flatter than fragment 1.

Proper preventative maintenance of the cracks in the oscillating arms would have detected the problem before the fracture occurred. The landing gear system is subjected to fatigue by its own function and operation, but fatal failures can be avoided with proper maintenance.

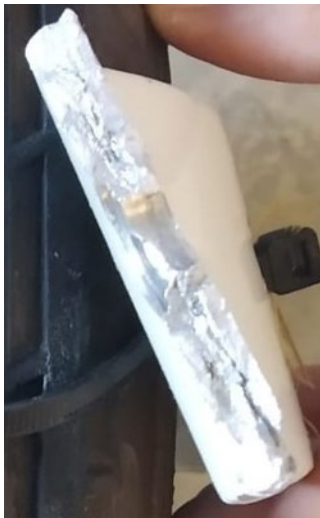
Photograph 8. Fracture of fragment 1

The fractures seen in fragment 1 are typical of those caused by overstress due to material fatigue, with a smooth, progressive fracture zone and an instantaneous or sudden fracture zone with a rougher or crystalline appearance.

The breakage of the oscillating arms, which occurred in the weakest area of the component, on a level with the holes for the shock absorber bolts, was probably caused by material fatigue, as demonstrated by the type of fracture seen in the fork fragments. The inspection of the fragment that remained attached to the leg for a few more seconds before it also fractured due to deformation, revealed that its broken edges impacted the runway, slightly wearing away the rough area around the break.

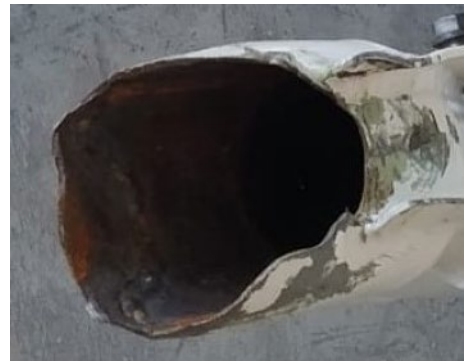
Photograph 9. Corrosion on fragment 3

The fractures seen in fragments 3 and 4 show corrosion, an angled breakage and deformation (photographs 7 and 9).

The internal corrosion revealed after the leg broke, while not considered to be a determining factor in the breakage, may have weakened the material and, therefore, contributed to the accident. The corrosion finding highlights the need for proper preventative maintenance.

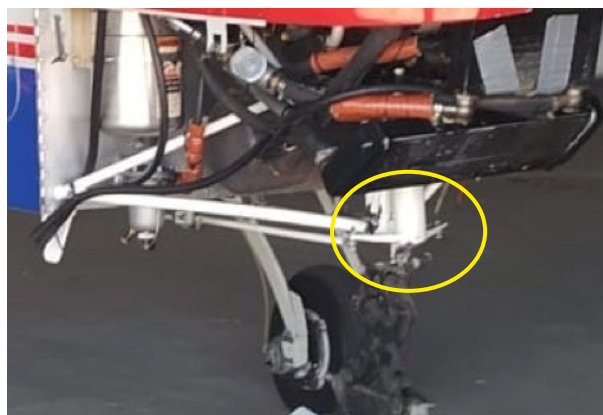
Photograph 10. Assembly accessory for attaching the nose gear leg to the engine mount

Photograph 10 shows how the nose gear leg was sectioned after the accident. Fragment 4 (circled in the picture) remained attached to the structure.
