Technical report

ULM-A-014/2021

Accident on 10 July 2021 involving a TECNAM P2002-S aircraft, registration number EC-FP2, in the municipality of Castejón de Sos (Huesca).

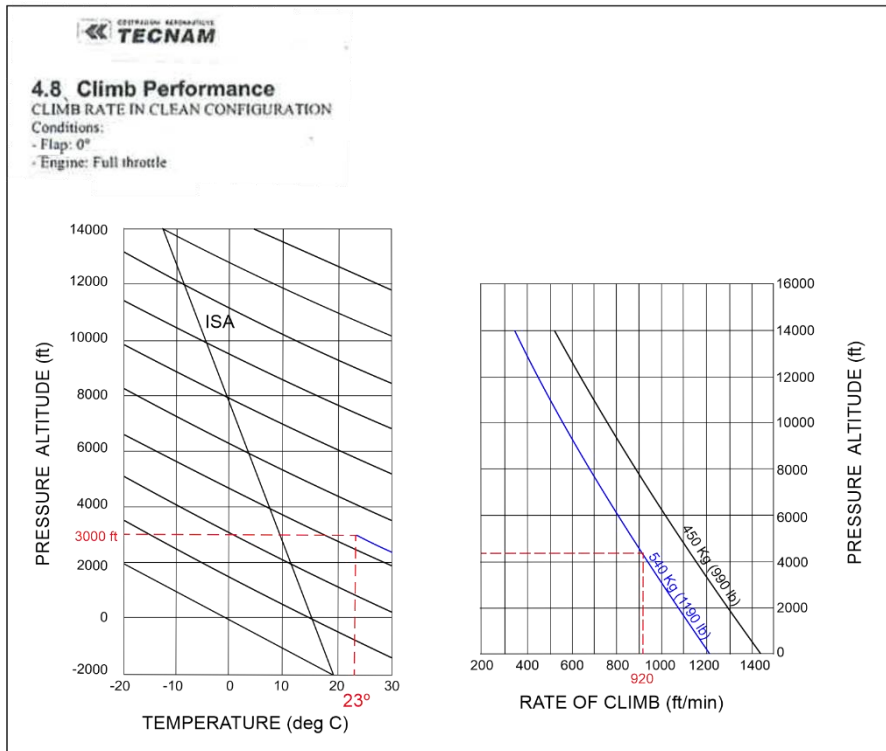
Fig. 2 - Rate of climb calculation tables

In the case in question, the total weight of the aircraft was estimated at 540 kg: 300 kg for the unladen weight, 180 kg for the occupants and 59 kg for the fuel (after subtracting the fuel consumed on the previous flight, and assuming the aircraft departed with its tanks full).

According to the tables in Figure 2, for a weight of 540 kg and flap conditions of 0°, flying under full power and at the speed providing best rate of climb, at sea level the aircraft's rate of climb would be in excess of 1,200 ft/min. After accounting for the altitude and weather conditions at the time of the accident, the rate of climb would be around 920 ft/min, in the best-case scenario.

Clearly, although it is sufficient to reach the most suitable altitude for exiting the valley, this rate is significantly lower than that to which the pilot would have been accustomed in his more habitual flights.

This may have caused him to believe that the rate of climb was insufficient, and so he may have erroneously attempted to improve it by increasing the angle of attack. However, rather than improving the situation, this action would have worsened it, as it reduces both speed and the rate of climb. This would have led to the aircraft adopting a slightly nose-up position and a virtually horizontal (or even downwards) trajectory, which is consistent with the way in which the aircraft impacted with the mountain.
