# CIAIAC

## Report ULM A-015/2020

Accident on the 13 November  
2020 involving an ICP BINGO  
aircraft, registration EC-EJ8, in the  
municipality of Turre (Almeria)

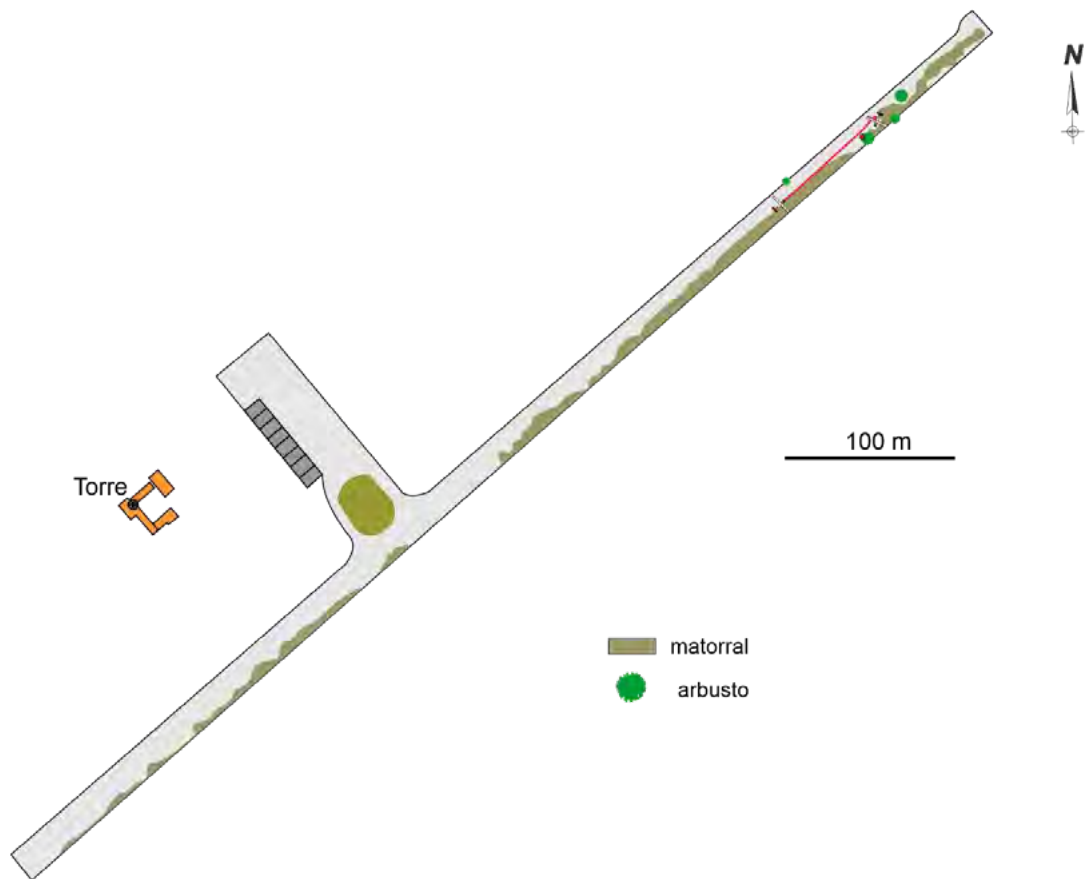
Fig. no. 1.- Diagram of the runway and location of the aircraft

The aerodrome is abandoned, and its runway is in disuse. Its surface area has several irregularities along its length in addition to abundant low scrub vegetation on the right side of the last 380 m section of runway 05.

The aircraft made an emergency landing on the last section of runway 05 at an abandoned aerodrome located in Paraje de Cortijo Grande in Turre (Almería).

Of the 690 m of runway, the last 380 m had low vegetation on the right side, reducing the available width without actually preventing an aircraft from taxiing on it, except for the last 90 m, where the extent of the vegetation, both in terms of its height and density, made that section completely unusable. Therefore, it can be stated that, while not in good condition, 600 m of the runway was usable and available to make a safe landing.

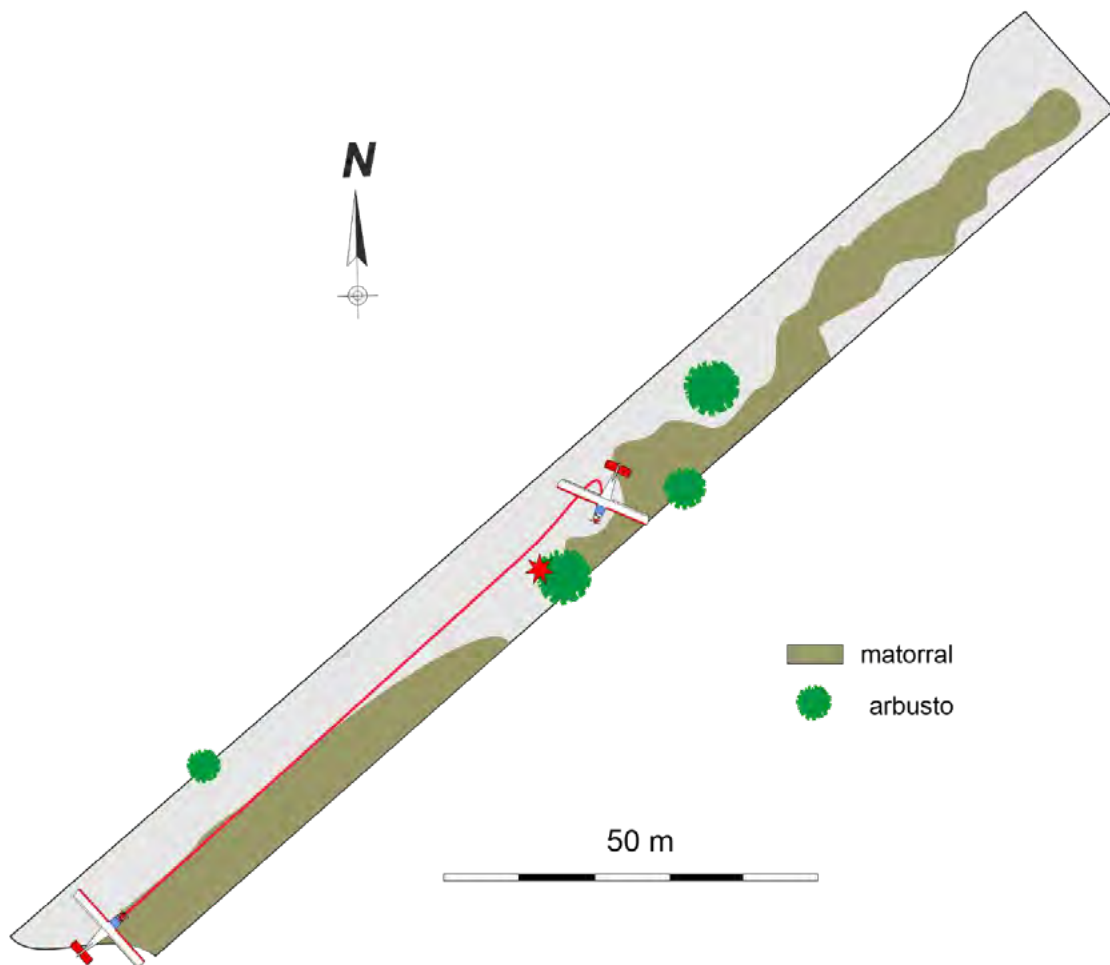
Fig. no. 2 - Detail of the emergency landing area

The aircraft stopped between some bushes to the right-hand side of the end of the runway, facing in the opposite direction to which it landed.

Some of the vegetation on the right side of the section prior to where the aircraft stopped was crushed, which is consistent with the aircraft's wheels having rolled over it.

As regards the aircraft, it was found between some bushes about 80 m from the end of runway 05, facing in the opposite direction to which it had landed, with damage along the full length of the leading edge of its right wing.

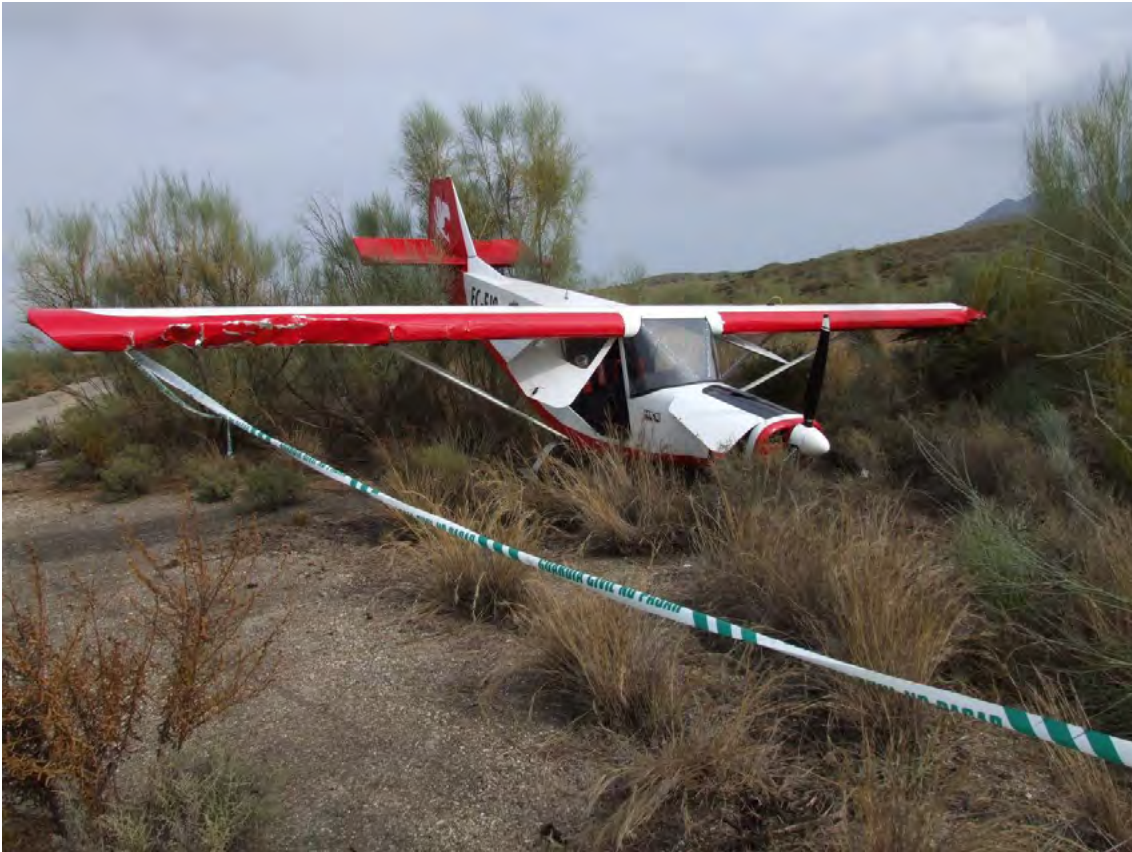
Fig. no. 3 - Frontal view of the aircraft's condition

Except for the nose wheel, which had detached and was found three m away, the aircraft was intact.

As a consequence of impacting the vegetation, the aircraft sustained significant damage to its nose leg, right wing (particularly its leading edge), left wingtip, and the horizontal stabiliser on the tail assembly. Creases and fractures were also observed on the engine fairing and doors. The tips of two of the propeller blades were damaged.
