Report ULM A-016/2017

Accident involving a Tecnam
P-92-Echo aircraft, registration
EC-LDZ, operated by ULM
ESCUELA DE VUELO, in
Villaminaya (Toledo, Spain) on
7 October 2017

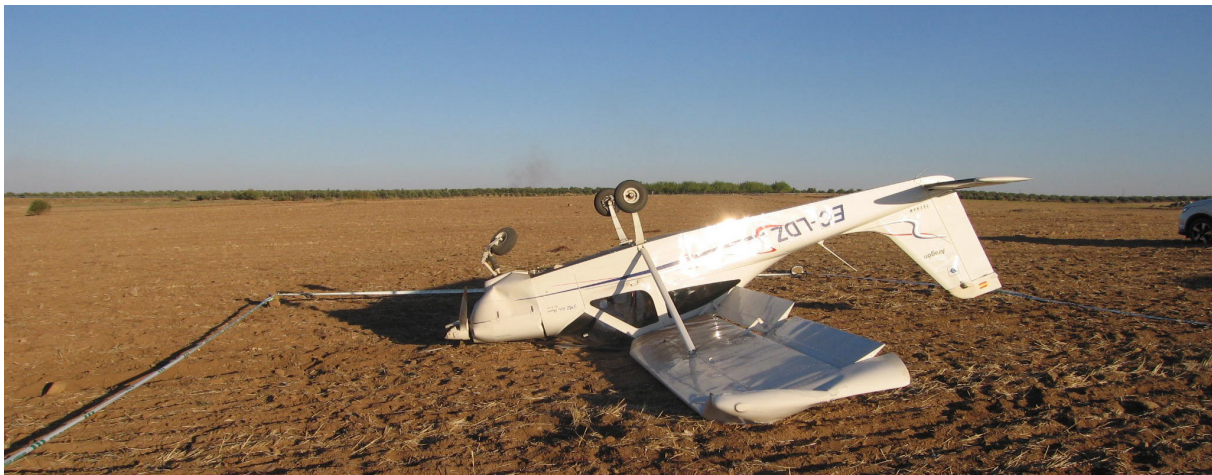
During the landing, the aircraft traveled forward several meters along the ground before flipping forward and ending up in an inverted position.

Figure 1. Final position of the aircraft

The main gear was fine but the front gear was bent. When it turned over, the top of the aircraft's tail impacted the ground and part of the fuselage was bent.

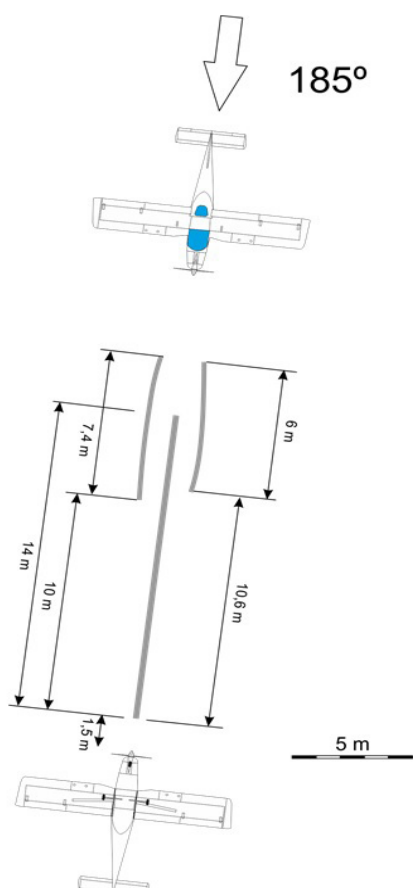
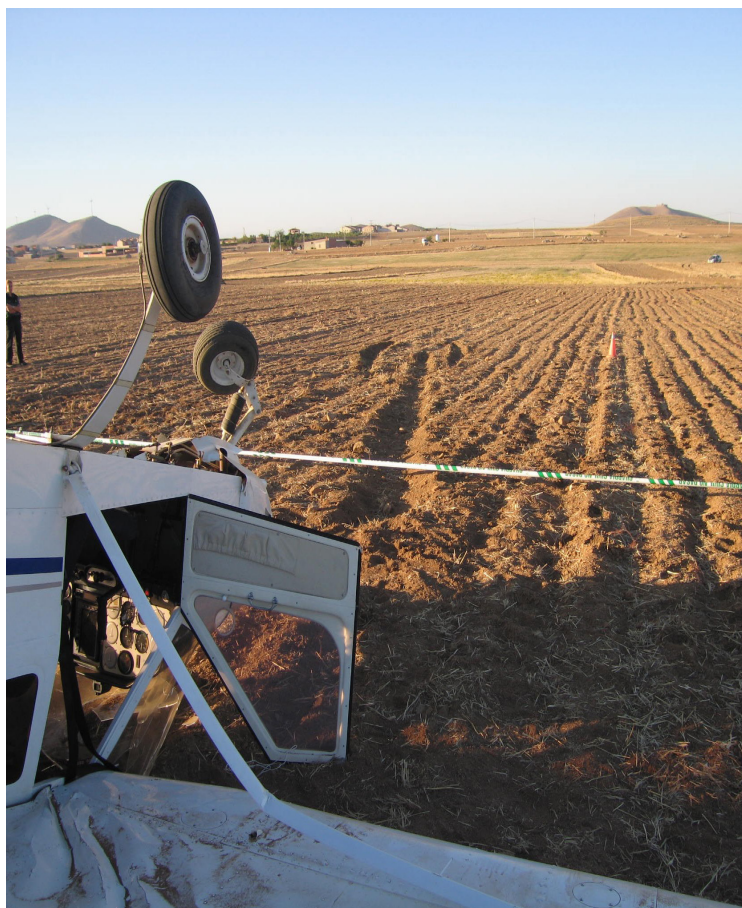
Three parallel trenches of variable length were found on the ground. The central one was longer and wider than the side trenches, as shown in Figure 3. The aircraft was found at one end of the longest and widest trench. It was upside down and leaking fuel. No parts detached from the airplane either during the flight or when it impacted the ground.

Figure 3. Marks on the ground left by the aircraft

The marks on the ground and final condition of the aircraft indicated that the propeller was not under power and that the aircraft's speed was low, which is consistent with a landing with the engine stopped, as the occupants explained.

The marks indicate that the emergency landing was carried out correctly, with the wings level and a shallow descent attitude so as not to impact the terrain too severely (there were no bounce marks on the terrain).

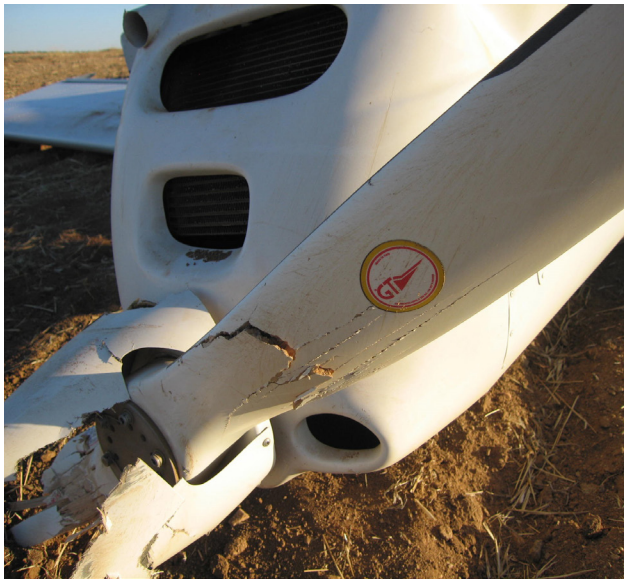
Figure 4. Cracks in the propeller

The propeller cone was heavily damaged and the blades had cracks as a result of digging into the ground when the aircraft overturned in the forward direction (see Figure 4). The blades did not exhibit signs of having been turning at the time they impacted the ground.

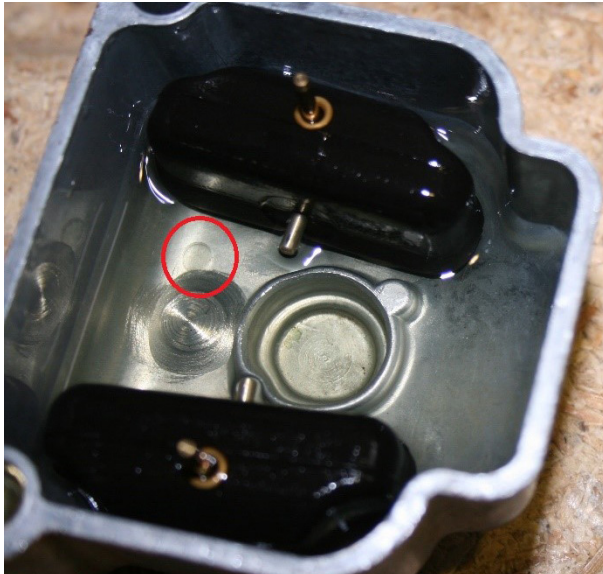
The carburetors were in good condition and maintained their integrity. When they were removed, water contamination was found in the pans of both carburetors, as shown in figures 5 and 6.

Figure 5. Carburetor of cylinders 1 and 3

A detailed inspection of the engine revealed water contamination in both carburetor trays. The possibility of water entering the carburetors after the accident can be ruled out since the carburetors were in good condition and maintained their integrity.

The water present in the fuel reached the engine, causing a loss of power.

The water detected in the carburetors came from the fuel tanks.

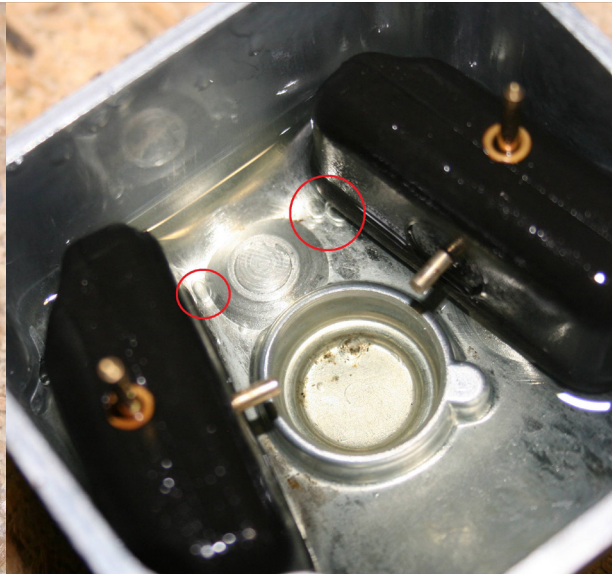
Figure 6. Carburetor of cylinders 2 and 4
