Report ULM A-020/2020

Accident involving a Tecnam
P-92 ECHO, ultralight aircraft,
registration EG-GQ4, at Alcocer
de Planes Aerodrome (Alicante)

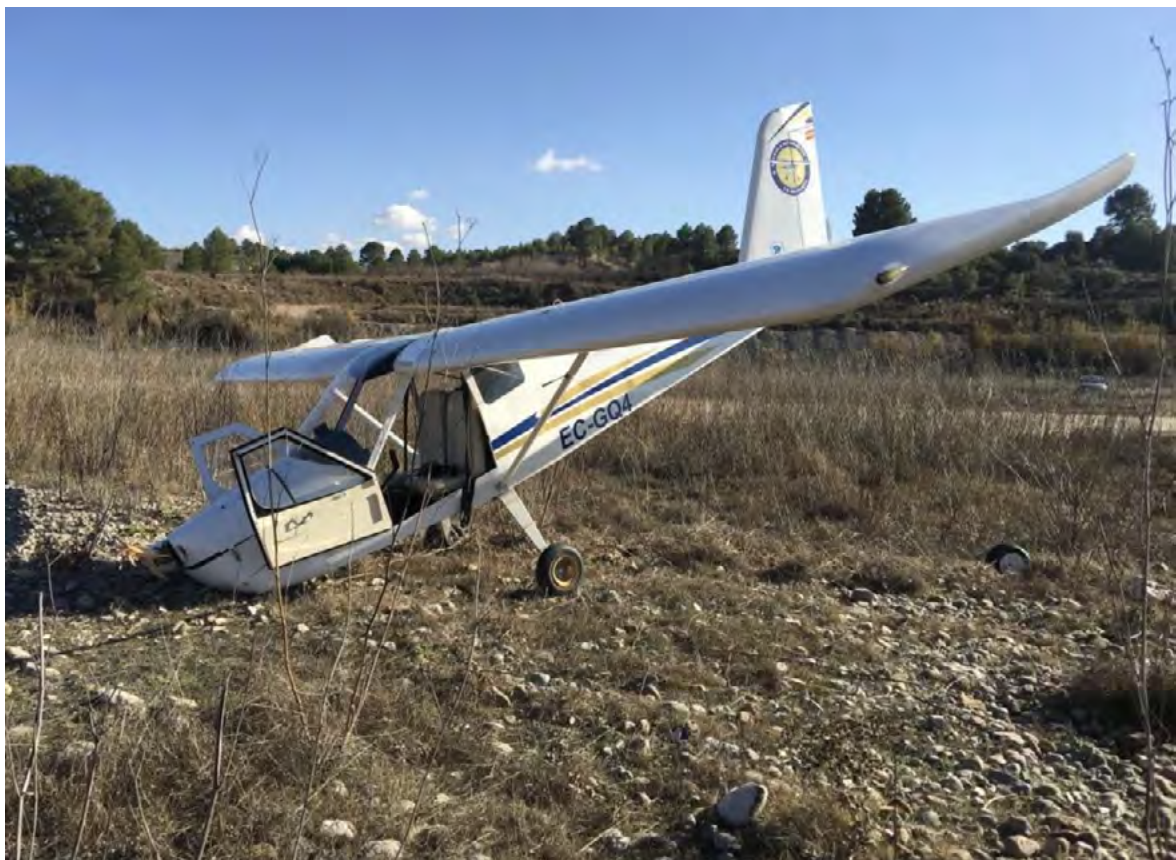
After bouncing several times and travelling about twenty metres from the edge of the runway, the aircraft's nose landing gear and propeller impacted the rocky terrain, and it came to a halt.

Photograph 1. Aircraft at the accident site

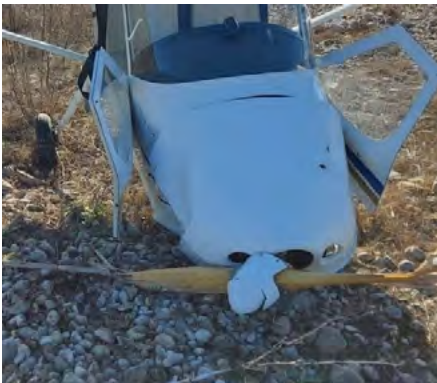
Photograph 3. Damage to the propeller

- Nose cone and broken and deformed propeller coupling flange.
- Propeller: broken and twisted.
- Engine mount: deformed
- Engine: broken exhaust pipes and oil and water distributors.
- Engine cowling and nose fairing: dented and deformed.
- Right wing: damage to the underside of the wingtip and strobe light.

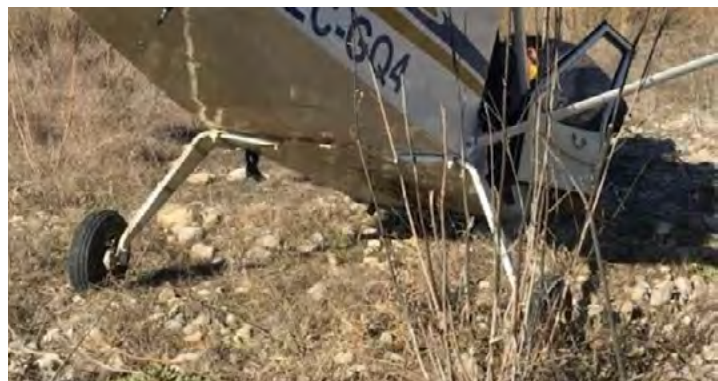
- Nose landing gear: destroyed with loss of wheel.
- Main landing gear: broken anchor points, damaged tyres and brakes.

Photograph 4. Damage to the landing gear

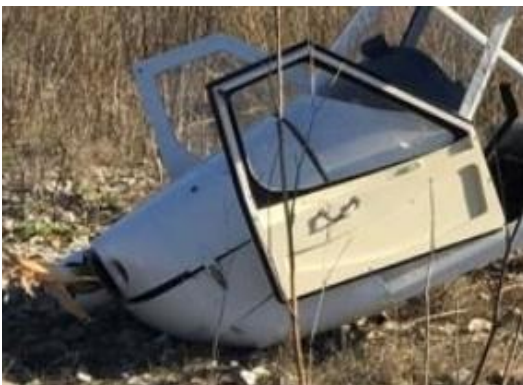
Photograph 5. Damage to the nose of the aircraft
