**COMISIÓN DE  
INVESTIGACIÓN  
DE ACCIDENTES  
E INCIDENTES DE  
AVIACIÓN CIVIL**

## **Report ULM A-023/2018**

Accident involving a powered  
Avid Flyer ultralight aircraft,  
registration EC-ZEC, in the vicinity  
of the aerodrome of Don Benito  
(Badajoz, SPAIN) on 22 December  
2018

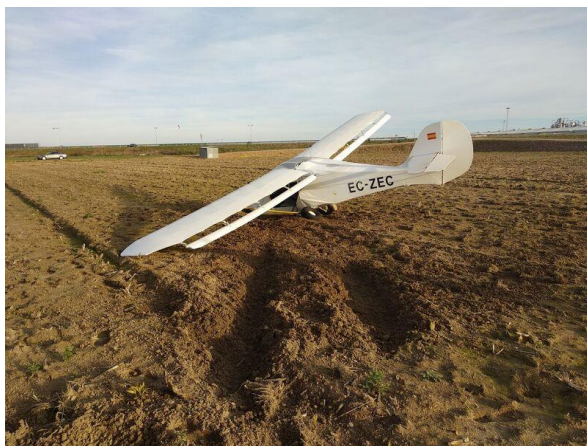
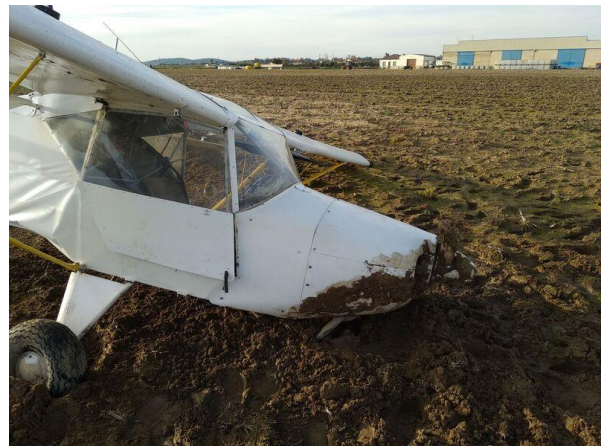
Figs. 1 and 2: Views from the left rear and right front of the aircraft after the accident

The aircraft sustained significant damage that affected the landing gear, fuselage, blades and wings (especially the left wingtip and the junction of both half wings with the fuselage).

The pilot made the emergency landing at the lowest speed possible while still maintaining control of the aircraft in order to minimize its energy. The main landing gear made contact with the ground first (slightly earlier with the left wheel), but the soft terrain made the wheel sink, and the left and nose wheels collapsed upon touching down. The marks made (see Fig. 1) were about 4 m long.

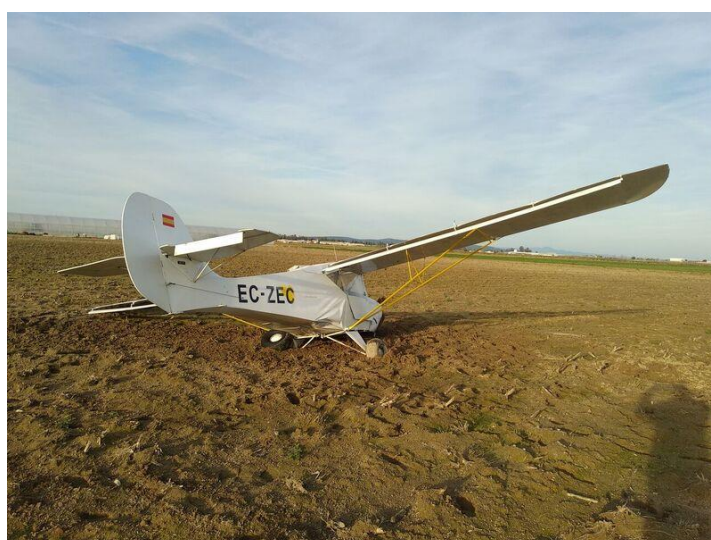
Fig. 3: View from the right rear of the aircraft after the accident

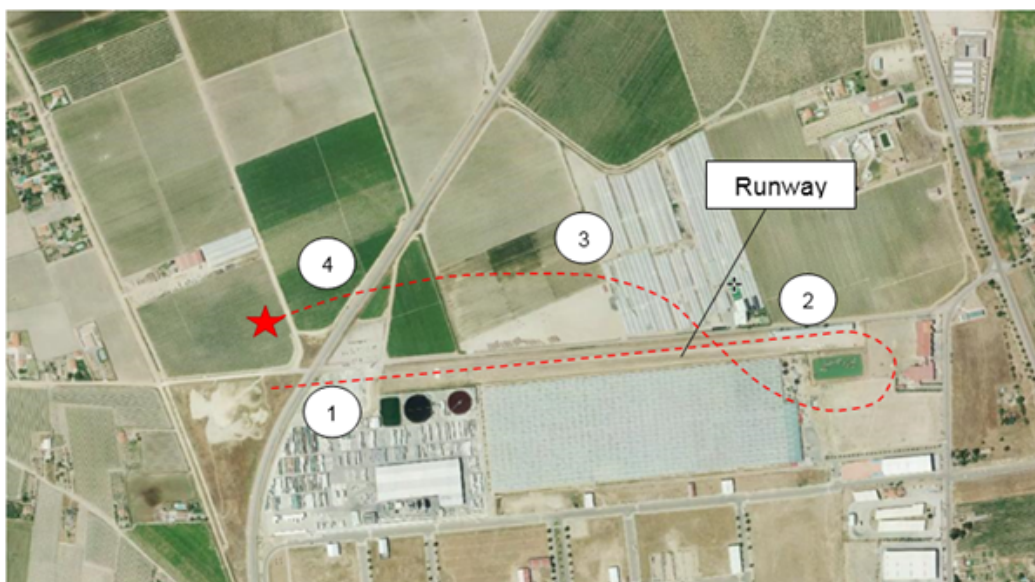
Based on his statement, the flight path before the accident has been reconstructed in Fig. 4, showing the significant points that correspond to his description of the event.

Fig. 4: Relative locations of aerodrome, flight path and accident site

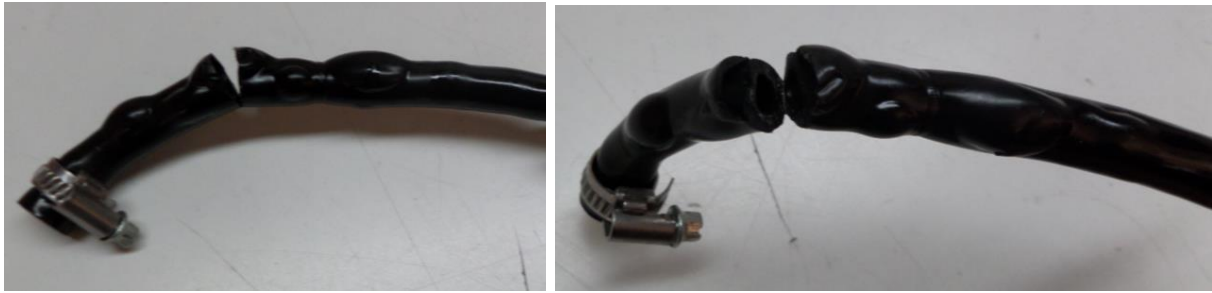
The original rubber hoses in the supply line from the mechanical fuel pump to the T-shaped connector leading to the carburetors was in poor condition. They were clearly worn, with very noticeable bubbles and deformations.

Fig. 5: Fuel hoses in poor condition

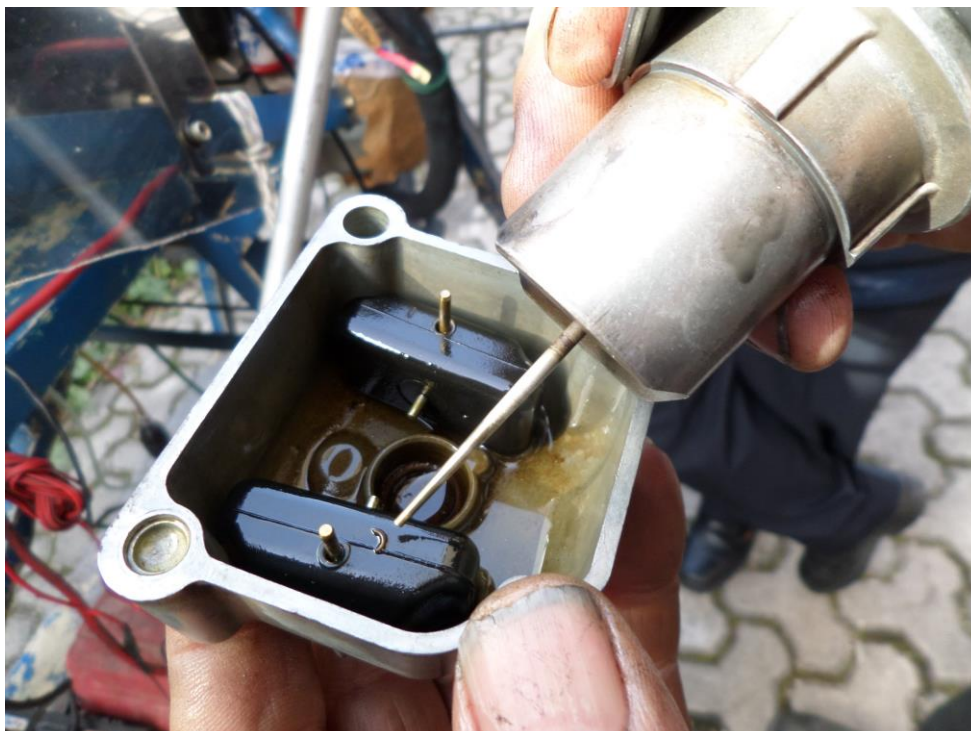
The float bowl was removed from the carburetor in question and found empty (which in and of itself explains why the carburetor was not supplying fuel to its cylinders). For some reason, fuel was not going into the float bowl. In addition, large metallic impurities were also found at the bottom of the bowl (see Figure 6).

Fig. 6: Metallic impurities in the float bowl of the carburetor for cylinders 2 and 4

The moving parts of the carburetor were disassembled and it was discovered that the fuel intake valve was blocked by impurities that were visible to the naked eye and that kept fuel from entering the float bowl.

The source of these metallic impurities was determined to be the area of the intake screw, which seals the entrance of the carburetor fuel hose to the valve. Without

The screw in question was removed and it and its housing were inspected in detail. The female thread on the housing for this screw was found to be in very poor condition, and the metal chips that had detached from this thread corresponded to the impurities found.

The investigation determined that the carburetor that supplied fuel to cylinders 2 and 4 stopped working<sup>4</sup> due to a blockage of the fuel intake valve that prevented fuel from entering the carburetor float bowl, which stopped cylinders 2 and 4. This blockage resulted from the highly deficient status of the female thread on the intake screw that seals the entrance between the carburetor fuel line and the valve. It was determined that the metal chips that blocked the fuel intake were of the same material as the poorly maintained female thread.
