Interim Statement EXT Andorra/2011

Accident involving an helicopter
AS 350, registration EC-LHP,
operated by Heliand (CAT
Helicopters), at Pleta de Juclar
(Canillo – Principado de Andorra),
on 15 June 2011

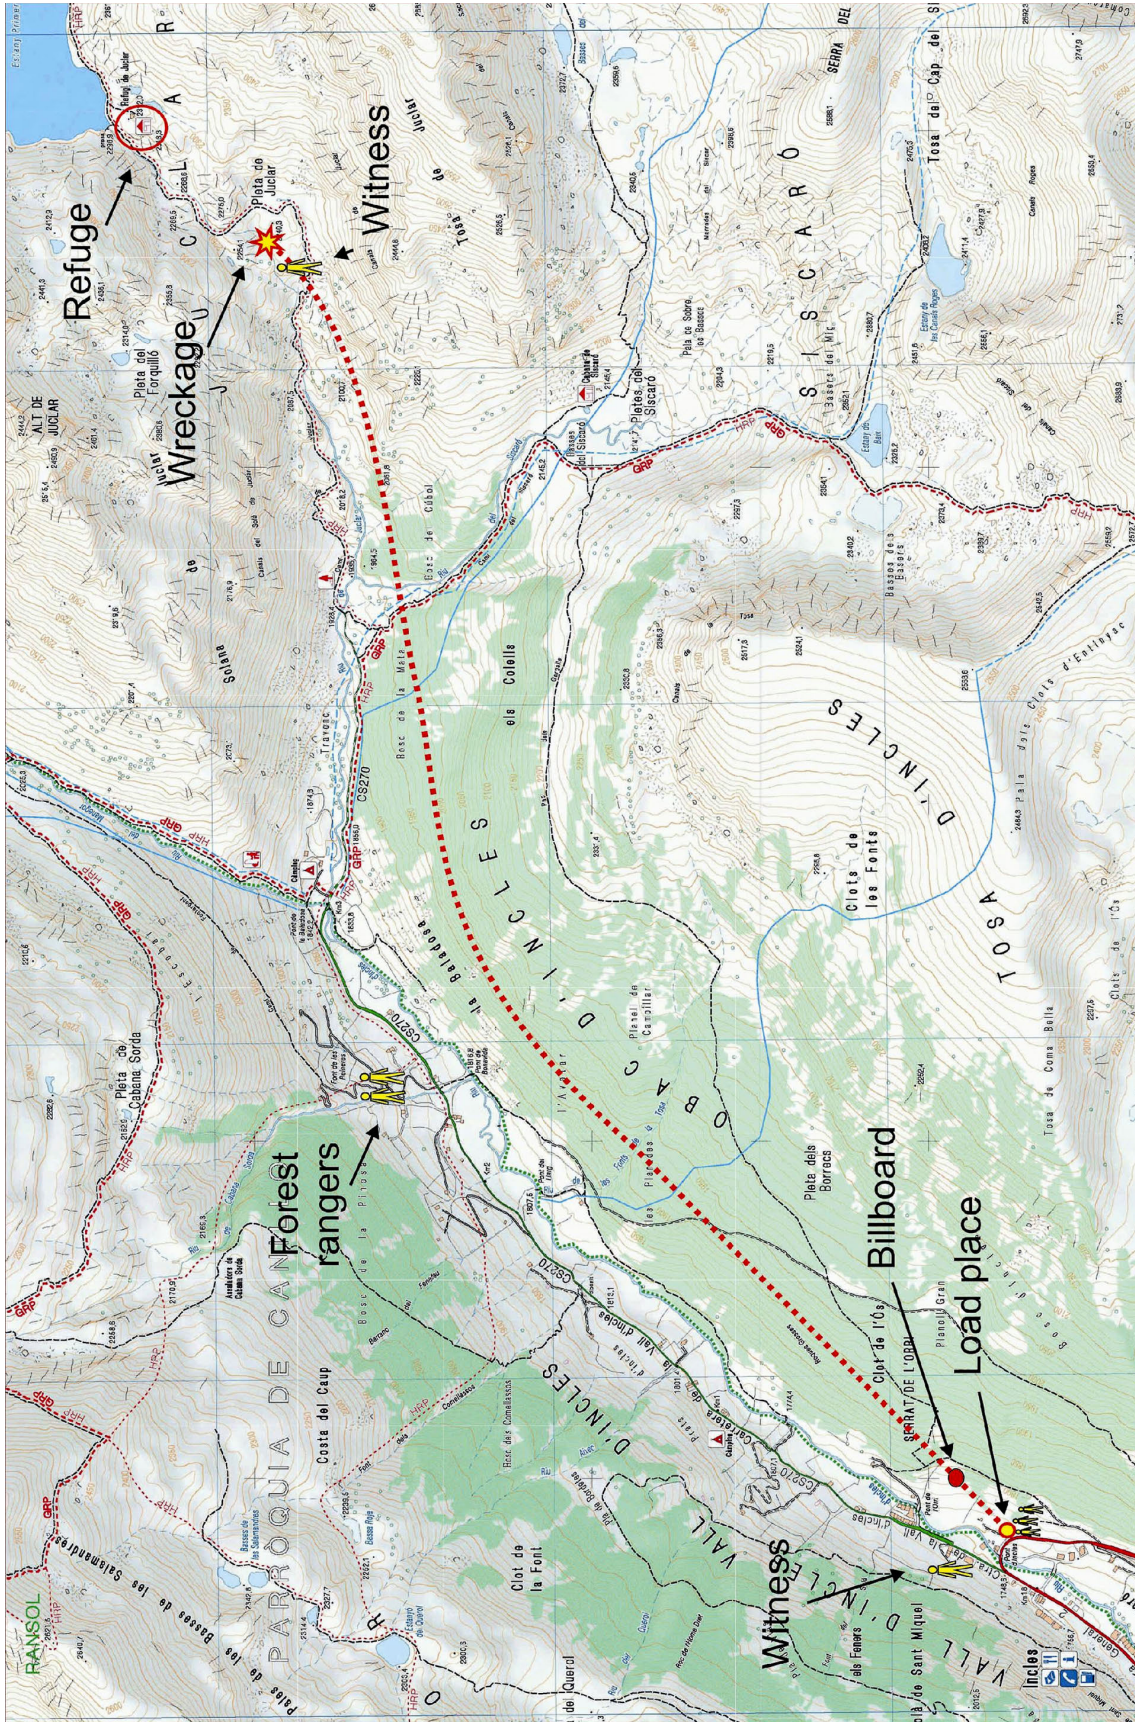
APPENDIX A
Diagram of the flight path
and of the wreckage

The accident took place after the helicopter flew past the crags. The helicopter impacted a tree situated on the north shore of a stream. The wreckage was turned 270° with respect to the original heading. The airframe was upside down. There had been a fire after the impact and the aircraft was destroyed. Of the 6 helicopter occupants, five of them died as a result of the impact, including the pilot and the maintenance technician. Four were burned and a fifth was ejected from the aircraft. The sixth occupant was the lone survivor and had burns over 70% of his body.

During the field investigation it was noted that just at the top of the crags, there was damage to the branches on one of the pine trees located in the area. The largest and most damaged branch had been torn from the trunk and exhibited abrasion and friction damage in one area, with a clear section near this area without any bark. Scattered branches, parts of the inner and outer sling cables, the protective sheath from the upper end of the sling and pieces of blade (fiber and foam) were found between this pine tree and the impact site. In the area immediately before the impact site there was a pine tree that was split in half with very little of its trunk left. The rest of the tree was found scattered among the main wreckage. The sling was found cut in two on the other side of the stream some 80 m away from the main wreckage.

The assembly consisting of the main gearbox, the mast and the main rotor was torn from the frame. The three blades remained attached to the head. Two had been affected by the fire. One of the burned blades had two significant marks along its leading edge some 250 cm away from the root that indicated that the sling had perhaps gotten tangled in the blade. The sling showed signs of abrasions in the area of the cut and remains of what appeared to be paint from the blade.

The helicopter skids were found among the main wreckage. They were upside down and facing in the same direction as the airframe (offset 270° from the original course). Also found was the trapeze structure that enveloped the load hook. The hook itself was closed. No parts of the sling were found in this area.
