Air Accident Investigation Unit Ireland

FORMAL REPORT

ACCIDENT
Fairchild Aircraft Corporation
SA 227-BC Metro III, EC-ITP
Cork Airport, Ireland
10 February 2011

AAIU Report No: 2014-001
State File No: IRL00911013
Report Format: Formal Report
Published: 28 January 2014

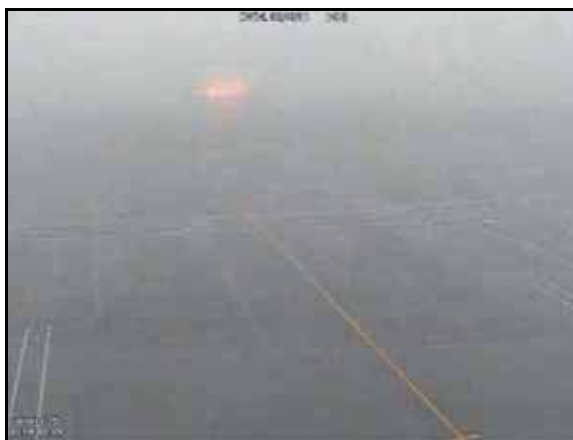
Photo No. 2: Initial flash fire

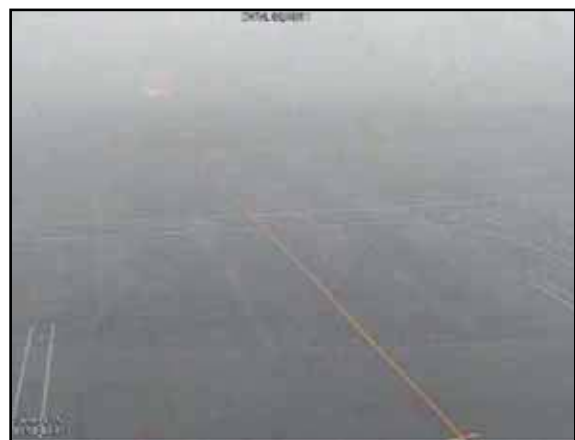
Photo No. 3: Second flash fire

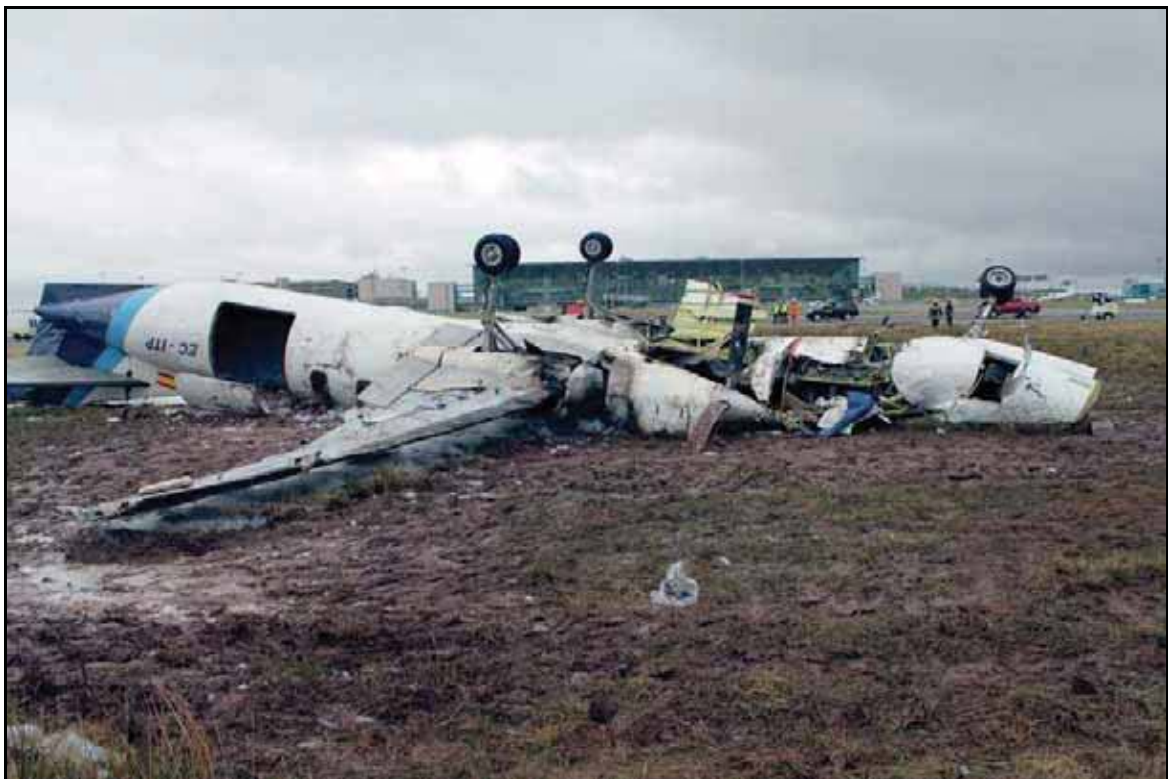
The aircraft wreckage was found in an inverted position, 189 m from the initial contact point and 72 m to the right of the runway centreline. All three landing gear legs were extended and undamaged. The forward fuselage was severely crushed; fire and impact damage occurred to both engines (**Photo No. 4**).

Photo No. 4: Final resting position of EC-ITP

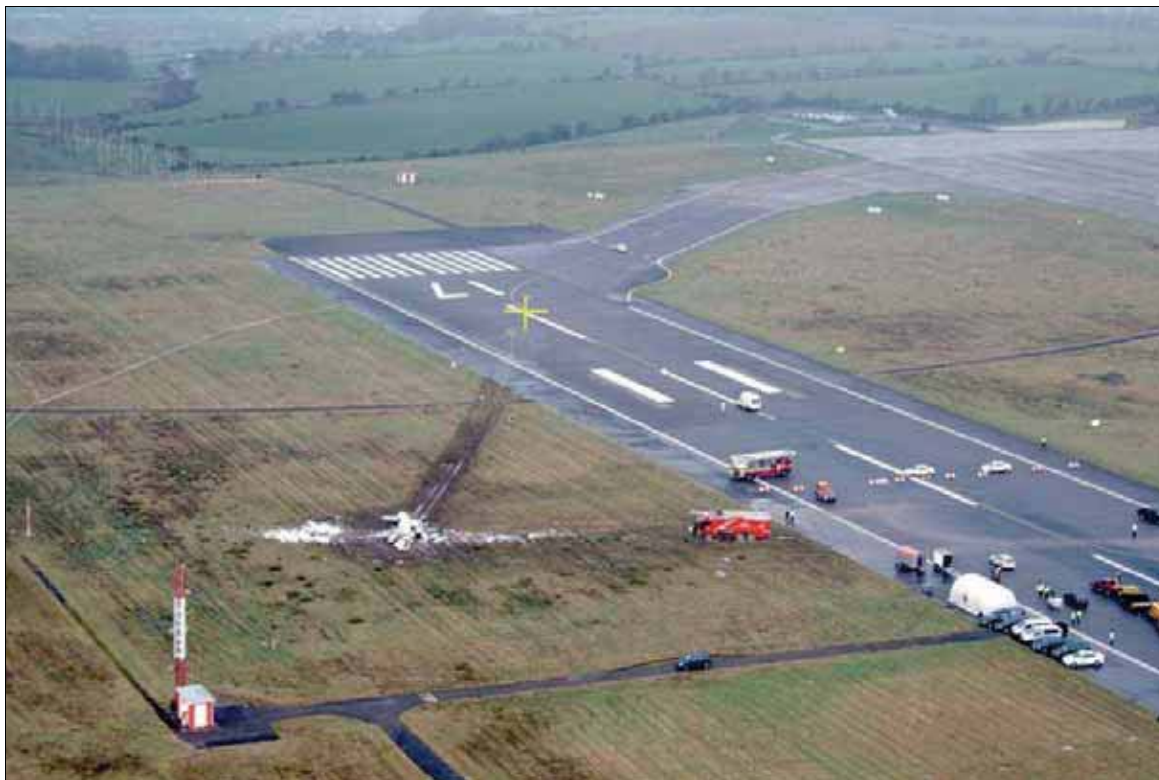
Photo No. 5: Point of initial wingtip contact (identified by the yellow reference mark), debris trail and final position of wreckage

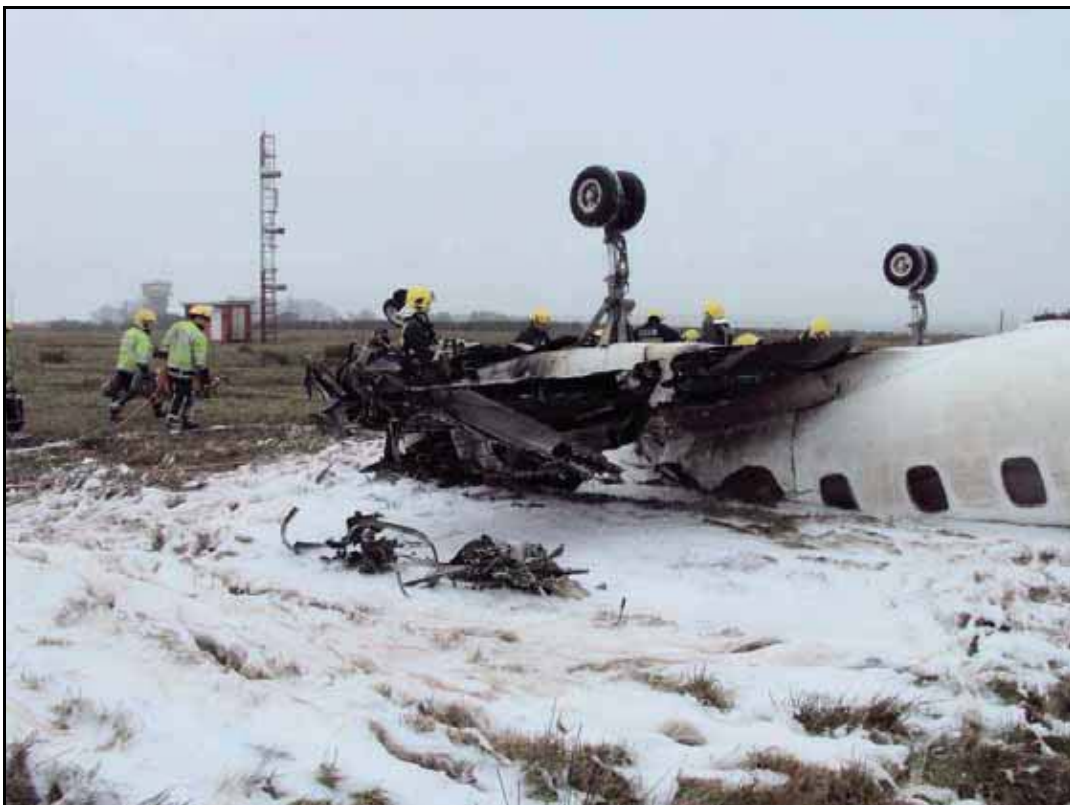
The portion of right wing and flap that remained attached to the fuselage ended several feet outboard of the right engine nacelle. Damage to the right wing had three distinct visible areas; the outboard section, the mid-section and the leading edge. The remnants of the wing attached to the nacelle had extensive fire damage (**Photo No. 6**). The structure had broken downwards at the outer end of the fractured wing.

Photo No. 6: Damage to right wing

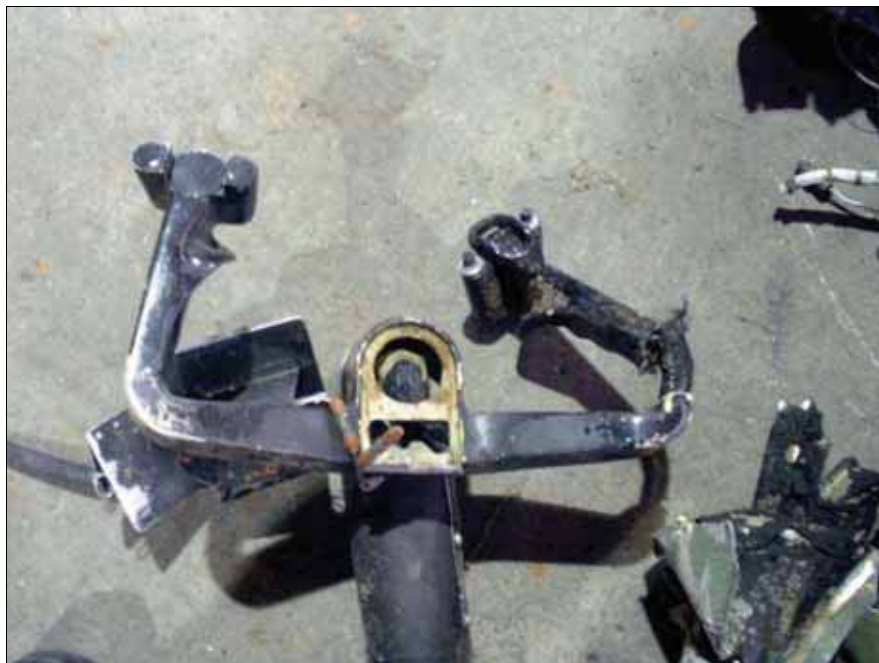
Photo No. 7: Co-pilot control wheel showing fracture of right-hand control grip

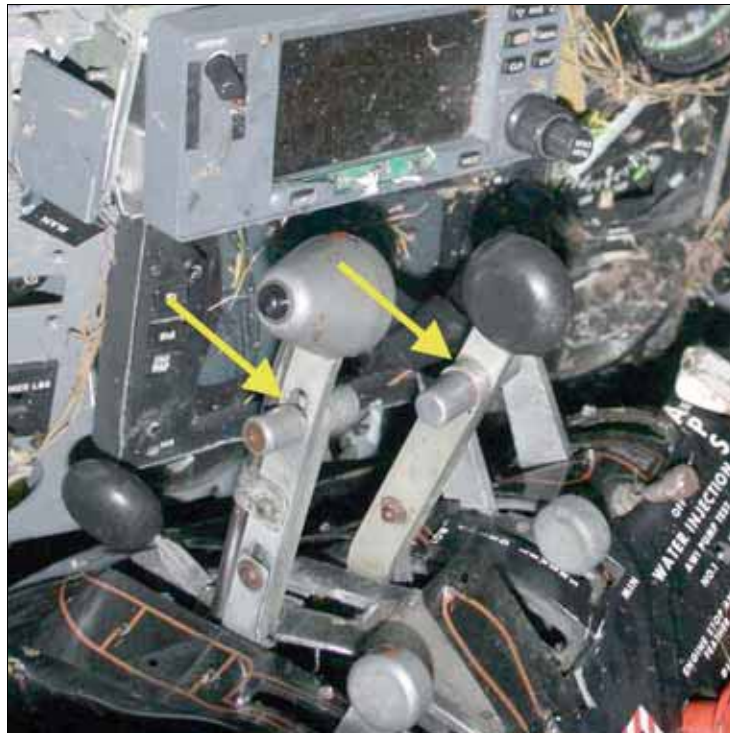
The engine control quadrant and control linkages were damaged by impact. As a result of this damage, the power levers and speed (RPM) levers were restricted in movement. The left Beta latch lever was found in the normal (down) position. The right Beta latch lever was found in the raised position (**Photo No. 8**). Both power levers were bent to the right. When the levers were straightened with minimal pressure, both mechanisms functioned correctly.

Photo No. 8: Left and Right Beta Latch lever positions

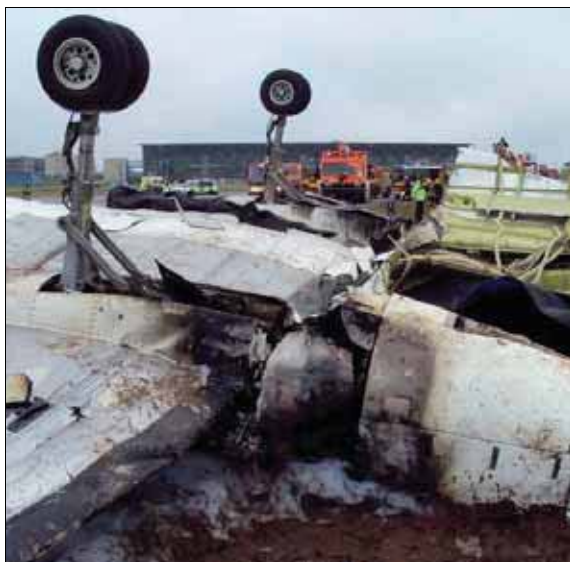
Photo No. 9: Left Engine Fire damage

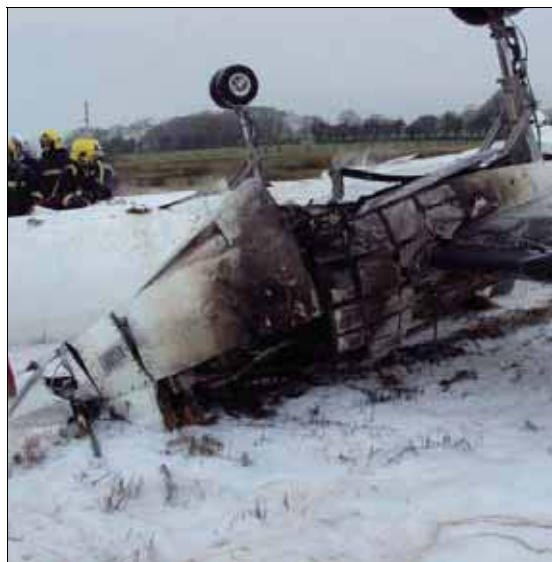
Photo No. 10: Right Engine Fire damage

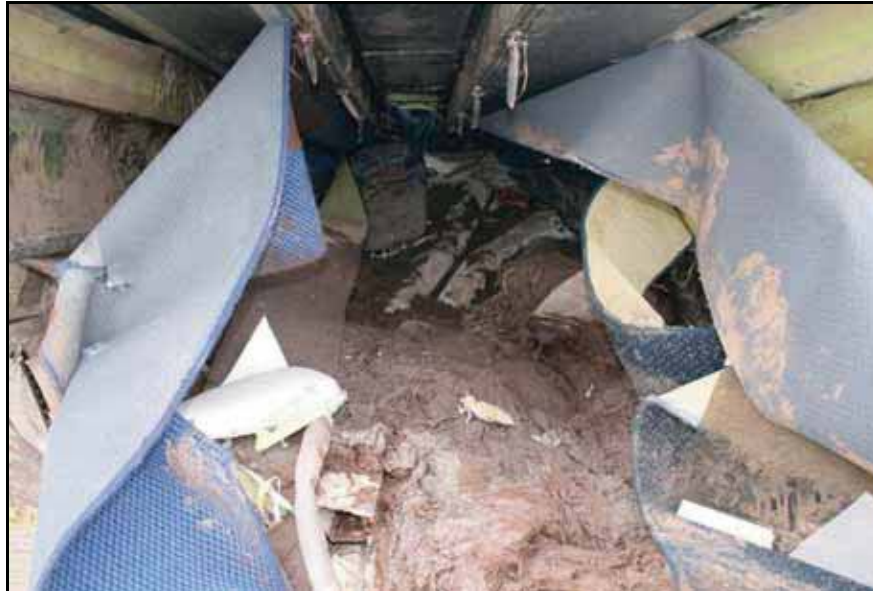
The cockpit and forward cabin were severely crushed in the impact, thus greatly reducing the volume of survival space. Furthermore, the opening in the upper fuselage allowed large amounts of soil to enter the forward cabin as the aircraft transited the grass area (**Photo No. 11**).

Photo No. 11: Forward view of inverted passenger cabin following rescue operation

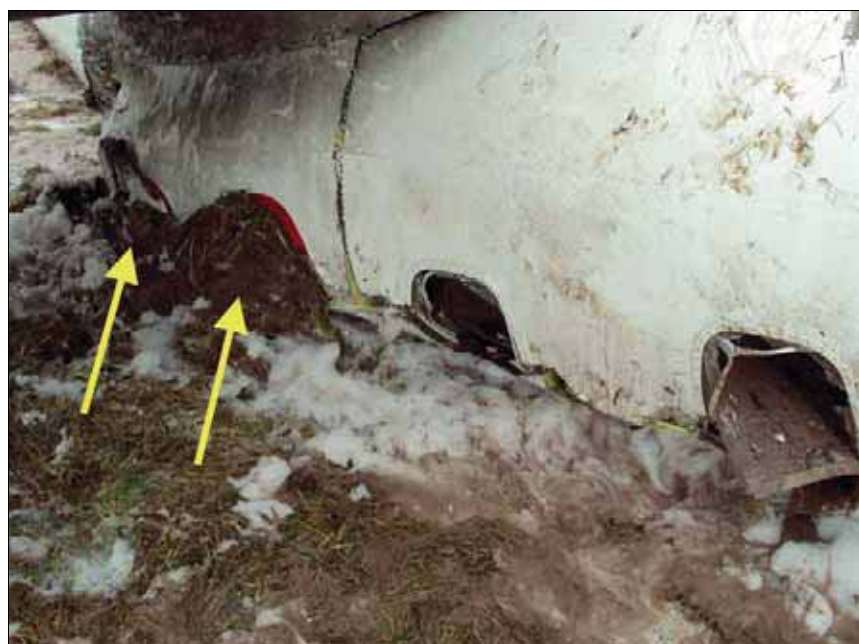
The AFS could not gain entry into the aircraft by normal means as the passenger door at the front left of the fuselage was severely crushed and could not be opened. The three emergency exits in the cabin were unusable due to crushing and were also blocked with soil from inside the cabin (**Photo No. 12**).

Photo No. 12: Starboard Emergency Exits

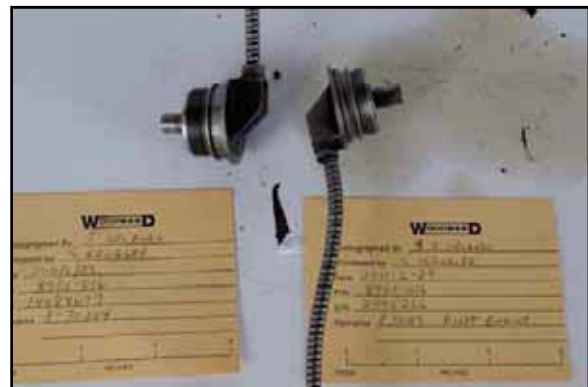
Photo No. 2:

According to the component manufacturer, the P_{T2}/T_{T2} Sensor was produced in August 1999 and was not returned to the manufacturer for any subsequent maintenance. The P_{T2}/T_{T2} sensor bellows displacement was measured using measuring tool WT-51467 # 1 (**Photo No. 1**). The height of the bellows was measured from the inside of the outer flange to the center of the bellows stem measured was 0.947 inches at a room temperature of approximately 75°F (specification is 1.023 ± 0.002 inches at 75°F). This is consistent with the sensor reading a lower temperature value than actual. The height of the bellows being considerably shorter than required would be consistent with a breach within the system (**Photo No. 2**).

Bellows height comparison

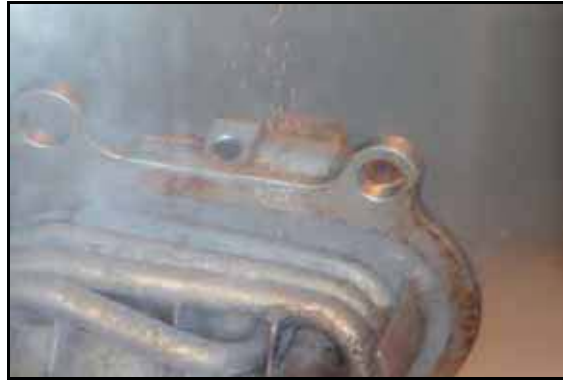
No leak (bubbles) was noted coming from the bellows but a streak of bubbles was noted coming from the sensing tube (**Photo No. 4 & Photo No. 5**). The sensing tube was marked where the bubbles appeared to have been coming from (**Photo No. 6**). Additional examination will be needed to determine the exact location and cause of the breach.

Photo No. 4: Sensing tube leak

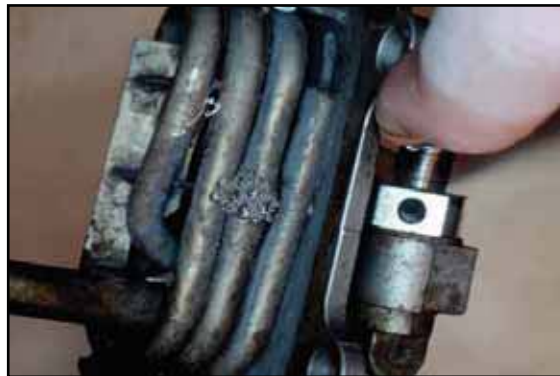
Photo No. 5: Sensing tube leak

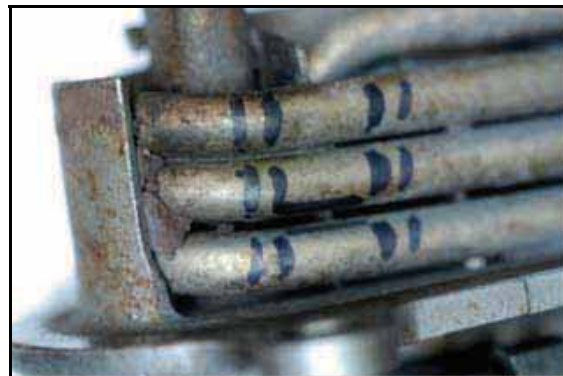
Photo No. 6: Possible sensing tube breach location

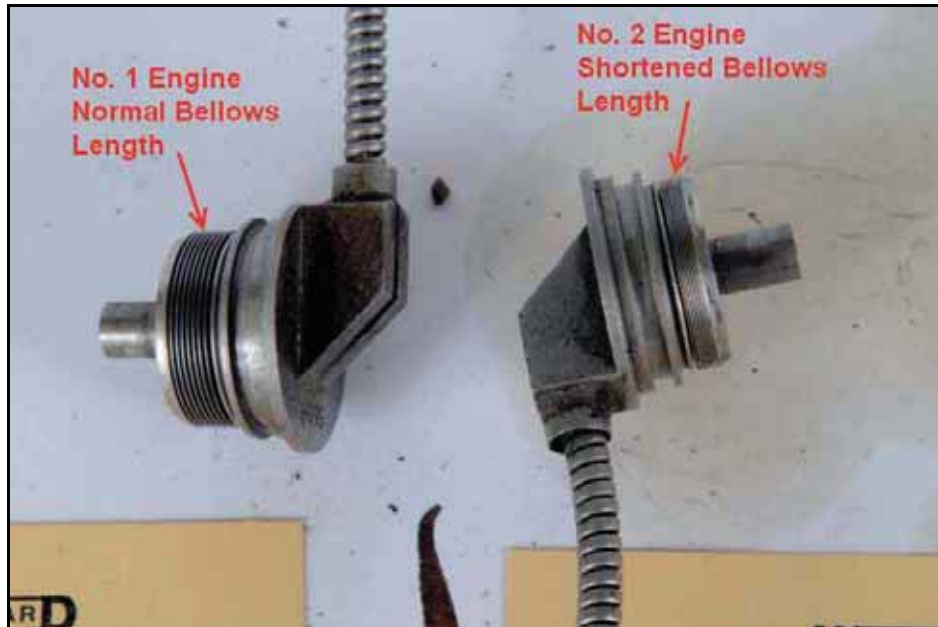
The length of the No. 2 engine bellows being considerably shorter than specified is consistent with a breach or leak within the system.

Photo No. 1: P_{T_2}/T_{T_2} sensor bellows from No. 1 and No. 2 Engines
