M/V “SUNPOWER” R- 043-2015 -DIAM
IMO No. 9521643
DATE: 26th July 2015

**REPORT ON THE INVESTIGATION
OF CARGO OVERFLOW AND POLLUTION ON**

M.V. “SUNPOWER”

On the 26th July 2015

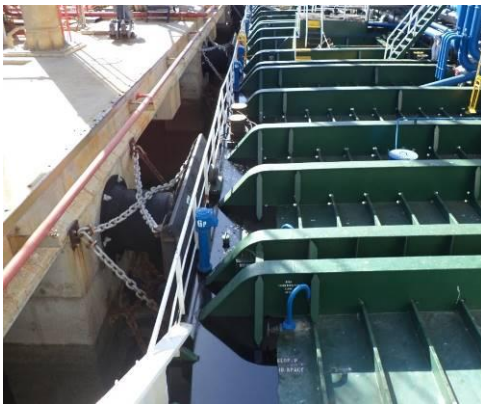
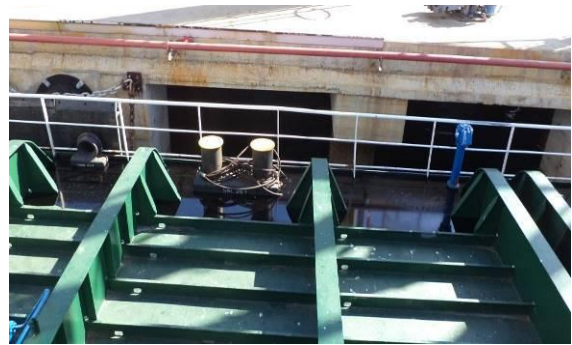
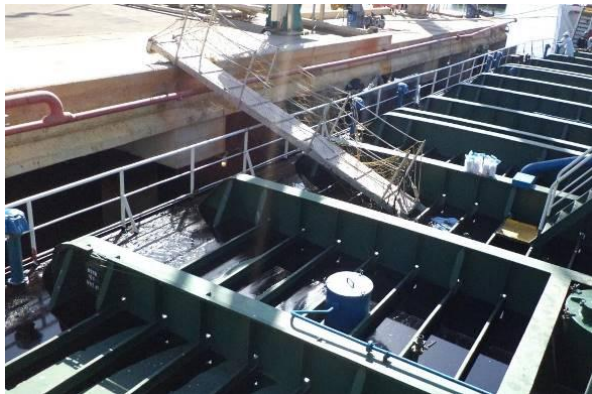
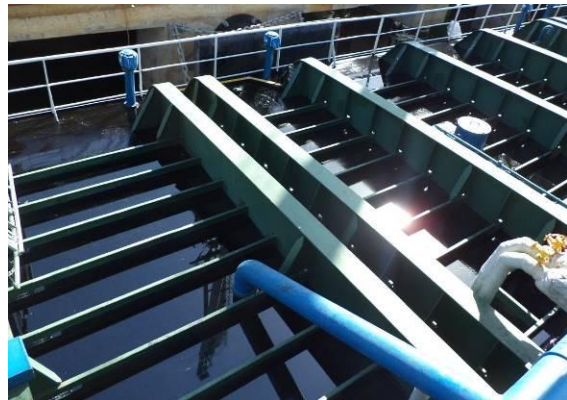
- 3.27 While topping up the slop tanks the 98% High level alarm was activated and silenced by the duty officer.
- 3.28 At that same moment the crew on deck spotted an overflow from tank 1 Port hatch which was not fully closed.
- 3.29 The emergency stop button was immediately pressed and SOPEP procedures started to avoid pollution at sea.

Figure 3.2– Port Side Overflow

Figure 3.3– Port Side Overflow

Figure 3.4– Port Side Overflow

Figure 3.5– Port Side Overflow

- 6.12 Tank no. 1 port cargo line valve was not properly closed hence allowing cargo into the tank while topping up the slop tanks.
- 6.13 The hatch cover for tanks was not closed tight foreseen sampling on completion of loading.
- 6.14 High level alarms were somehow ignored since they were reset by the duty officer.

- 10.1 Distribute a safety notice throughout the fleet describing the accident and including the accident in the following scheduled safety training.
- 10.2 Comprehensive internal audit focusing on the crew familiarization with the onboard SMS.
- 10.3 Ensure that all cargo tanks are closed and valves are double checked
- 10.4 Ensure that radar system ullage readings are considered by the duty officer.
- 10.5 Consider the possibility to build reading panel in main console.

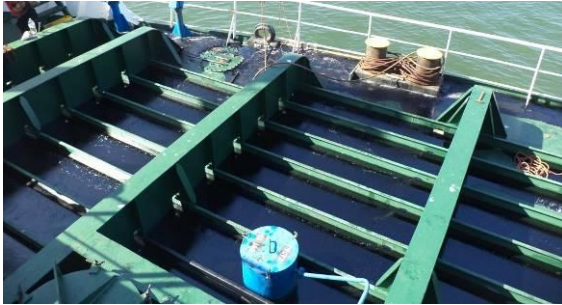
Figure 3.6– Starboard Side

- 3.30 During cleaning and early assessment of the overflow, an unknown quantity of cargo was spotted on the water surrounding the vessel's hull on the port side.
- 3.31 Charterer emergency number was contacted followed by the Spanish national pollution number as taken from the MSC-MPEC.6/Circ.13
- 3.32 The amount of cargo spilled was estimated on 20 tonnes.

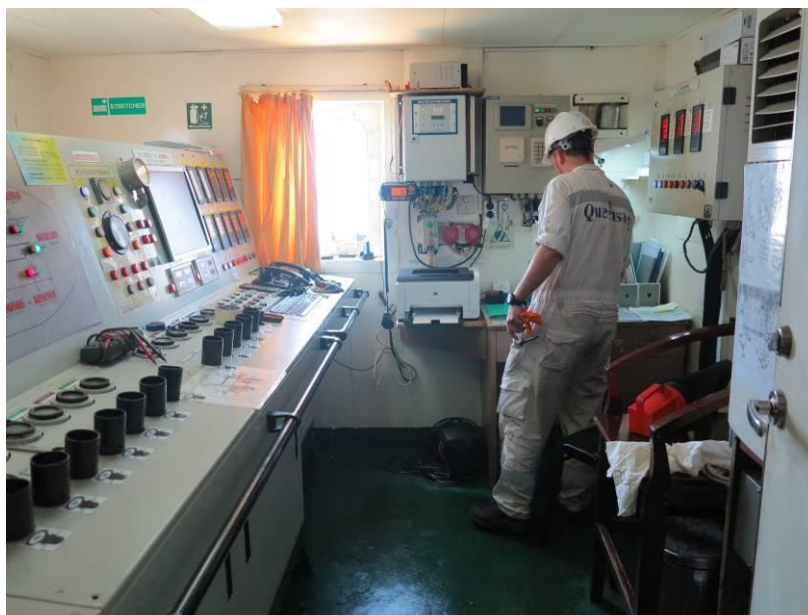
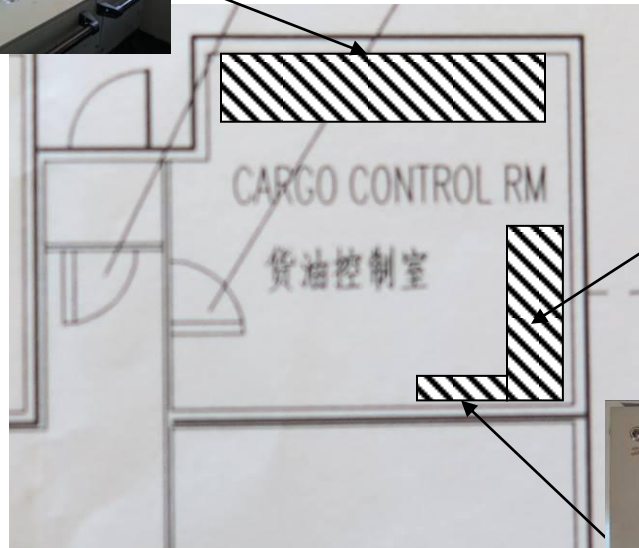
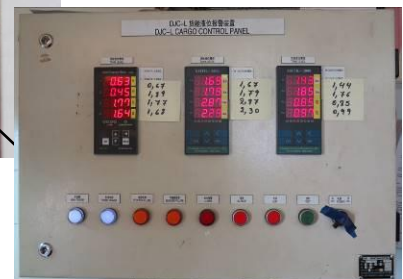
- 6.5 Despite being fitted with a radar system, the officer on duty was observed to rely on ullage information from the AB on deck.
- 6.6 The radar reading panel is currently fitted facing backwards to the duty operator) who is normally said to be working on the computer and controlling the valves on the main console.

- 6.7 Therefore the duty officer tends to look to the console but not to the radar reading gauges.

Duty Officer during cargo operations looking to the main console, VHF and table, leaving ullage Reading son his back

- 7.3 The radar design of the cargo control room was such that while the duty officer is watching the main console, the radar gauge readings are behind. Therefore it was an error not to keep an eye closely on the readings shown on the panel.
- 7.4 There valves are manually closed and open on deck with no visual indication if they are open or closed. This might have contributed to the fact that the operator on deck could not have either closed properly the valve or that the valve had been left open.
- 7.5 It was mentioned during the investigation that port state control found that the radar gauge from the tank no. 1 port although at the time of our investigation the gauge was giving apparently correct readings.

- 7.10 The design of the control room somehow contributed to the accident since the fact that the radar gauge readings are opposite to the console does not help the operator in controlling the ullages insitu while working on computer and looking at the main console.

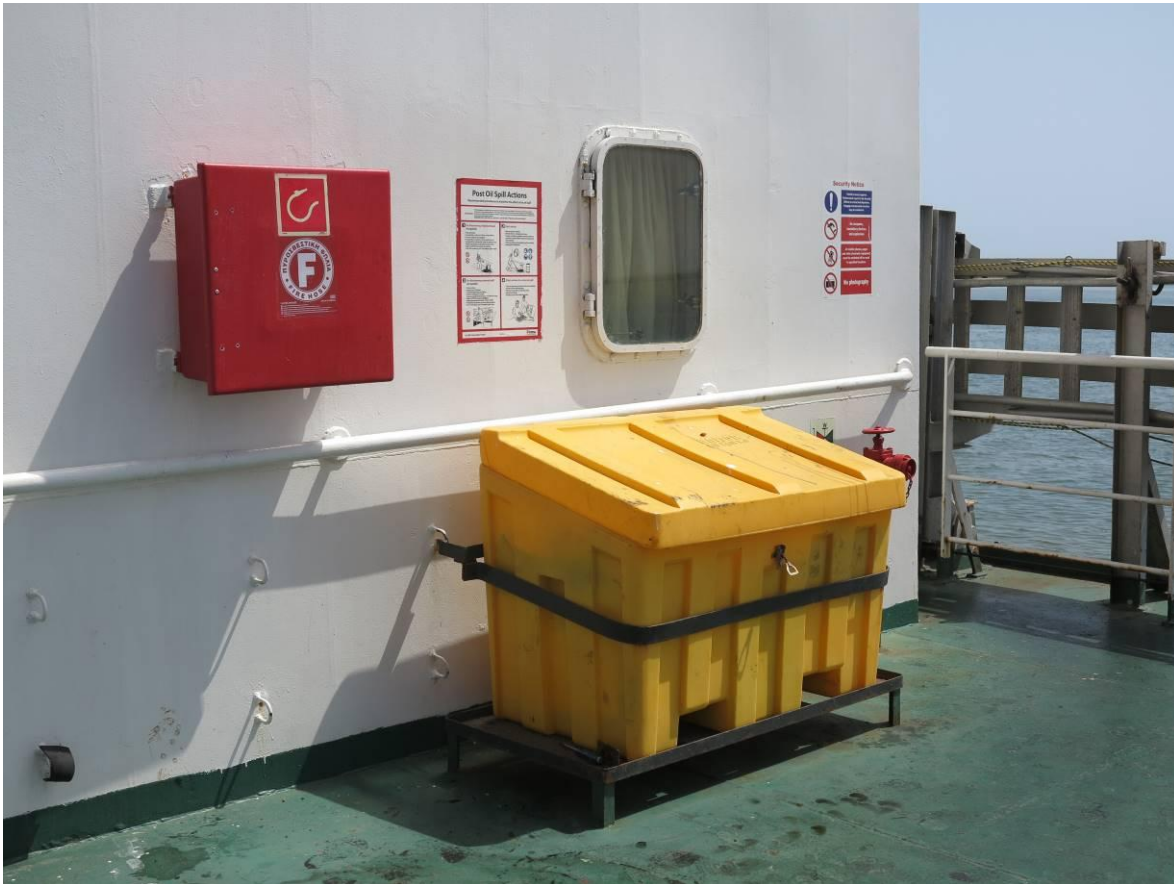
Figure 6.2–SUNPOWER SOPEP Locker

- 6.15 On discovery of the overflow the reaction and the timing to stop loading via the emergency stop button was adequate.
- 6.16 All crew had been familiarized with SOPEP procedures.
- 6.17 All SOPEP material was in good condition and was able to be immediately used..
