Panama Maritime Authority
Directorate General of Merchant Marine
Marine Accident investigation Department

REPORT: M.V. PINE 5" R- 037-2015- DIAM

IMO: No. 9438391

INVESTIGATION REPORT

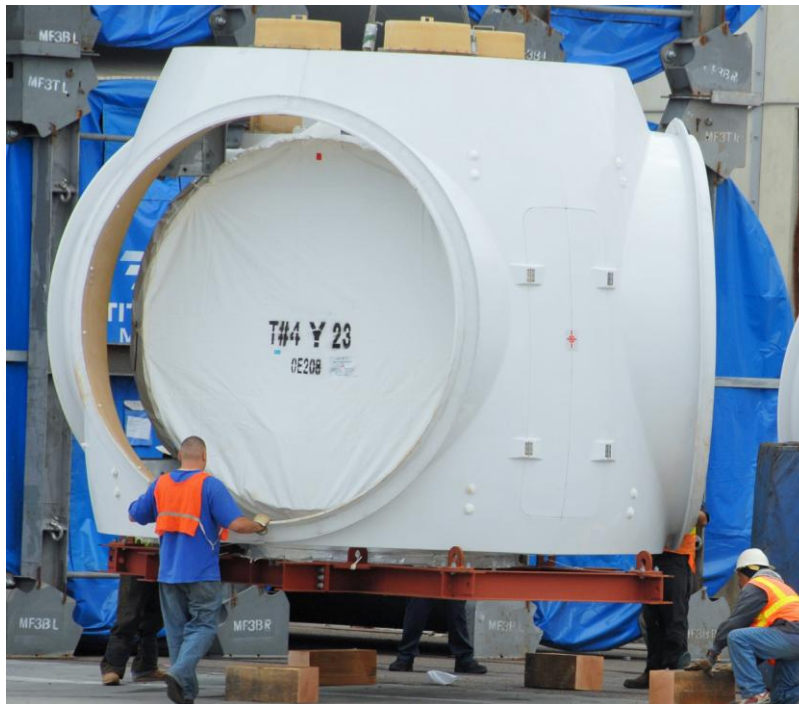
LOADING OF NACELLE

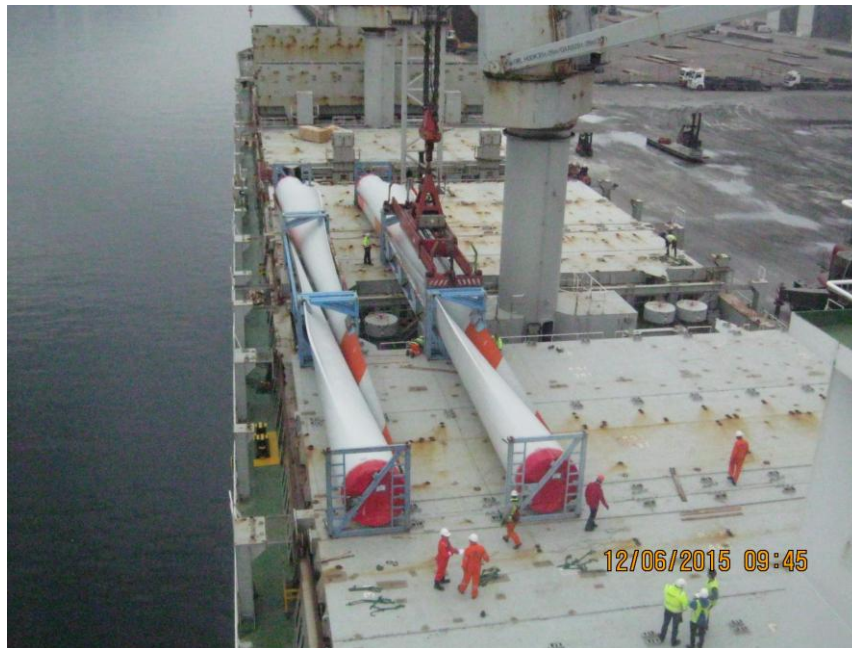
Wind Mill Blades being loaded on top of No. 4 & 5 Hatch Covers

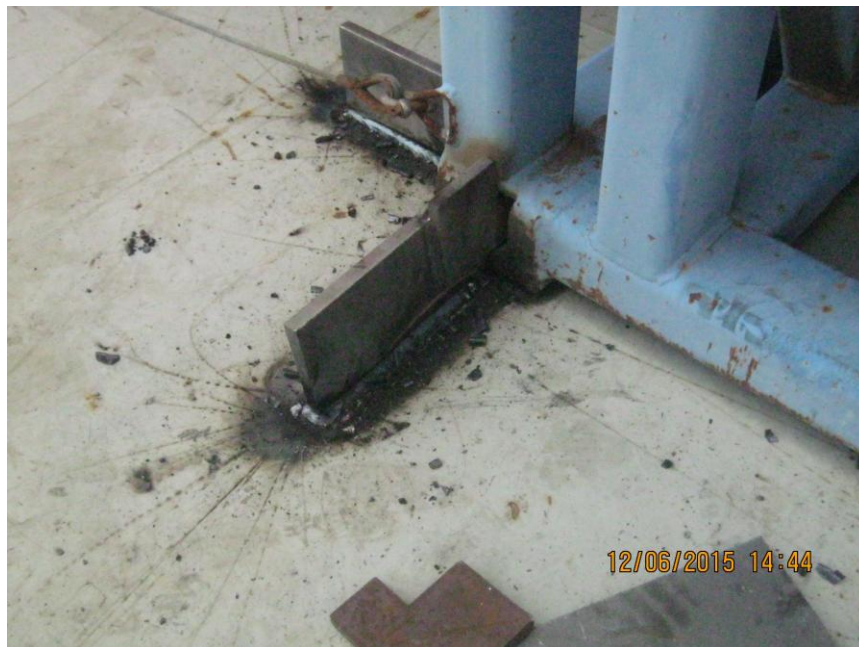
Welding of Lashing Stoppers on top of Hatch Covers
