CIAIM-08/2017 REPORT

Grounding of the vessel TIDE NAVIGATOR at the Port of Vilanova i la Geltrú on 2 August 2016

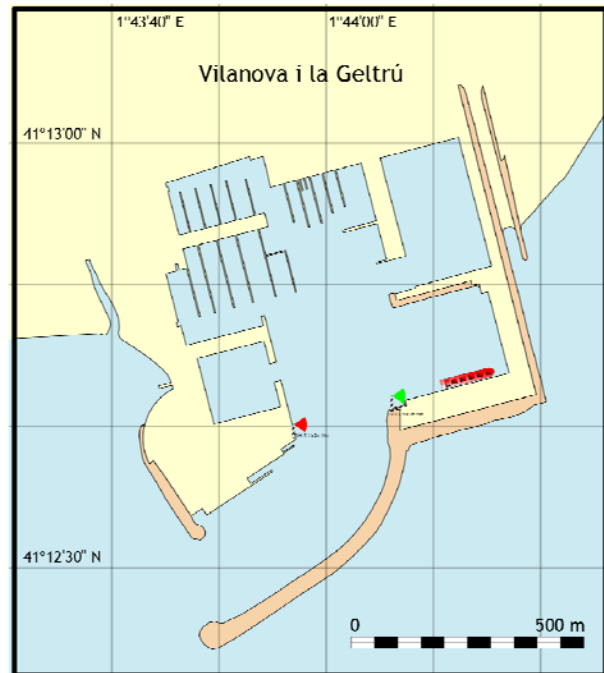
Figure 4. Port of Vilanova i la Geltrú. In red, mooring site of the ship TIDE NAVIGATOR

By approximately 12:30, the ship was berthed to starboard at the Baix a Mar dock (Figure 4).

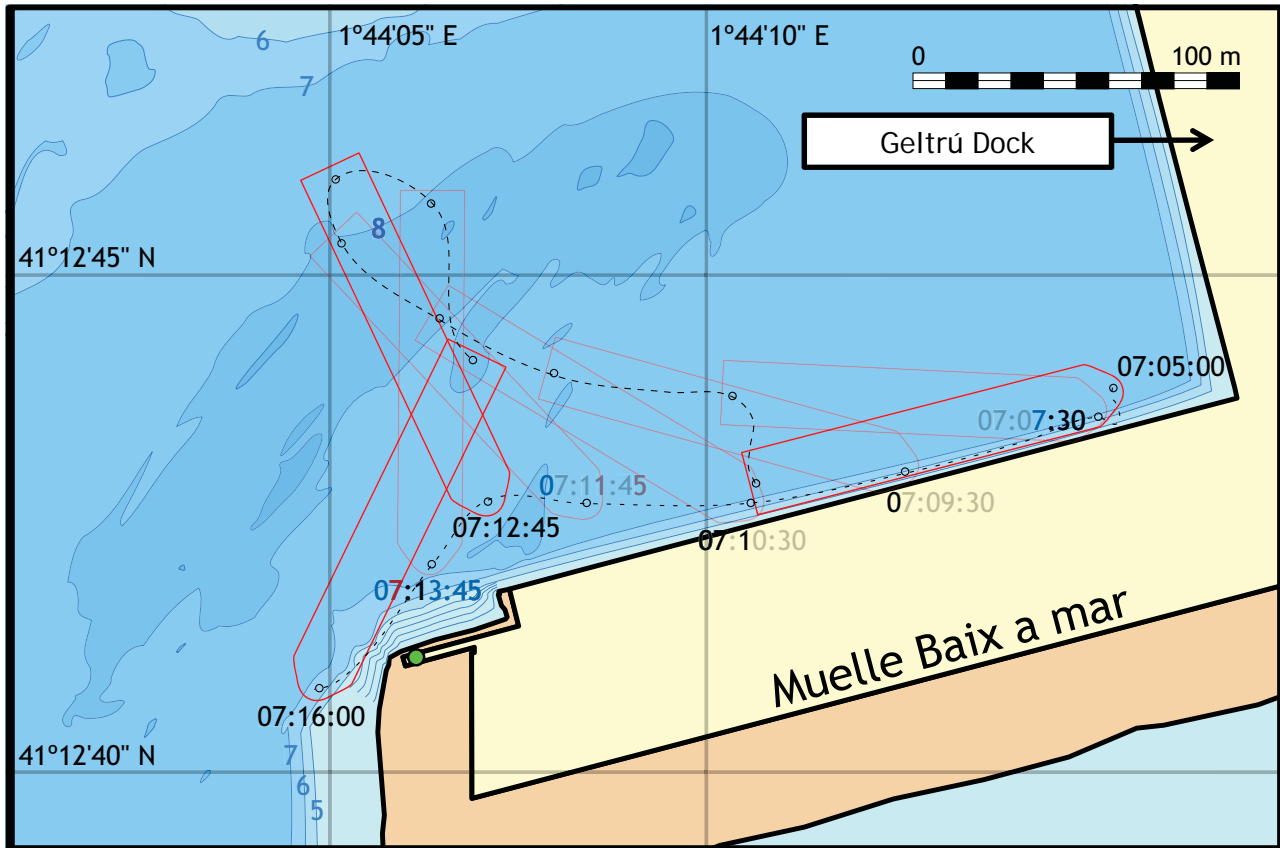
Figure 5. Diagram of the exit maneuver by the ship TIDE NAVIGATOR at the Port of Vilanova i la Geltrú, showing the ship's successive positions.

The ship's stern was maneuvered away from the dock, and the ship moved aft until the stern was in the middle of the commercial harbor (see Figure 5). The ship then had to halt its backward momentum by ordering ahead slow until it came to a stop and then rotate with the

help of the maneuvering thruster. However, since the ship was moving faster than recommended (1 knot in reverse), the captain had to increase the forward thrust to offset the inertia.

This excessive forward thrust not only stopped the ship, it made it move forward before it was able to complete its turn and line up correctly with the exit channel.

At 07:16 the ship was unable to line up with the exit channel and as it attempted to turn to starboard, the port side of the bow ran aground when it struck the side of the dock's closure dams.

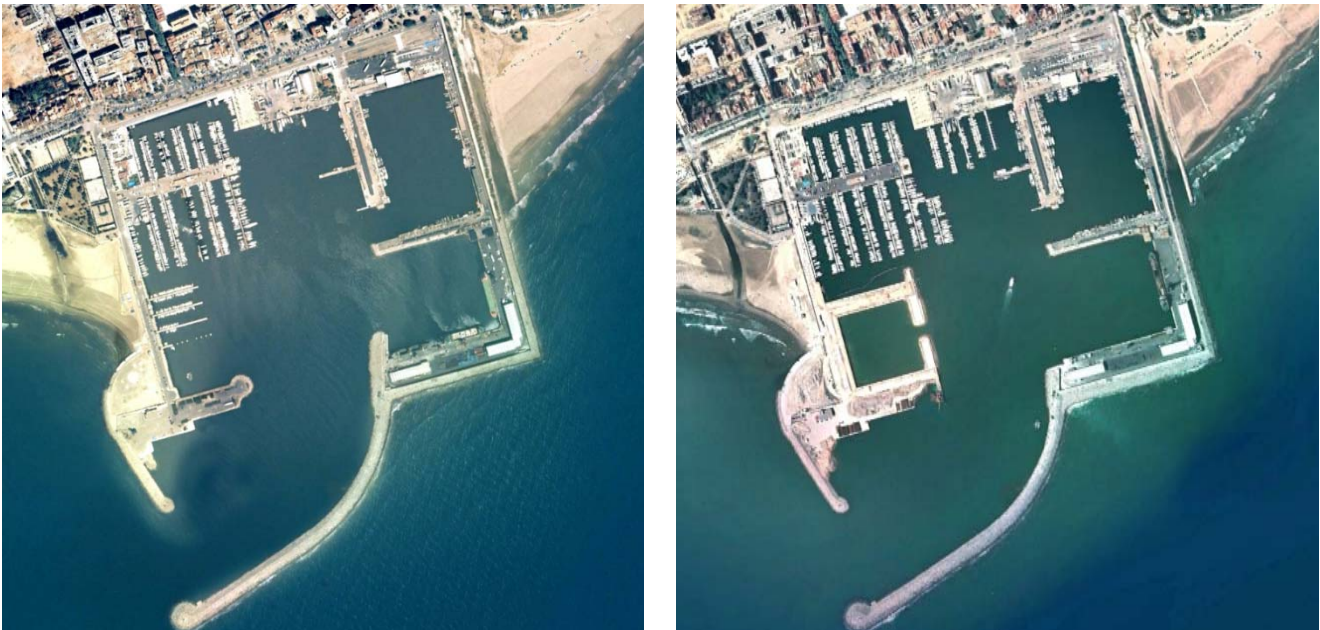
Figure 6. Before and after the modifications at the Port of Vilanova i la Geltrú.

The area where M/V TIDE NAVIGATOR ran aground was modified years ago (see Figure 6).

At one end of the commercial harbor, a jetty that was perpendicular to the dock was removed. Even though the bottom in the rest of the port is sandy, in the area where the jetty used to be the seabed is made of rock.

Since the ship ran aground atop a rocky seabed, the damage was much more severe and the refloating process more complicated than if the bottom had been sandy.

The damage to the ship involved an area of the ship's bow on the port side measuring 9 m long by 3 m wide. The hull plating between frames 150 and 159, from the forepeak to the double bottom of the bow thruster housing, was deformed. Five cracks some 15 cm long were found between frames 155 and 156, which caused flooding in the forepeak.
