STANDING
COMMISSION FOR
MARITIME
ACCIDENT
AND INCIDENT
INVESTIGATIONS

MINISTERIO
DE FOMENTO

ANNUAL
REPORT
2010

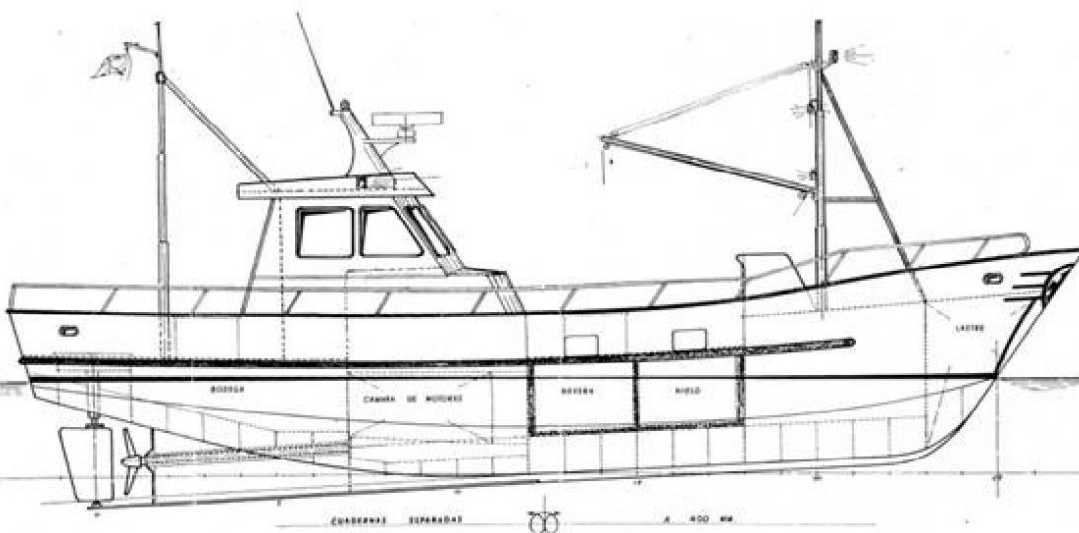
A-05/2010. JOSE ALMUIÑA

Long-line fishing vessel JOSE ALMUIÑA capsized in the Atlantic Ocean after the fishing hold flooded during fishing rig hoisting operations under foul weather conditions. The vessel sank and four of her crewmembers were declared missing.

The investigation found that the vessel's design included certain vulnerabilities during operational errors, which placed the vessel at risk. The fact that the vessel underwent modifications that were not authorized by the Administration and that it left port in an overload condition contributed to the accident.

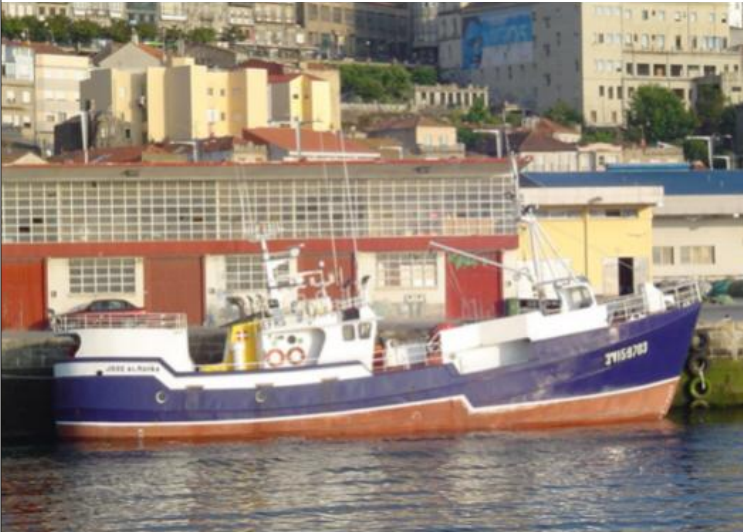
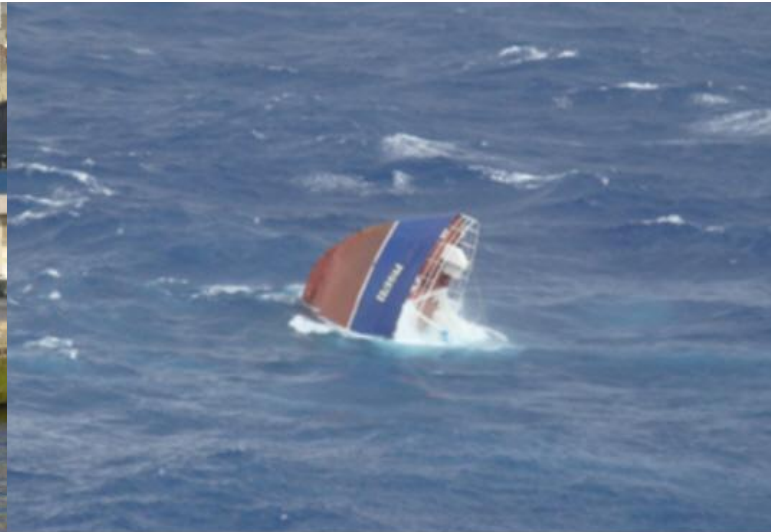
Deficiencies were also detected in the certification and training of the crew and in the distress call procedures that were used; and also, the hydrostatic release mechanism of one of the life rafts failed, preventing it from deploying.

The CLAIM provided eleven recommendations to the European maritime administrations, to fishing vessel designers and to the companies that manufacture GMDSS equipment and life rafts, which were aimed at correcting the discrepancies that had been discovered.

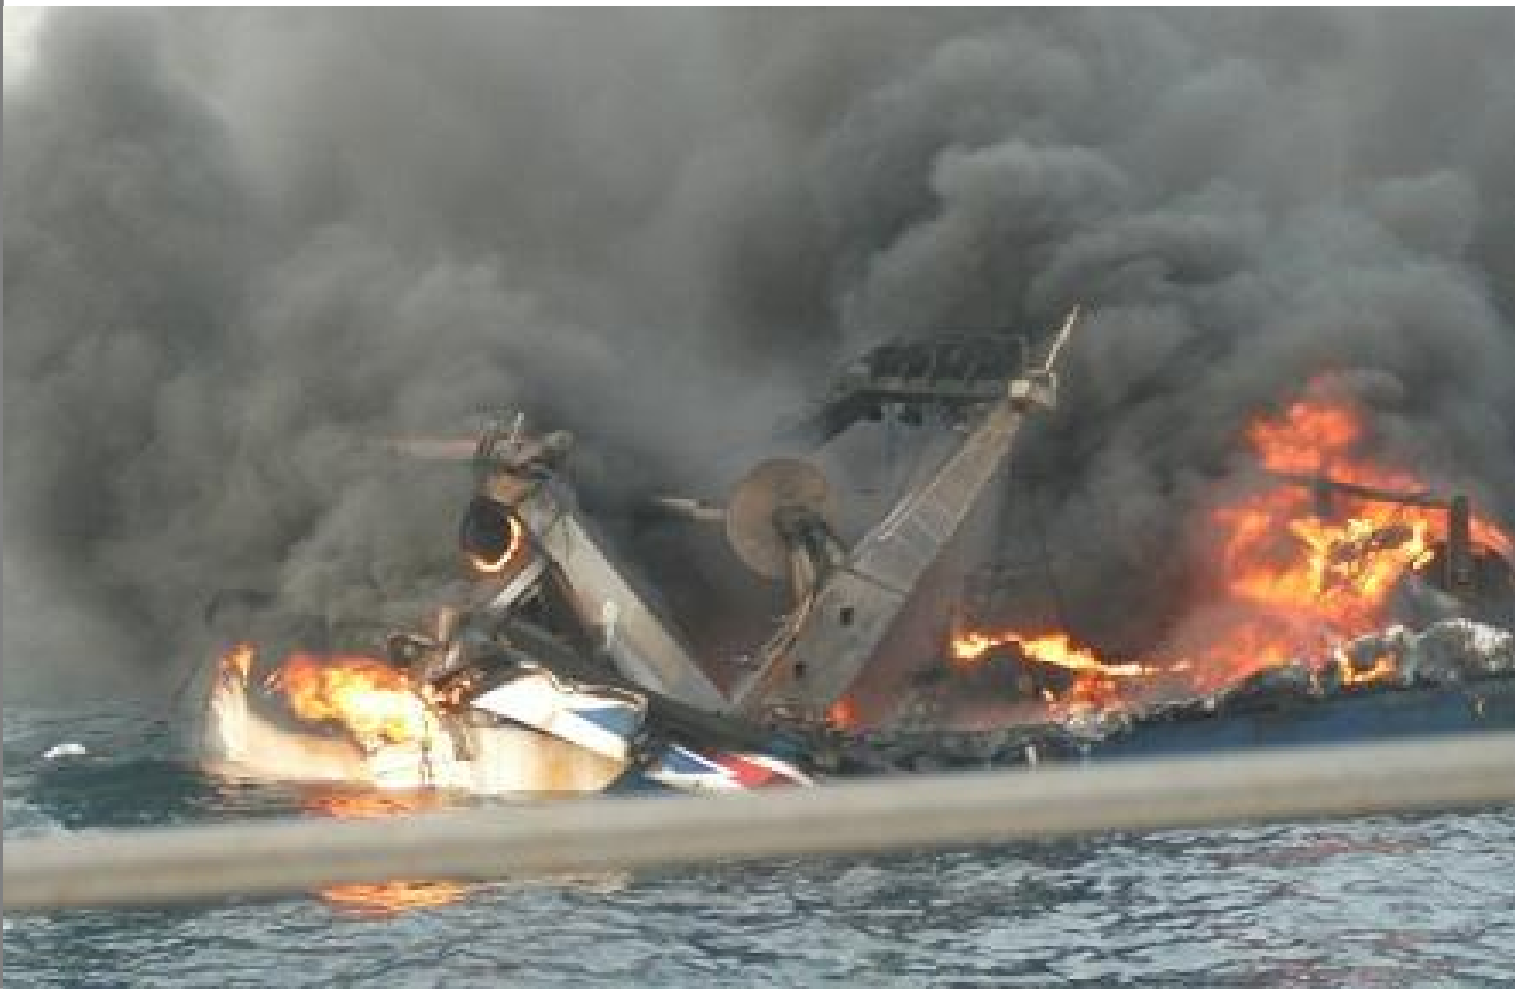
The engine room of fibreglass fishing vessel NOU ESQUITX caught on fire and it could not be controlled by the crew. The fire spread to the rest of the vessel, which ended up sinking in spite of the efforts by SASEMAR and the Catalanian Fire Department to save her. However, the crew was safely rescued.

The fire was caused by a gas-oil leak, which spilled onto a hot surface of the engine; the fire could not be controlled due to the low fire resistance of the materials used in its construction and because it was not possible to completely close the engine room compartment. The subsequent action carried out by the emergency services was unsuccessful in extinguishing the fire.

The CIAIM provided five recommendations to ship-owners, fishing vessel skippers and designers, and public administrations.

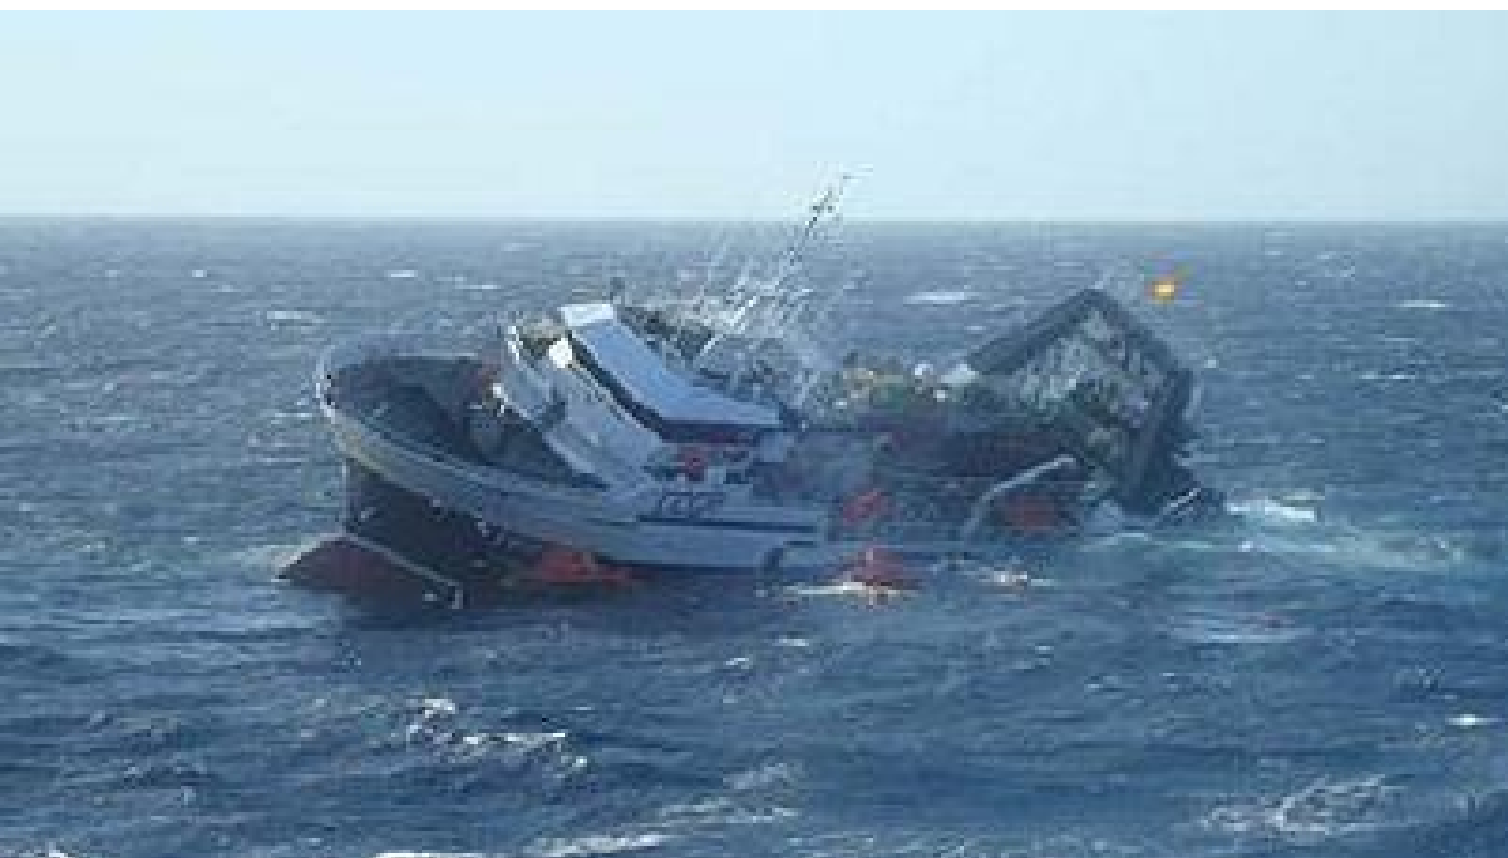
A-10/2010. MONTE GALIÑEIRO

Trawler vessel MONTE GALIÑEIRO sank while it was operating 235 miles from Saint John's after an uncontrolled flood broke out inside her engine room. The origin of the flood could not be determined, but because the vessel sank quickly, it was determined that the flood must have occurred through the sea water collector; however, other hypotheses were not ruled out.

During the investigation of this accident irregularities were detected in the vessel's operation, which resulted in eleven recommendations aimed at the ship's designer, the ship-owner, the administration and to fishing vessel owners in general.

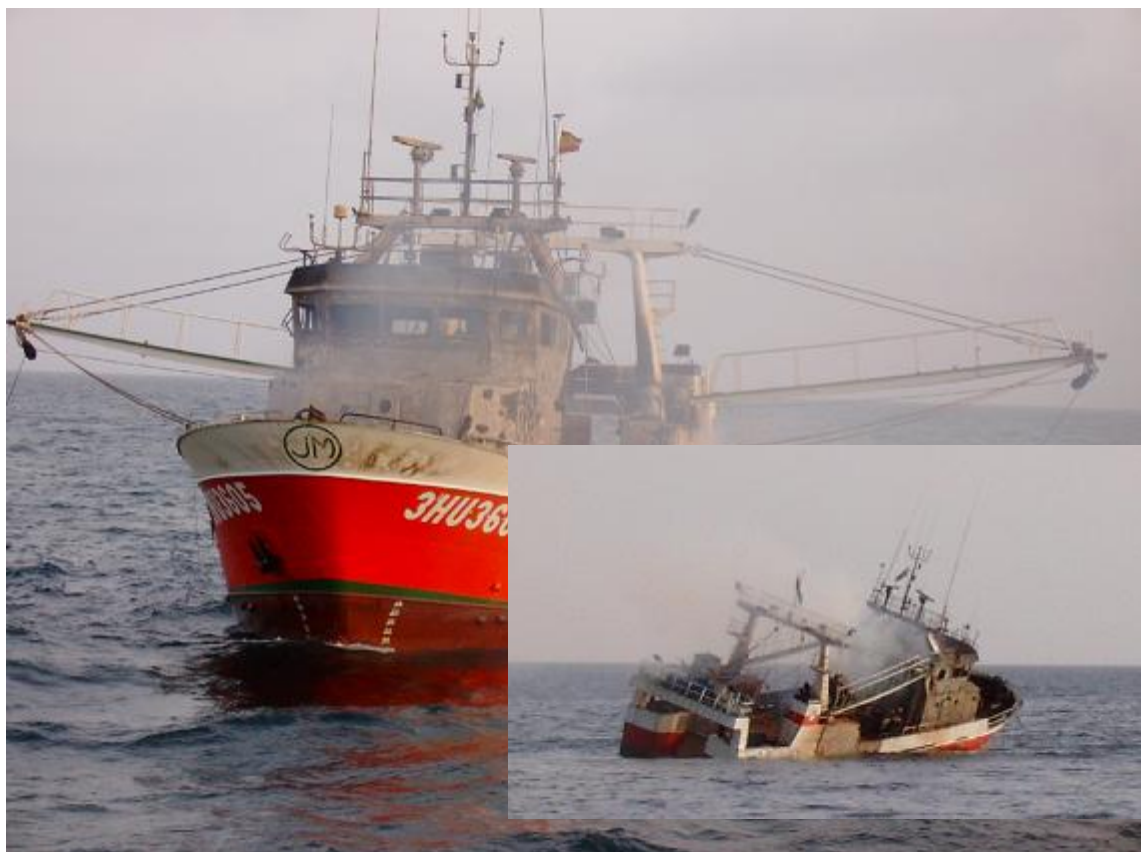
A fire broke out on board fishing vessel PEIX MAR TREINTAYUNO while it was operating off the coast of Mauritania. The fire was controlled and the vessel was towed to the port of Dakar by another fishing vessel owned by the same company. Improper procedures carried out by the Dakar fire Department caused the vessel to finally sink because the water that had been sprayed on board could not be pumped out.

During the investigation, it was determined that an efficient control is not carried out of the fishing vessels that operate at Mauritanian fishing grounds as part of the fishing agreement between the EU and that country. This lack of control extends to the enrolled crewmembers, their certifications and the quality of their training as well as the safety conditions on board.

The CIAIM provided five recommendations; three for the ship-owner and two for the administration to improve the procedures for controlling fishing vessels operating off the coast of Mauritania.

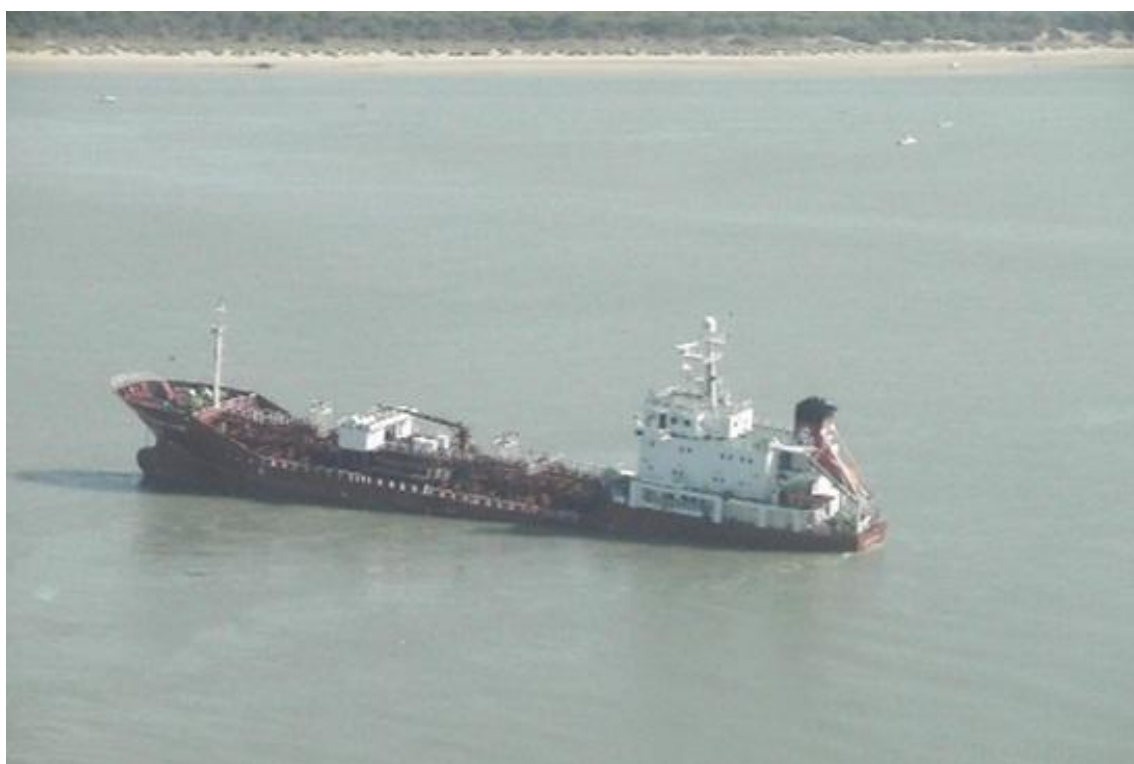
A-13/2010. SICHEM COLIBRI

Chemical tanker SICHEM COLIBRÍ, which was transporting dangerous cargo, lost steering due to a steering gear failure when she was beginning her journey up the Guadalquivir River in Seville. Given the proximity to the coast, her running aground at the mouth of the river could not be avoided; however, she did not suffer serious structural damage or loss of cargo.

The failure consisted in the accidental breaking of a steering gear hydraulic circuit valve. The CIAIM provided recommendations to the manufacturer of the steering gear to ensure that the manufacturing process meets the specifications of the system. A recommendation was also provided for the Port of Seville to study the implementation of special conditions for the transiting of vessels carrying dangerous cargo up and down the Guadalquivir River.

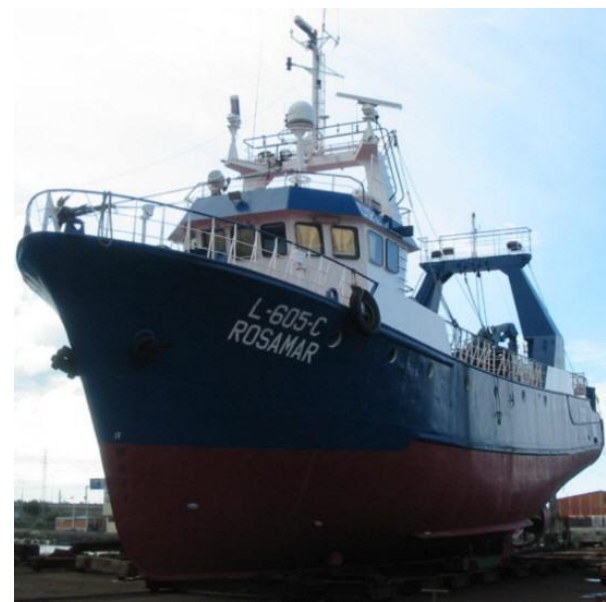
Fishing vessel ROSAMAR under Portuguese flag sank after her fishing gear got snagged and her trawling machines continued hoisting the gear while her crew was unable to release it. It was concluded that the manual control of the trawling machine had probably been improperly locked in the hoist position. Also, some design aspects of the vessel contributed to the flooding, which could not be controlled.

The necessary recommendations were issued to correct these deficiencies and the maritime administration was asked to carry out studies regarding the snagging of fishing gears in order to develop operating procedures for Skippers to follow during these situations..
