# TECHNICAL REPORT A-15/2010

Investigation of the sinking of F/V ROSAMAR,  
24 miles from Burela on the 5th of December, 2008

# Technical report

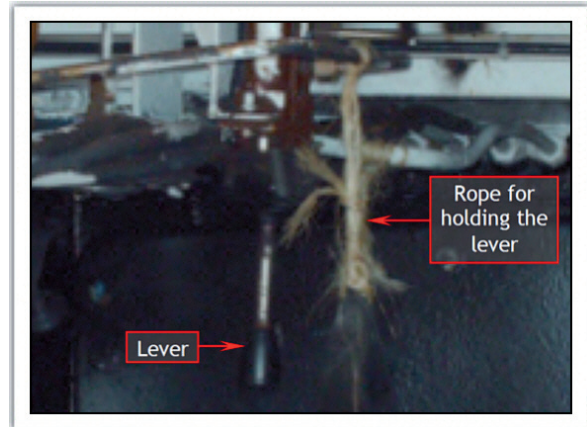
**Figure 20.** Piece of rope used to hold the trawling machine's manual operating lever

Operating the machines in manual mode required that crewmembers be present next to the machines or at the controls for the machines that were located in the wheelhouse. Since at the time of the accident, none of these conditions were met, it was thought that this could not have been the operating mode of the machines during the accident. However, after having visited F/V PENNINSULA, sister to the mishap vessel, it was interesting to see that next to the manual operating lever for the trawling machines there was a piece of rope that was used for holding the lever in several hoisting positions, as can be seen in figure 20. The use of this rope allowed the crew to momentarily leave the lever in a hoisting position while they left the area to carry out other tasks.

If when the gear gets snagged and the machines are operating with the constant tension control engaged, the tension applied to the cable would not cease and this tension would in turn be transmitted to the vessel, sinking her stern, just as occurred to F/V ROSAMAR. If at the time of the accident, the machines had been operating with the constant tension control engaged and this system would not have malfunctioned, it would have sufficed if the Skipper or the Fishing Skipper had disconnected it from the panel located at the wheelhouse, which was easily accessible, and the machines would have stopped hoisting. However, the fishing Skipper did not attempt to access the machine's controls that were located at the wheelhouse upon realizing that he could not reach the fishing machines, and the Skipper did not use said controls. Therefore, it is considered that at the time of the accident, the constant tension control system was either disconnected or it malfunctioned and could not be disconnected; the latter would be the second hypothesis explaining the causes of the accident.

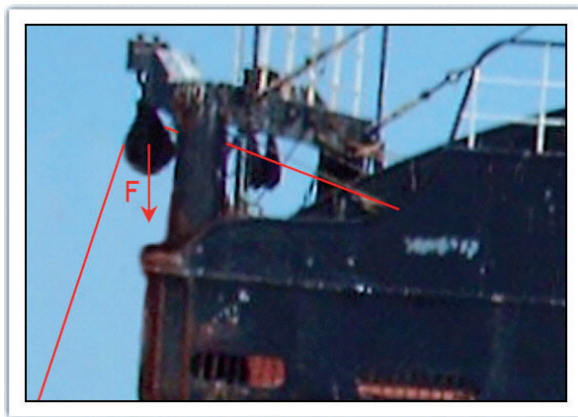
**Figure 21.** Downward vertical force generated by the machine's hoisting after the gear getting snagged

on the cables generates forces on the snatch blocks that are broken down into horizontal forces, which push the vessel towards the location where the gear got snagged, and vertical forces that push the stern downward.

Figure 21 shows the point where the vertical forces act upon one of the snatch blocks.

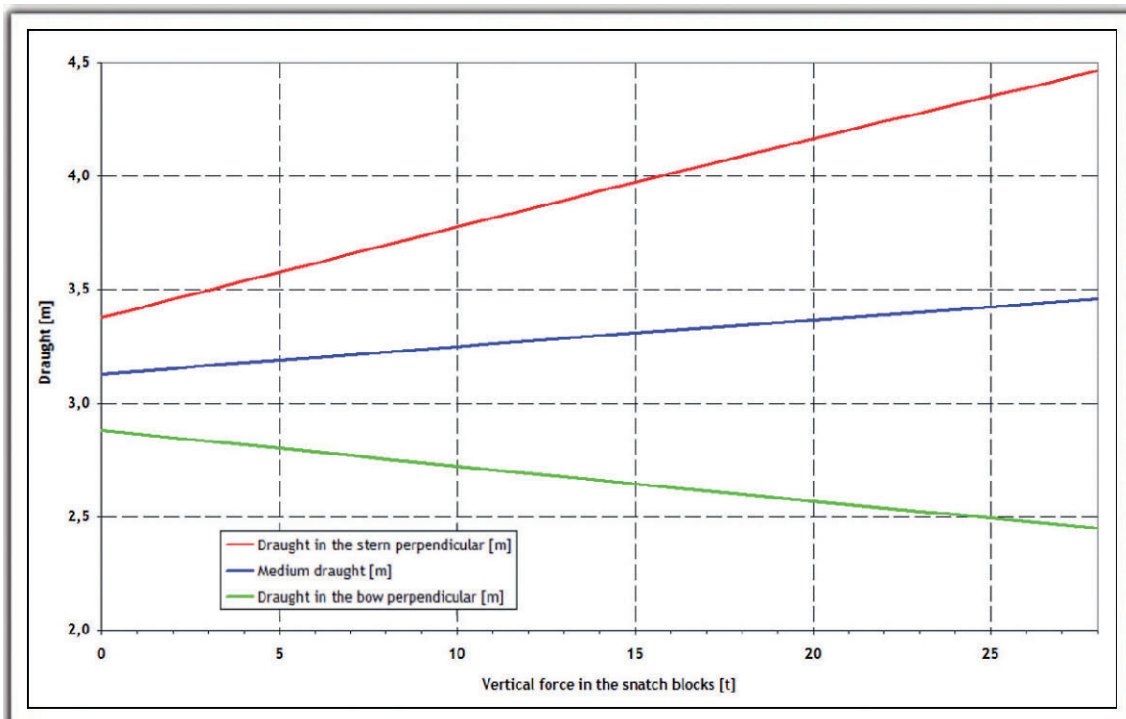
**Figure 22.** Vessel's draughts in calm seas according to the vertical forces acting on the snatch blocks

The approximate draught conditions that the vessel would have had in calm seas as the total vertical force applied to the gear's snatch blocks was increasing, has been calculated. To accomplish this, we have used the vessel's stability test data and the load condition at the time of the accident according to the statements provided by the crew.

The result of this calculation is shown in figure 22, where the red line corresponds to the draught of the stern perpendicular, the green line to the draught of the bow perpendicular and the blue line to the average draught.

The crew noticed that a lot of water was entering the fish processing area through the doors used for accessing the trawling machines. The drains in the area where the trawling machines were located, which can be seen in figure 23, were adequate for draining this area. Therefore, the sea level at the time of the accident had to reach the lower part of the doors used for accessing the fish processing area, with a draught at the stern perpendicular of approximately 4 m.

The maximum pull of each machine was 14 t, and therefore, it was possible to generate a vertical force of 8 t on each snatch block, in the mode in which the machines of F/V ROSAMAR were operating in, with the reel below its average capacity. The minimum break load for the type of cable used on board the vessel was 25.5 t, which was not exceeded by the machine's pull and therefore the cables did not break.

In the graph of figure 22, we can see that the draught of the stern perpendicular of approximately 4 m in calm seas corresponded to a vertical force acting on the snatch blocks of approximately 16 t, which meant 8 t on each snatch block.

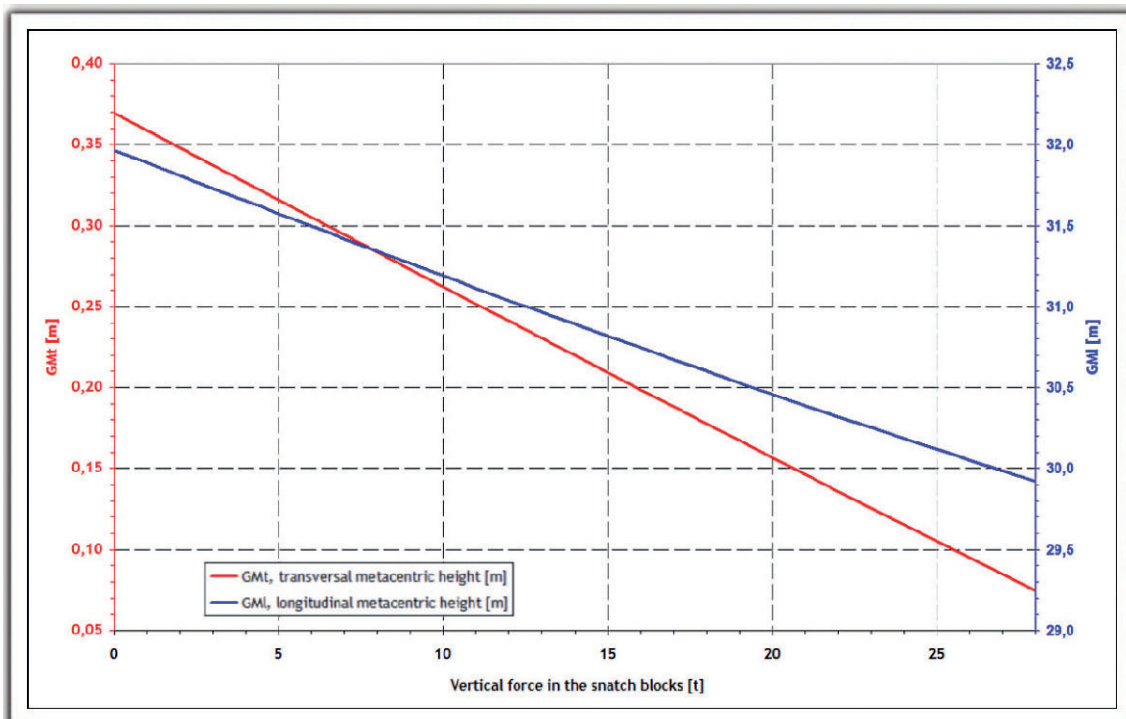
Figure 24. Transverse and longitudinal metacentric heights of the vessel in calm seas according to

The diagram of figure 24 shows the values of the transverse and longitudinal metacentric heights of the vessel in calm seas as the total vertical force applied to the snatch blocks increased. We can see that the metacentric height values de-

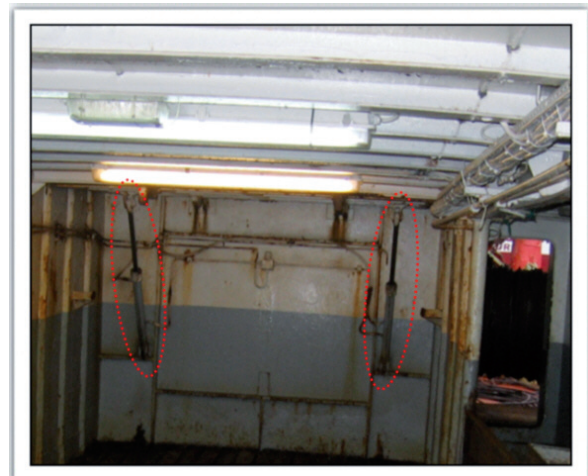
**Figure 25.** Fastening hardware for the door used for accessing the fish processing area from the upper deck

- None of the crewmembers closed the doors used for accessing the fishing machine from the fish processing area, which opened outward.
- None of the crewmembers closed the door used for going down to the engine room from the main deck.
- The hatch used for accessing the fish processing area from the upper deck opened inward

and it was held by a hydraulic locking system. This way, the hydrostatic pressure of the water that accumulated on the upper deck when the stern sank caused the hatch to open and the fishing area to flood.

If the aft door of the fish processing area and the door for the access ladder going down to the engine room had been closed, since these are watertight doors, the progressive flooding would have been avoided. In this configuration, the vessel could have been saved if the heeling towards port caused by the effects of the waves had not become so severe as to cause the progressive flooding of the vessel through other important openings.
