Report ULM A-009/2016

Accident involving an Avid
Flyer Stoll aircraft, registration
EC-YEM, flown by a private
operator, at the La Llosa
aerodrome (Castellón),
on 25 March 2016

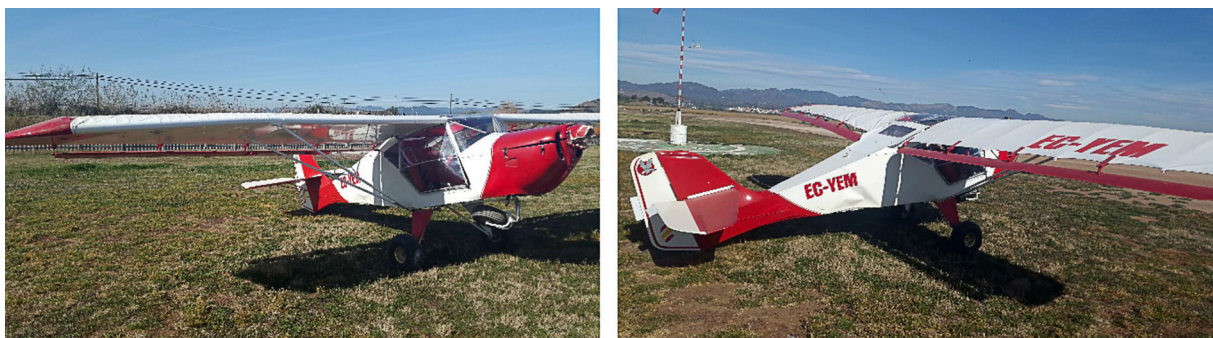
Figure 2. Damage to the aircraft after the accident

The aircraft had significant damages: the front wheel of the landing gear was bent and the struck and the wings were deformed.

The photographs below show the damage sustained by the ultralight. The landing gear was destroyed, its nose wheel bent backwards, and the wings and tail were also bent and deformed. The fuselage was warped and the propeller detached.

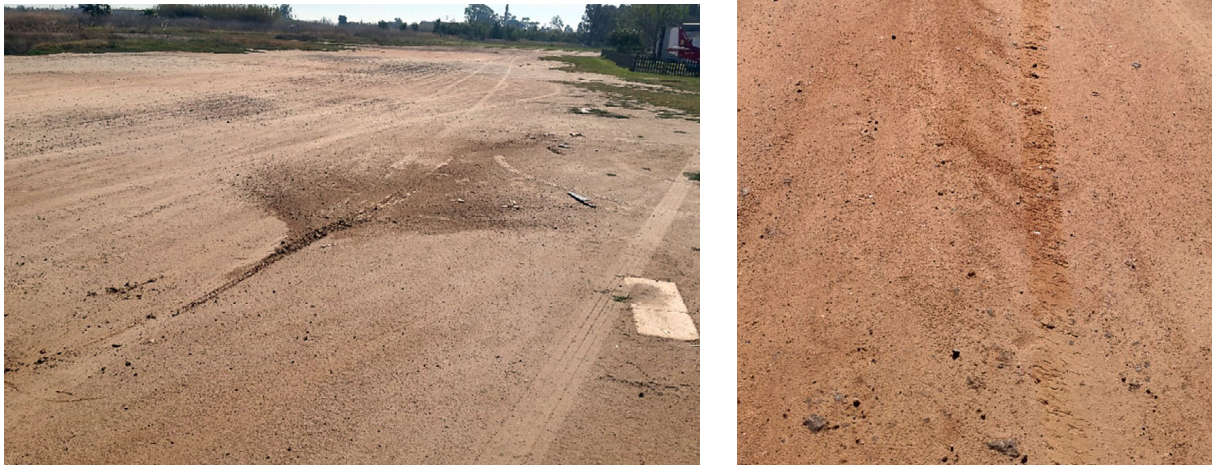
Figure 3. Marks left by the aircraft on the runway

These other photographs show the path that the aircraft took on the runway. The photograph on the right reveals that the aircraft scraped along the runway for several meters, and the one on the left shows a close-up of the point where the aircraft came to a stop and subsequently flipped over.
